Enhancing Impact Energy Absorption, Flexural and Crash Performance Properties of Automotive Composite Laminates by Adjusting the Stacking Sequences Layup

Abstract: In response to the high demand for light automotive, manufacturers are showing a vital interest in replacing heavy metallic components with composite materials that exhibit unparalleled strength-to-weight ratios and excellent properties. Unidirectional carbon/epoxy prepreg was suitable for automotive applications such as the front part of the vehicle (hood) due to its excellent crash performance. In this study, UD carbon/epoxy prepreg with 70% and 30% volume fraction of reinforcement and resin, respectively, was used to fabricate the composite laminates. The responses of different three stacking sequences of automotive composite laminates to low-velocity impact damage and flexural and crash performance properties were investigated. Three-point bending and drop-weight impact tests were carried out to determine the flexural modulus, strength, and impact damage behavior of selected materials. Optical microscopy analysis was used to identify the failure modes in the composites. Scanning electron microscopy (SEM) and C-scan

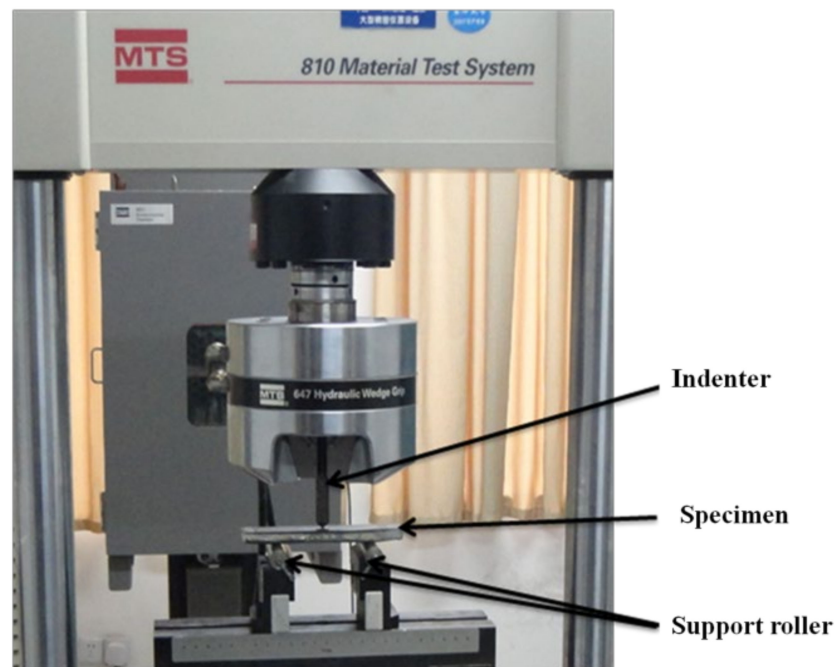
Figure 2. Three-point bending test using an MTS machine.

Flexural tests were carried out using a three-point bending test in accordance with ASTM D7264 [29], and at least three specimens for each laminate were tested. The tests were performed in a Material Testing System (MTS 810-647 hydraulic wedge grip, MTS Systems Corporation, Eden Prairie, USA) machine (Figure 2). The applied velocity was 2 mm/min, with an indenter diameter of 8 mm. The bending test specimens had dimensions of 170 mm in length and 30 mm in width and were all cut with a water jet cutter. Optical microscopic analysis was used to identify the failure mode in the specimen after the bending test. The flexural strength (σ_f) and modulus (E_f) of the composite laminate were calculated according to the following equations [9,29]:

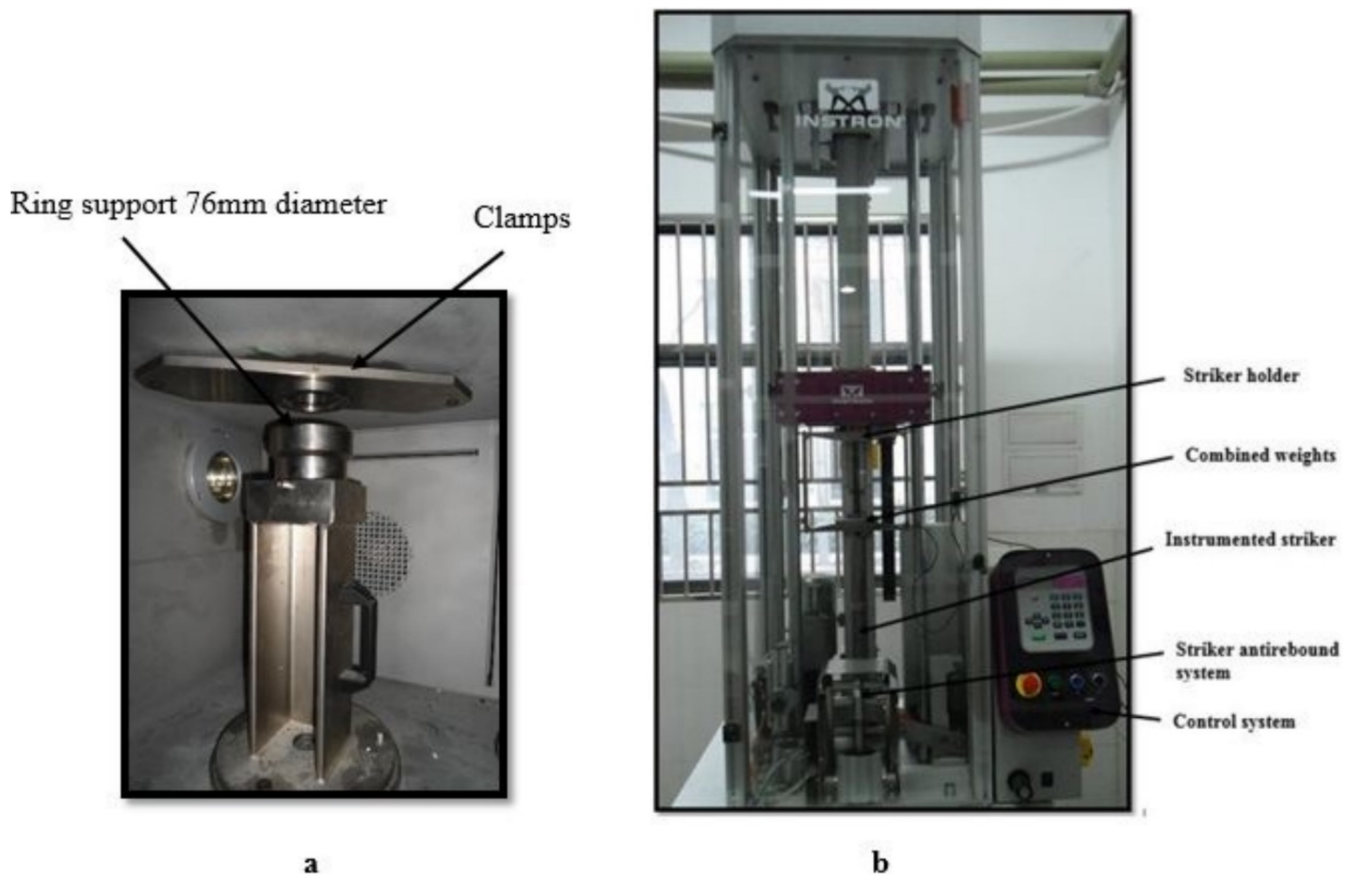
Figure 3. CEAST 9350 impact tester (a) test chamber and (b) device system.

The INSTRON CEAST 9350 drop tower impact tester machine (Instron Corporation, Norwood, MA, USA), as shown in Figure 3, was used to investigate the impact properties. The ASTM 7136 standard [30] was used as the baseline for testing. The testing process involved dropping a 2.277 kg hemispherical striker with a diameter of 16 mm on the subjects from different heights. The composite laminate was subjected to various energies of 5 J, 15 J, and 25 J. The incident velocity was 2.10, 3.63, and 4.69 m/s, with corresponding drop heights of 224.8, 671.8.78, and 1121.5 mm. Please note that low-velocity impact events occur in the range of 1 to 10 m/s depending on the material properties and the projectile mass [31,32]. At every impact energy level, at least three samples were tested. Following the impact test, the damage in the composite sample was inspected and analyzed using a scanning electron microscope (TM3000, HITACHI, Tokyo, Japan). Moreover, optical microscopic analysis was used to identify the failure mode in the specimen after the impact test. During an impact event, these equations were used to compute the absorbed energy from the load–displacement curves [33,34]:

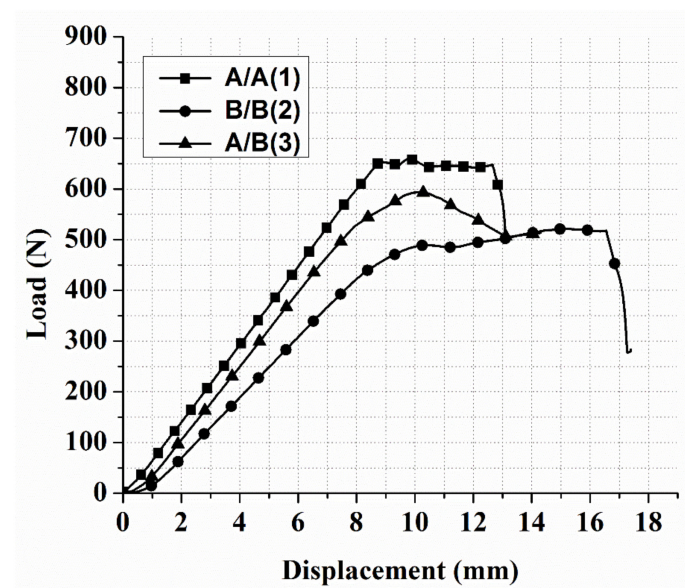
Figure 4. Load–displacement curves for CFRP composites with different stacking sequences.

The load–displacement curves obtained for analysis of the flexural strength and modulus of the composite laminates are shown in Figures 4 and 5. As can be seen in Figure 4, the performance of the flexural properties of the different stacking sequences was similar in terms of linearity up to peak load. Among all the stacking sequences, [A/A] exhibited the highest peak load, flexural strength, and flexural modulus due to the symmetry of the structure and balanced structure. The curve showed the lowest displacement among all the tested structures, revealing a brittle property. Following the peak load, the structure displayed cracks and delamination in the upper ply, indicating an occurrence of damage on the compressive side of the composite laminate. After the

crack, the structure observed a plateau region, meaning there was no more effect on the surface of the composite. Subsequent to the plateau region, the structure reached a critical point in carrying a heavy load, leading to final failure. The [B/B] and [A/B] stacking sequences demonstrated linearity, ductility (indicating a high displacement due to the high elongation property of this structure), and plateau behavior. Figure 5 shows that the [B/B] stacking sequence had the lowest peak load, flexural strength, and modulus. This is because the orientation of the ply was a critical issue in the structure. The initial slope of the load–displacement curve of [B/B] played a vital role in the flexural strength and flexural modulus value. It was observed that the highest displacement curve had the lowest flexural strength and flexural modulus.

The ply-stacking sequence was found to influence the flexural modulus and flexural strength. For all the stacking sequences used in this study, the initial slope of the load–displacement curves exhibited non-linear characteristics due to initial damage that took place on the compressive side. The orientation of the layers in the composite laminate

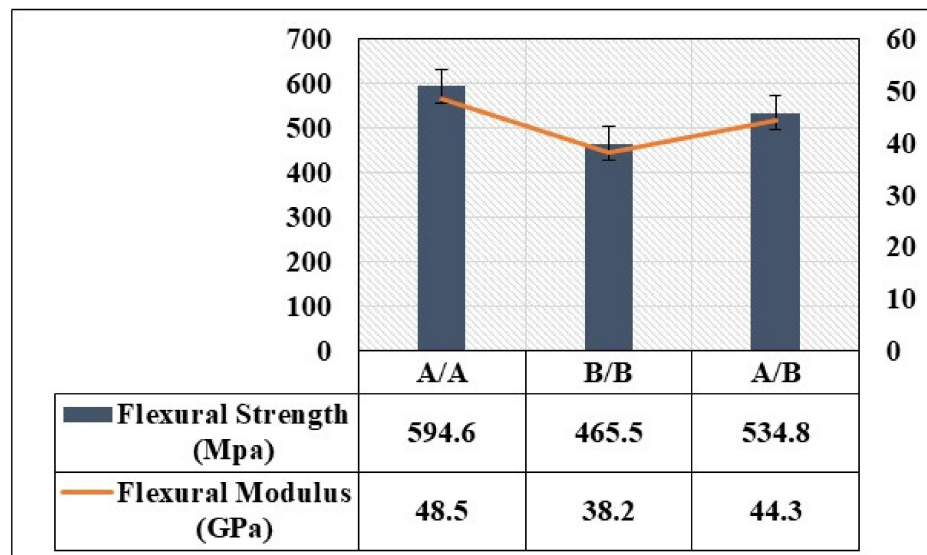
Figure 5. Flexural strength and flexural modulus of the composite laminate.

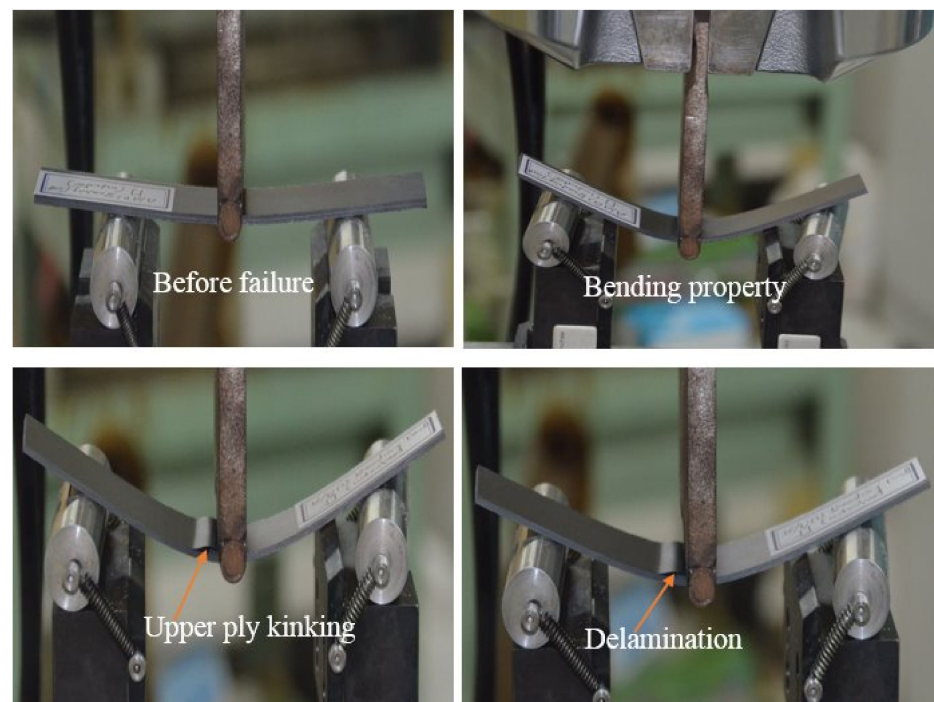
Figure 6. Visually inspect failure modes of the composite laminates.

Common failures identified due to flexural loading included tensile failure, compressive failure, delamination, and shear. Nonetheless, failure by compression was found to be the most common [7]. Figure 6 depicts the visual inspection of the specimens following the flexural tests, with the failure modes observed being crack, upper ply kinking, and delamination. Hence, the failure modes were directly dependent on the laminate's stacking sequences. Figure 7 shows optical images of the failed surfaces (compressive side) of the composite laminates after flexural tests. The shapes of the cracks that occurred on the compressive side of [A/A], [B/B], and [A/B] were different because of the orientation of the plies and stiffness properties.

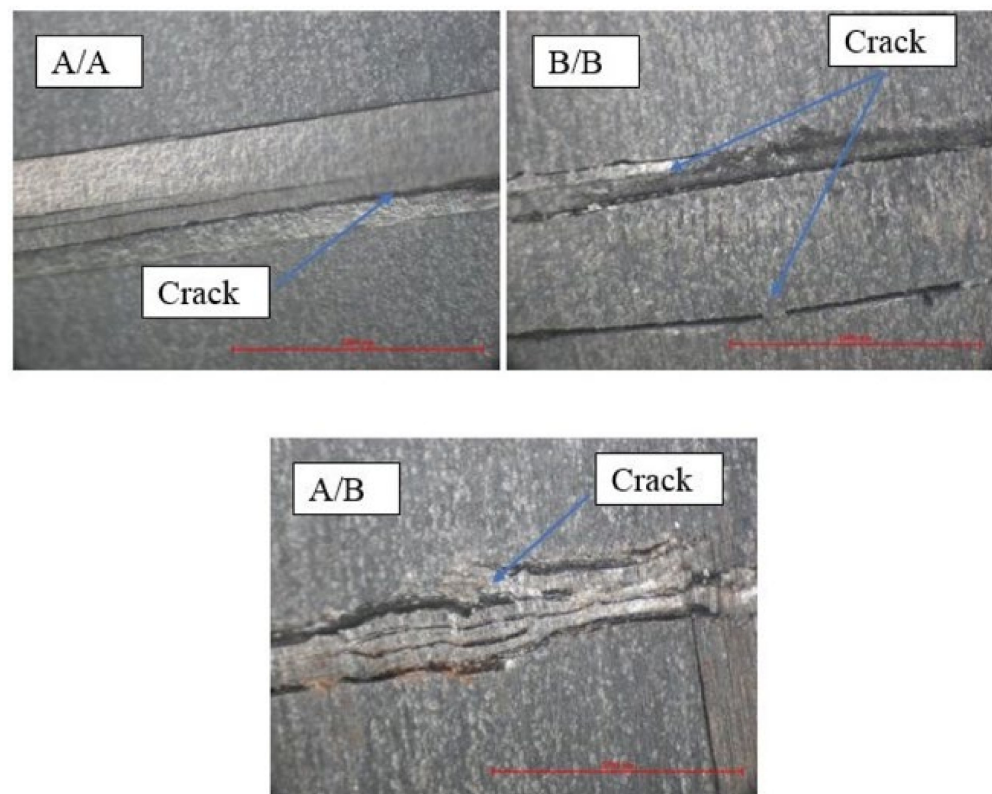
Figure 7. Optical images of failure surfaces (compressive side) of the composite laminates after flexural tests.

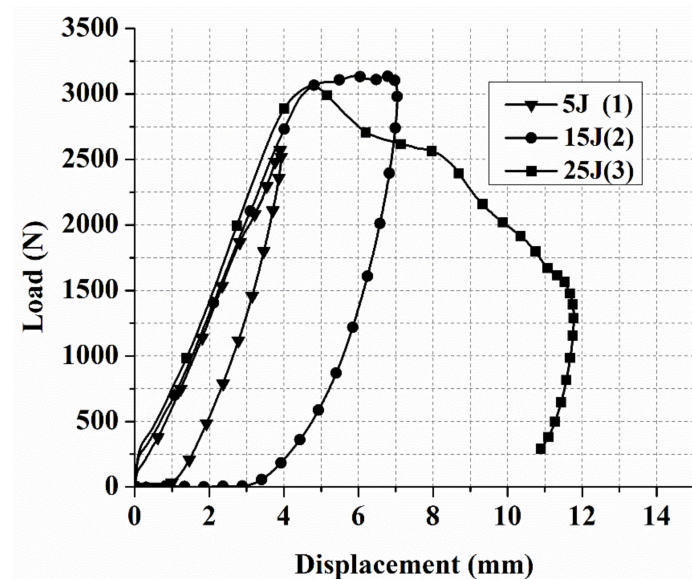
Figure 8. Load–displacement curves for low-velocity impact tests of laminate composites with [A/A] at 5, 15, and 25 J.

The laminates' failure modes and impact damage were evaluated from the various obtained energy levels of load–displacement plots. The overall extent of damage on specimens after an impact event was assessed by visual, SEM, C-scan, and optical microscopy inspection. The impact damage failure modes varied with the impact energies on the laminate composite structures. The damage modes were characterized by combinations of matrix cracking, surface buckling, delamination, fiber pull-out, fiber fracture, and penetration. The impactor could perforate the impacted surface depending on the impact energy. Several tests were performed under three impact energies (5 J, 15 J, and 25 J) in order to examine the damage progress in the stacking sequences of [A/A] (Figure 8), [B/B] (Figure 9), and [A/B] (Figure 10).

Figures 8–10 illustrate the load–displacement plots of different composite laminate structures at 5, 15, and 25 J impact energy, respectively. At 5 J, the behavior of all stacking sequences can be explained by the structure in the first stage of bending stiffness having reached a peak load and rebounding to the original point in the graph. Because of the composite laminate's resistance at 5 J and the absence of visible damage on the front and back surfaces, a closed-type curve was obtained. The absorbed energy during the impact event is represented by the area under the closed curve.

The response of all stacking sequences at 5 J in Figures 8–10 were found to have varied peak loads, displacement, and area under the curve (absorbed energy). These distinctions were attributed to the effect of stacking sequences, lay-up, and manufacturing conditions. The highest peak load and lowest displacement (indicating brittleness) were recorded in [A/A] for all the stacking sequences tested at 15 J. At 15 J, the first stage of all stacking sequences was similar to the 5 J case in terms of bending stiffness, i.e., at this point, the structures could carry loads. The maximum carrying load for the [A/A] structure was 3137.3 N (Figure 8). After this point, this structure could not have any additional load,

in a closed-type curve. Because of the stability of the structure and the symmetry of their ply-stacking sequence, [A/A] (Figure 8) exhibited the highest peak load of all stacking sequences, at 15 J (quasi-isotropic stacking sequence). At 25 J for all the stacking sequences, the laminate response to impact damage was almost similar in terms of the curve type obtained (Figures 8–10). It was an open curve, which means that the damage occurred when the impactor penetrated or perforated the specimen during impact. The peak load at 25 J for the [A/A], [B/B], and [A/B] was 3058.2, 2113.7, and 2403.7, respectively.

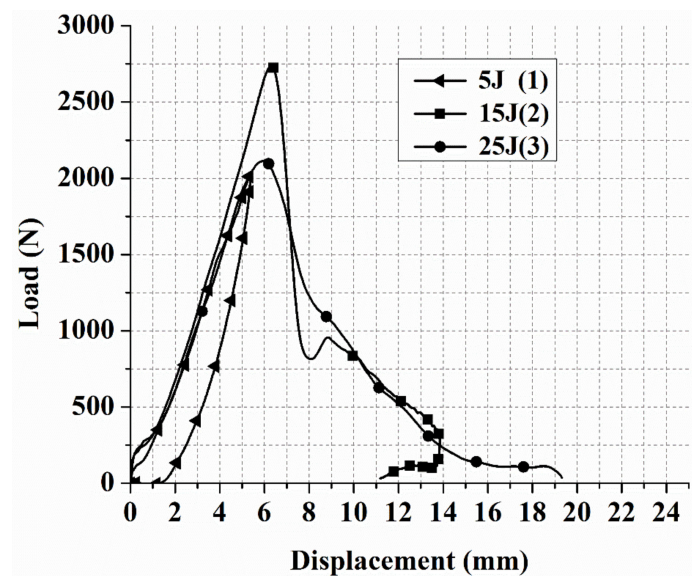
Figure 9. Load–displacement curves for low-velocity impact tests of laminate composites with [B/B] at 5, 15, and 25 J.

The response of the [B/B] stacking sequence to impact damage at 15 J, as shown in Figure 9, was different from that of other structures. The curve showed a rapid and steep load rise at 15 J. After reaching a high load of 2735.8 N, the structure was unable to support any additional load, resulting in fiber breakage under the impact site, matrix crack, fiber pull-out in the back surface, and delamination. The type of curve obtained was an open curve at 15 J for [B/B], meaning that the specimens were either penetrated or perforated by the impactor during the impact. Figure 10 shows the failure modes of the [A/B] stacking sequence at 15 J after carrying a high load of 2510.5 N; fiber breakage in the upper and bottom surface, fiber pull-out in the back surface, matrix crack, and delamination were observed. Because the impactor made contact with the upper layer, the damage occurred without penetrating the specimen and returned to the original point in the graph, resulting

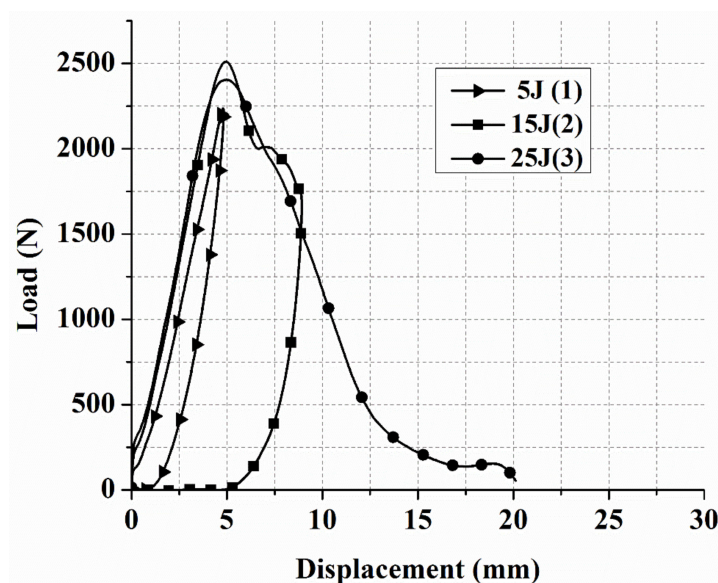
Figure 10. Load–displacement curves for low-velocity impact tests of laminate composites with [A/B] at 5, 15, and 25 J.

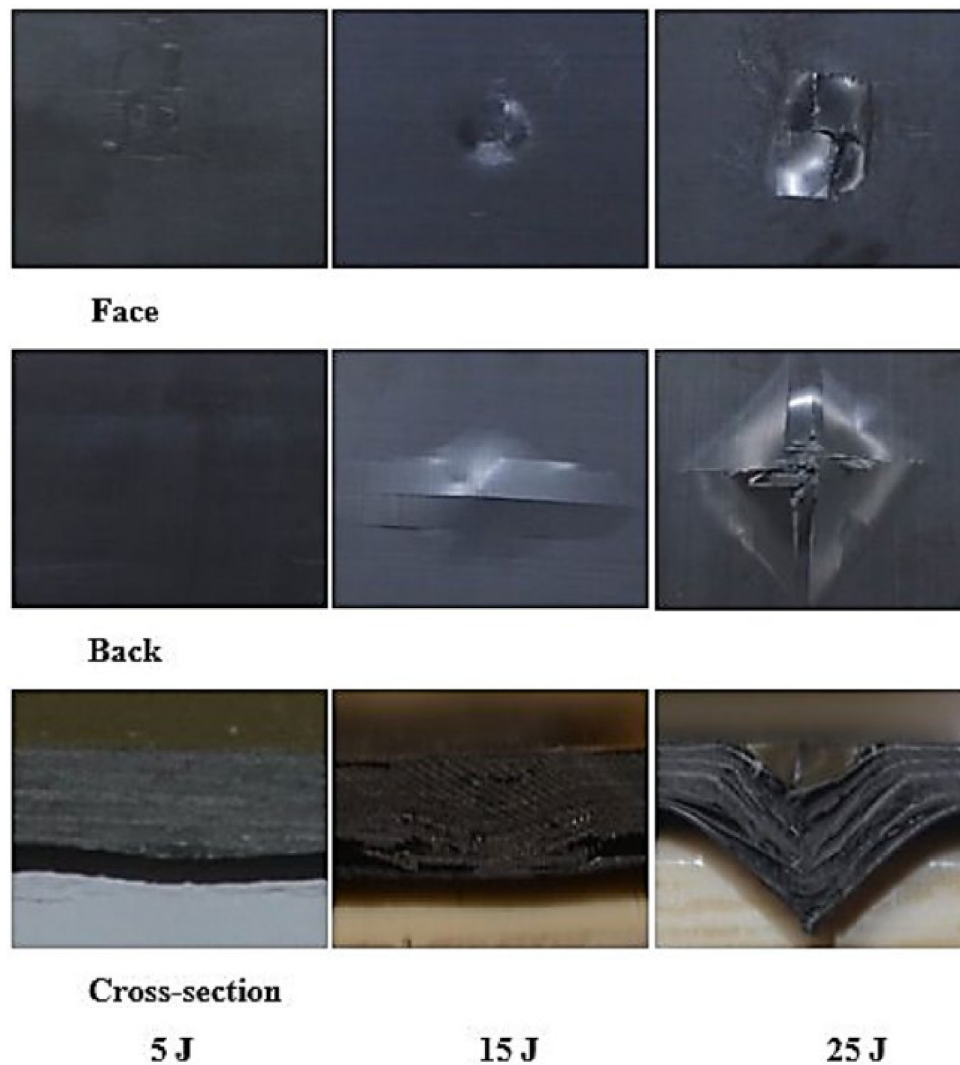
Figure 11. Pictures of the top and bottom surfaces and cross-sectional view of [A/A] at 5, 15, and 25 J.

Figures 11–13 show damage modes of [A/A], [B/B], and [A/B], respectively, and the damaged areas on the face, back surface, and the cross-section of the composite laminate after impact tests. The damage shapes and sizes in the delaminated areas varied depending on the materials' stacking sequences, fabrication processes, and mechanical properties of ply. Upon visual inspection, no failure was observed in the face, back surfaces, or cross-section view at 5 J due to the structures' resistance to impact damage (Figures 11–13). At 15 J, all the composite laminates were observed to be damaged, with failure in the face,

back surfaces, and cross-section because of the degradation. According to the lay-up and critical point to carry high loads, the size and damage shape were different in the face, back surfaces, and cross-section. Damage areas were located in the center of the specimen due to the impactor being in contact with the sample's surface at this point. The damage resistance was computed based on the final size and damage type in the specimen.

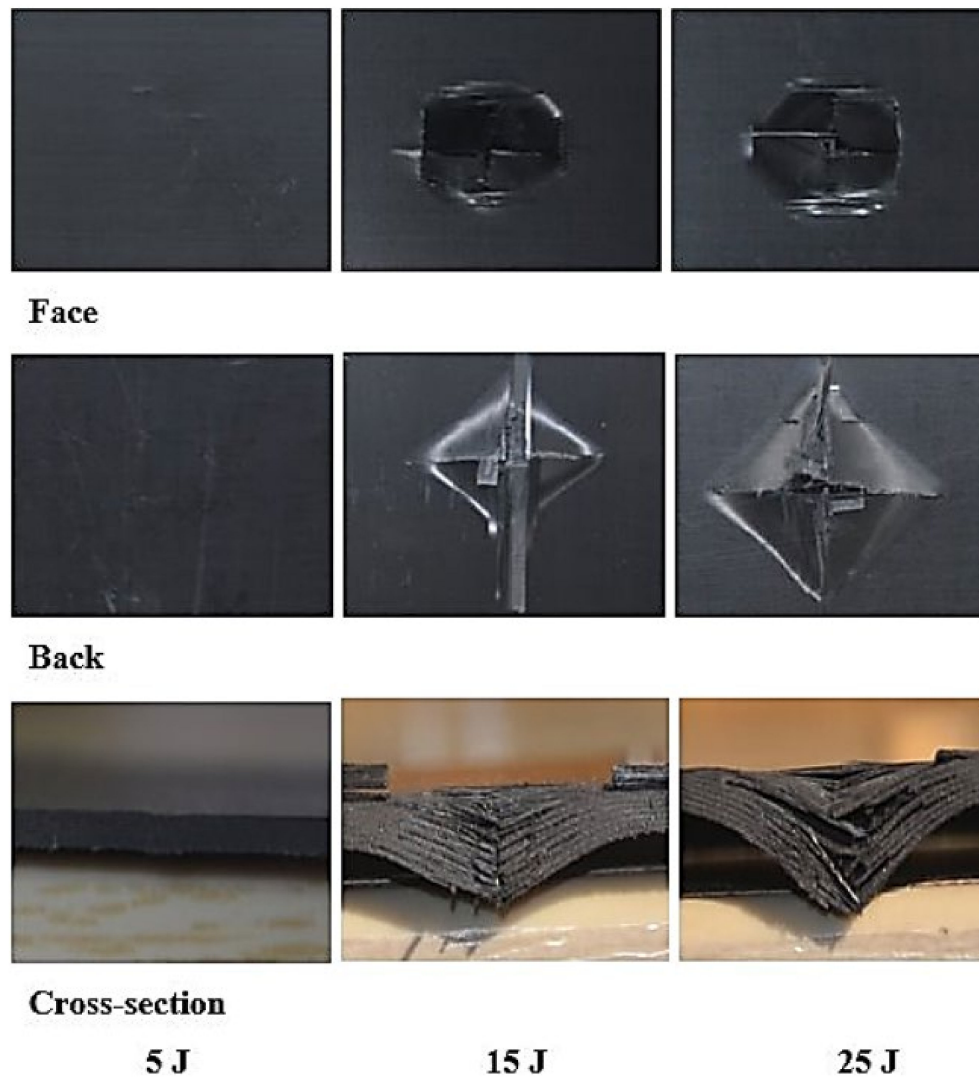
Figure 12. Pictures of the top and bottom surfaces and cross-sectional view of [B/B] at 5, 15, and 25 J.

The penetration mode on [B/B] was observed to occur earlier at 15 J than the other two structures. The delamination and fiber breakage started to appear on the lower layers of [B/B], resulting in an earlier penetration of the impactor into the specimens. Visually inspected damage modes in the composite laminate included a circular shape on the facial surface, dent/depression, cross-sectional delamination, splits, and matrix crack and fiber breakage. At 25 J, the penetration mode was observed in the composite laminate since the fiber failure had reached a critical event, facilitating complete penetration of the specimens. The penetration process was profoundly influenced by orientation, fiber sizing, interface, weave architecture, and matrix type [47]. Several factors, such as laminate thickness, impactor mass, impact velocity, impact energy, geometry, ply thickness, striker tip geometry, stacking sequence, environment, and boundary conditions, determine how composite laminate is impacted by damage [30]. The damage size on the face surface of [A/A] was smaller than that of the other structures due to the quasi-isotropy and stability of this structure. The size of the damage increased with the rise in impact energy. The size,

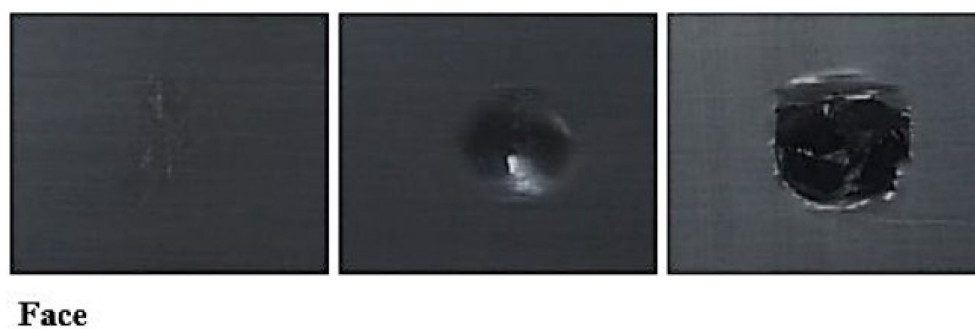
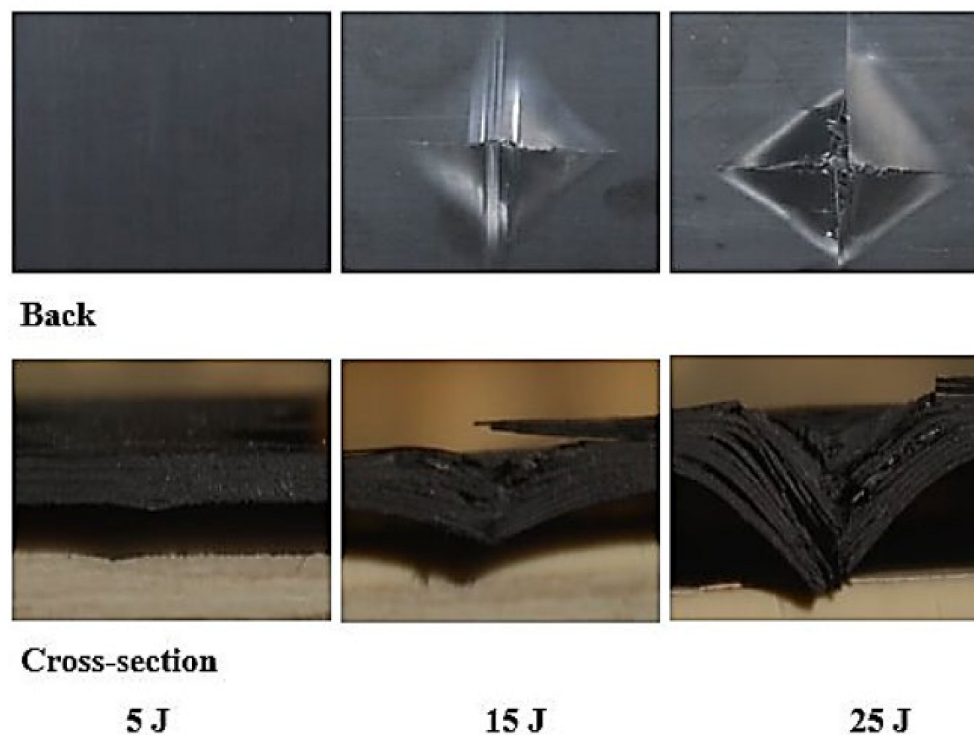
Figure 13. Pictures of the top and bottom surfaces and cross-sectional view of [A/B] at 5, 15, and 25 J.

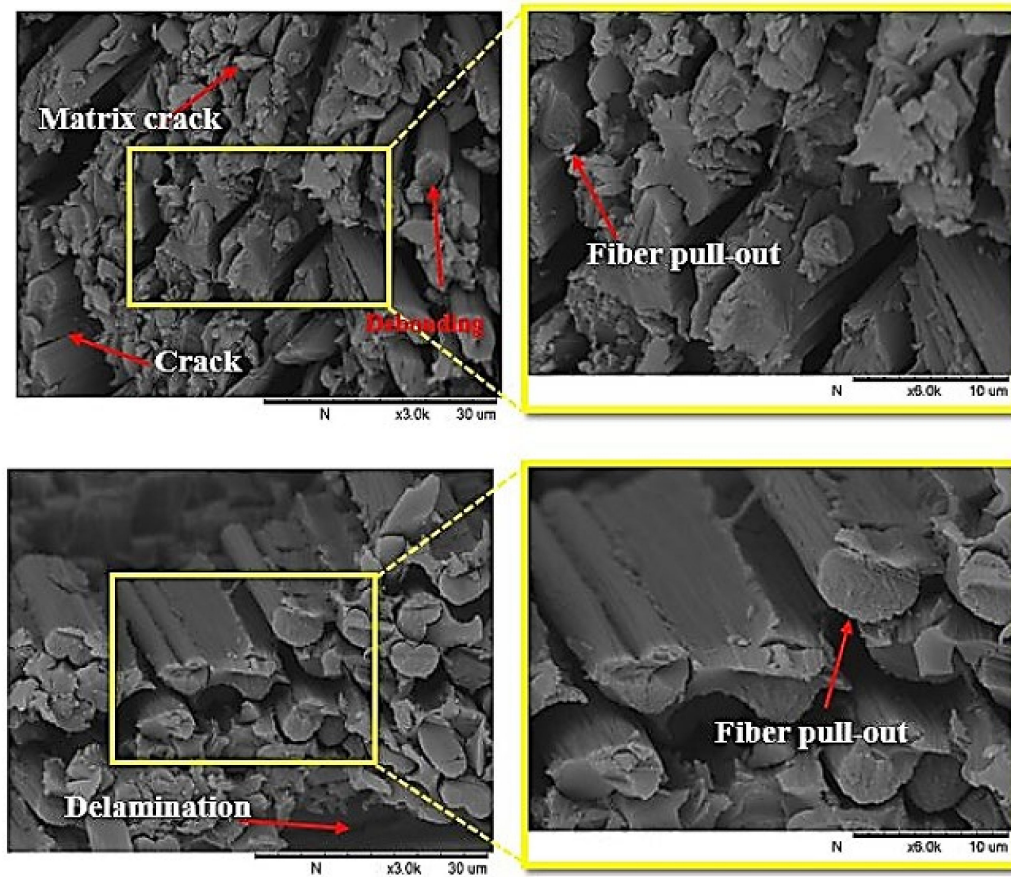
Figure 14. Low- and high-magnification SEM images of the cross-section of the fractured surfaces of the composite laminates at the face side after impact tests.

The damage behavior of the composite specimens was examined and analyzed using a scanning electron microscope (TM3000, HITACHI, Tokyo, Japan) after the impact tests. To conduct a thorough investigation, an inspection of the damage that occurred in the composite laminate was performed, and SEM was used to detect the crack in the surface and cross-section views of the composites. The SEM images of the specimens are shown in Figures 14 and 15. The failure modes inspected by SEM were fiber pull-out, matrix/fiber debonding, delamination, and fiber crack. The failure occurrence can be explained first in terms of the transverse LVI-induced matrix crack. Matrix damage typically includes matrix cracking, fiber/matrix debonding, and delamination initiation. In the upper layers, the matrix cracks were initiated at the impactor's contact edges. The global characteristics specific to the impacted specimens dictated the type of matrix cracking. The second failure occurrence was during the fracture process. This involved delamination and matrix cracking, which occurred first, followed by pull-out and fiber crack failure. High local stresses, non-impacted face (as a result of high bending stresses), and indentation effects (governed by shear forces) caused the fiber failure to occur below the striker. Delamination is defined as the process through which plies are separated in the resin-rich area. It is caused by bending stiffness variation between adjoining layers, that is, the contrasting fiber arrangement between the layers [47].

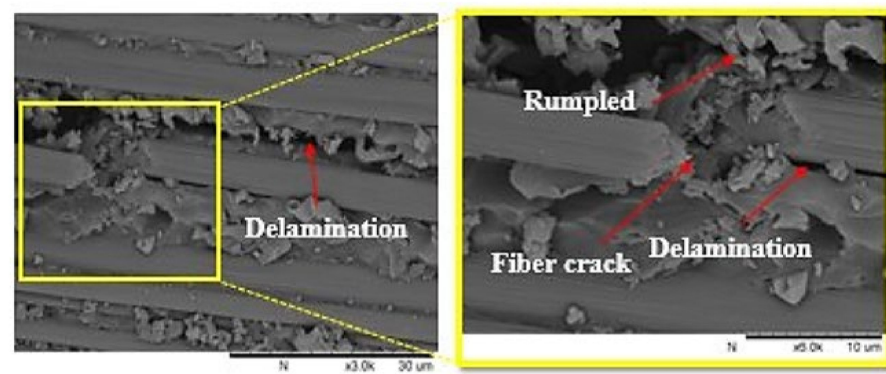
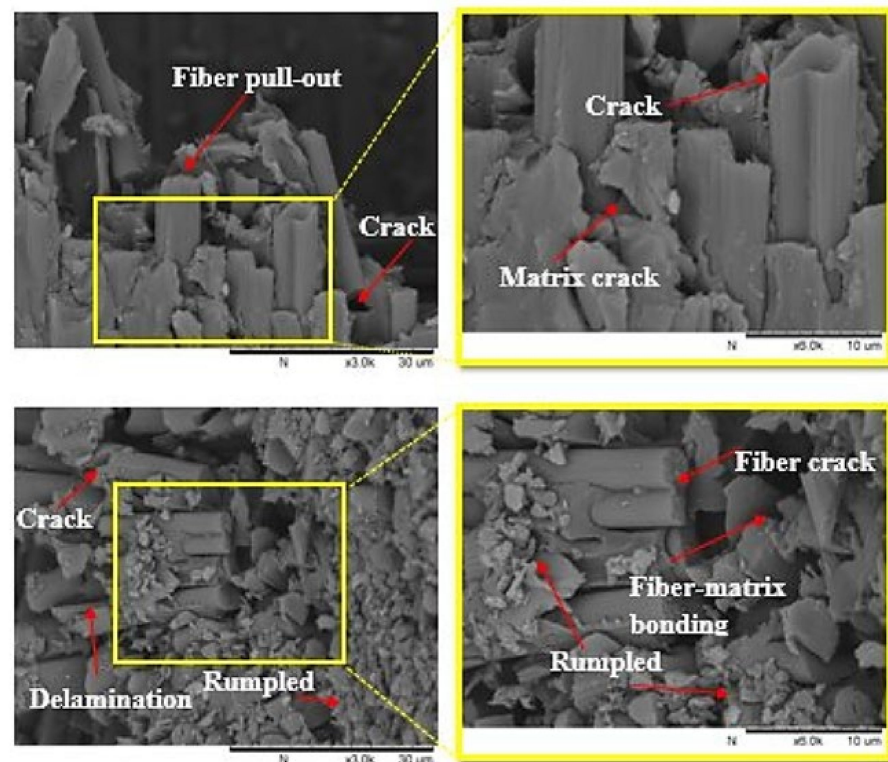
Figure 15. Low- and high-magnification SEM images of the fractured surfaces of the composite laminates at the face side after impact tests.

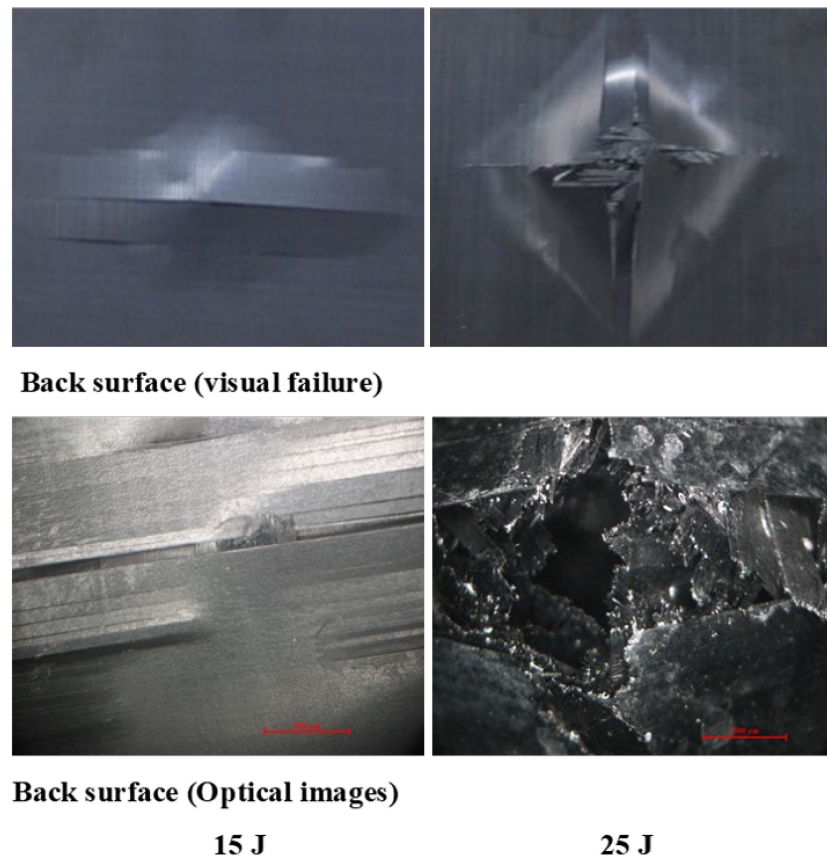
Figure 17. Pictures of the back surface failure view with visual and optical microscopy of [A/A] at 15 and 25 J.

A delaminated C-scan image with blue and yellow colors showed the size and shape of the delamination in composite plates. When impact energy increased, the delamination area also increased, which could be attributed to the fiber orientation of the laminate composite structure. The size of the impact damage obtained from C-scan detection is always smaller than via visual inspection because the C-scan images only show the overlapping delamination area directly under the impact site. In contrast, visual inspection of the laminate surface and microscopic observations of the sample section illustrated the magnitude of the largest single delamination. The visual and C-scan inspection images at 15 J for [A/A] were not the same because C-scan combined the damages that occurred on the face and back surfaces. However, in the optical image of the cross-section at 15 J, the damage happened at the face surface of the sample along the fiber direction. Visual and optical microscopy back failure images of [A/A] at 15 and 25 J are presented in Figure 17. Failure images at the back surface are not shown at 5 J because no damage was detected by visual or optical inspection. The shape of the failure image on the backside was the same

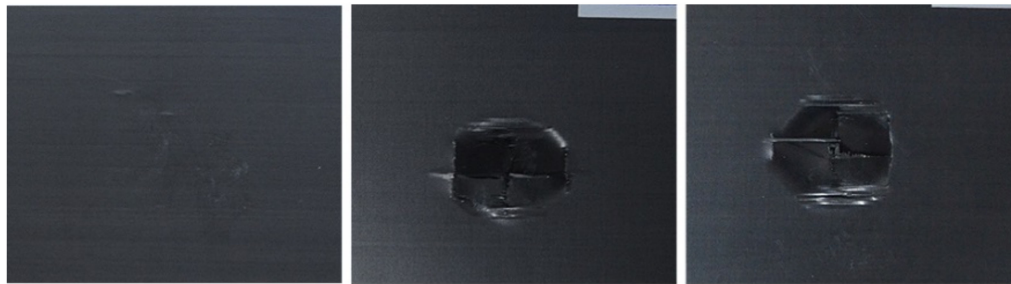
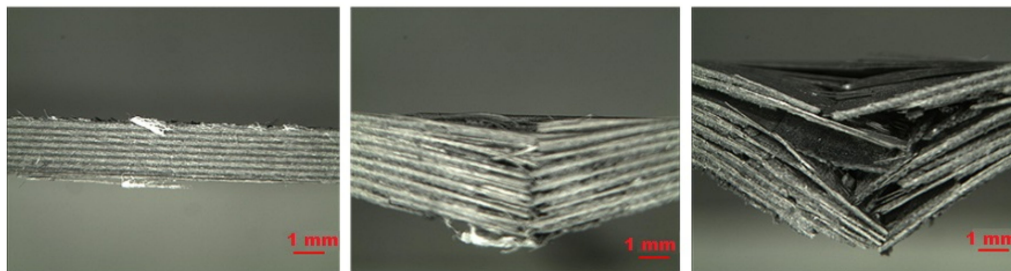
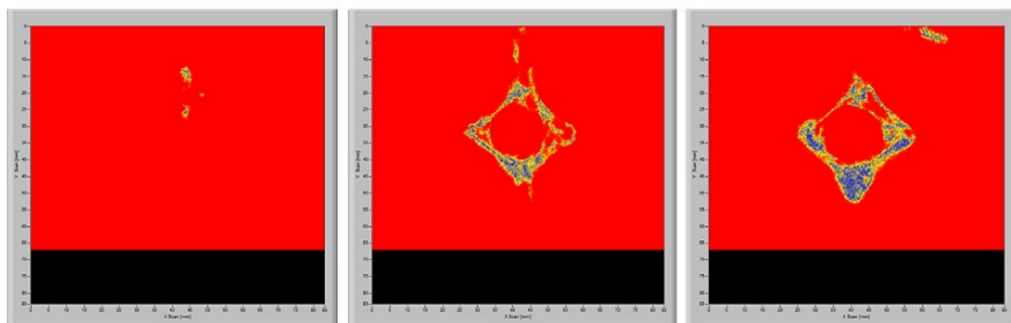
Face-Visual inspection

Cross-section-Optical microscopy inspection

Face-C-scan inspection

Figure 18. Pictures of the top surface view with C-scan and cross-section with optical microscopy of [B/B] at 5, 15, and 25 J.

for both visual and optical microscopy inspection. The main damage modes were fiber breakage, fiber pull-out, splits/cracks, and indentation. Figure 18 shows that the damage shape by visual inspection was more apparent than the C-scan image and shows the same shape at the face side of the samples. The C-scan was manipulated to identify damage and delamination on the laminate's backside caused by the distance between the pulse and receiver.

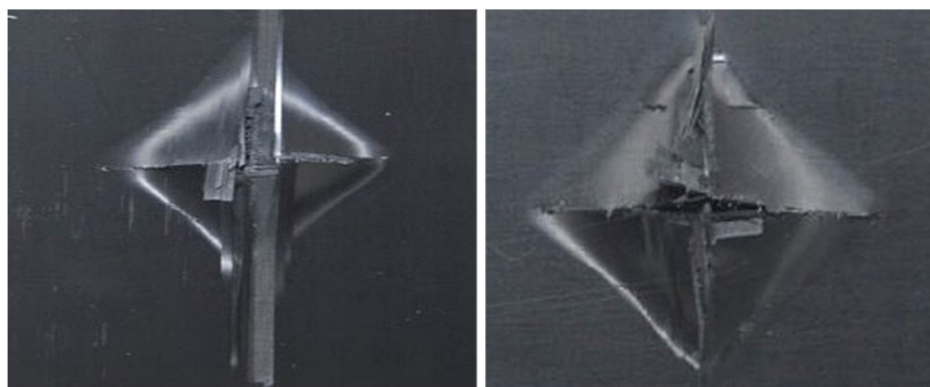
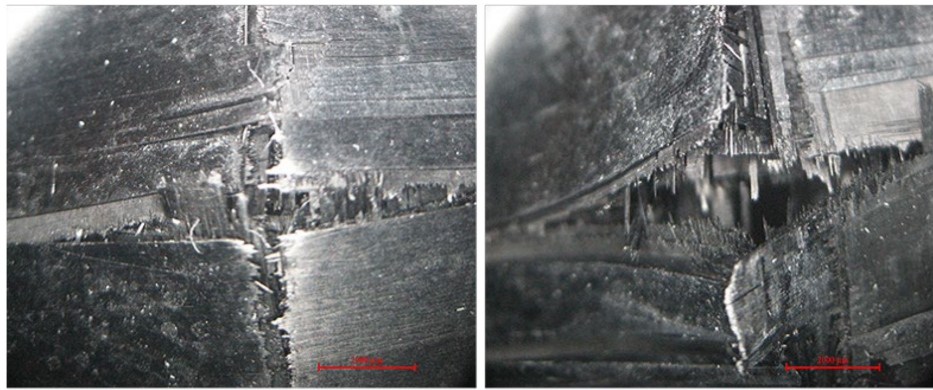
Back surface (visual failure)

Back surface (Optical images)

Figure 19. Pictures of the back surface failure view with visual and optical microscopy of [B/B] at 15 and 25 J.

The size of the crack was found to be different between visual inspection and C-scan due to damage in the backsides caused by fiber shear-out. The final image of the damage was less visible than via visual inspection due to the shorter distance between the backside of the composite and the bottom probe (receiver). The optical cross-section failure and face C-scan failure images revealed that delamination occurred at 15 and 25 J, as seen in the C-scan with blue color and the fiber crack with yellow color (Figure 18). It was observed that 25 J brought about severe delamination. There was agreement between visual and optical microscopy damage modes on the back surface of the samples, as shown in Figure 19.

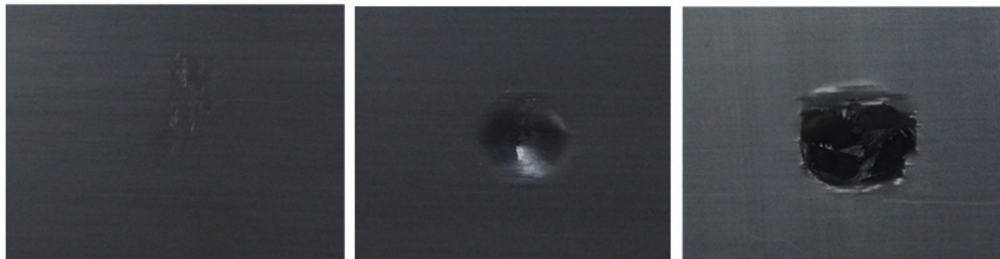
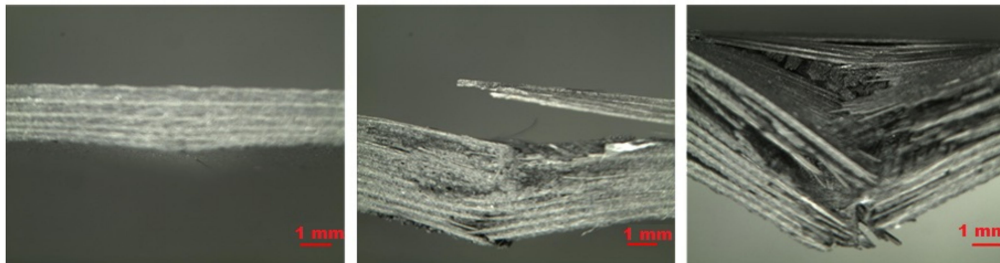
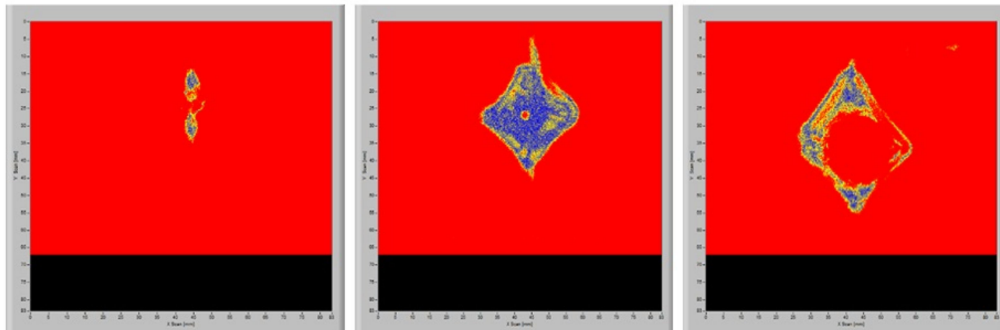
Face – Visual inspection

Cross-section- Optical microscopy Inspection

Face – C-Scan inspection

Figure 20. Pictures of the top surface view with C-scan and cross-section with optical microscopy of [A/B] at 5, 15, and 25 J.

Deducing from Figure 20, the resulting area by C-scan exhibited only overlapping extended damage at every layer of the laminate composite structure. The extent of the damage impact at both 15 J and 25 J retrieved from the C-scan investigation was constantly smaller than via visual inspection. C-scan image was the most suitable way of detecting damage location sensitivity, damage size sensitivity, delamination, and surface distance. At 5 J, there was no visible damage in the face surface or optical microscopy cross-section image; however, a small failure was detected in the face surface by C-scan, which is a unique feature of C-scan. Delamination and fiber breakage were observed at 15 and 25 J in the optical cross-section and C-scan damage images. In addition, penetration was observed at 25 J due to the composite's inability to bear more load, as it had already passed the critical point for carrying a heavy load. Figure 21 shows the failure shapes of visual and optical back surface images—almost the same damage modes, such as fiber breakage, fiber pull-out, and penetration, were evident at 25 J. The C-scan images illustrated minor delamination on the face surface of composite laminates at 5J for all stacking sequences (Figures 16, 18 and 20). However, the visual inspection did not reveal delamination because the C-scan modes only showed the extent of damage and internal inhomogeneity. At 15 and 25 J, the damage shape in both the visual and C-scan inspection was totally in agreement for [B/B] and [A/B], depending on the type of damage in the composites. The penetration depth in the 25 J case was more significant for all the structures than in the 15 J case because the composite material had reached the critical point in carrying any additional load at 25 J (Figures 16–21). A similar damage tendency was observed in composite materials when the impact energy was raised after reaching the crucial point for carrying a load. Since the penetration mode shape in the C-scan image was circular, the damaged part of the center was colored red. The size of the failure areas of the composite laminate obtained by C-scan are presented in Table 3.

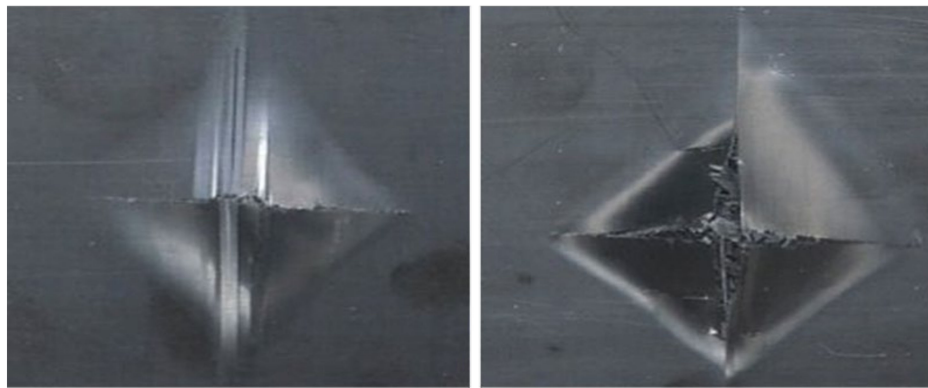
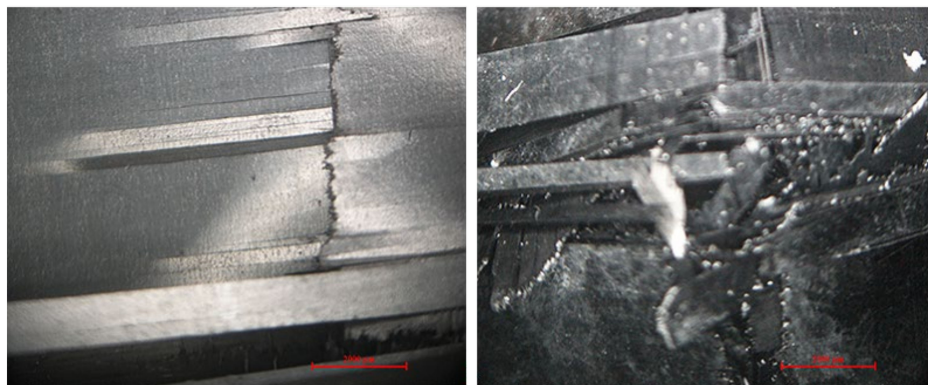
Back surface (visual failure)

Back surface (Optical images)

Figure 21. Pictures of the back surface failure view with visual and optical microscopy of [A/B] at 15 and 25 J.
