Case Report

Use of a partial humeral head resurfacing system for management of an osseous mechanical block to glenohumeral joint range of movement secondary to proximal humeral fracture malunion

Kyriacos Eleftheriou, Nawfal Al-Hadithy, Vinay Joshi, Daniel Rossouw¹

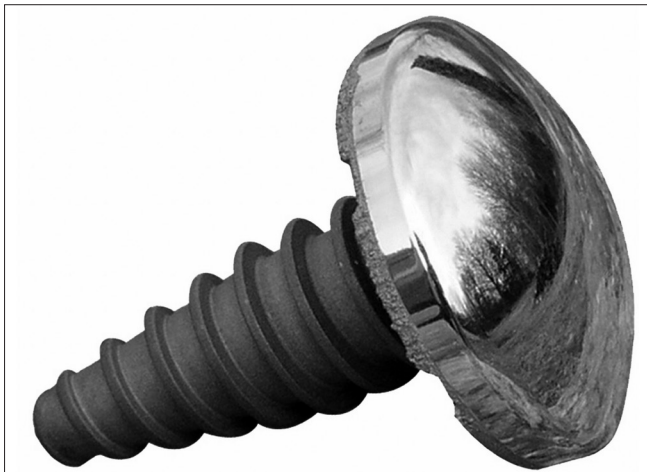
Figure 1: The HemiCAP implant

The HemiCAP system (Arthosurface, Franklin, MA, USA) allows a more focal resurfacing of an articular surface and is indicated in the management of humeral head osteoarthritis,

avascular necrosis as well as management of local chondral defects and other isolated defects such as Hill-Sachs lesions restoring articular congruity and preserving bone stock. The system provides instruments to map and prepare the focal damaged area to allow implantation of a cobalt–chrome and titanium implant [Figure 1] that precisely aligns the contours of the articular surface and restores a smooth articular surface at the area of the defect using a range of implants of varying diameters and curvatures.

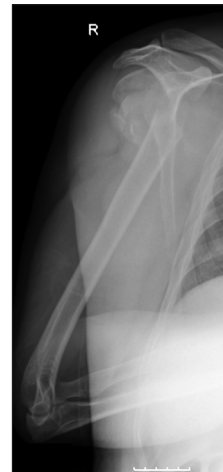
Figure 2: Original injury

An active 46-year-old right hand-dominant nonsmoking healthy male chef presented with a four-part proximal humeral fracture following a motorcycling accident [Figure 2]. In view of his age, he underwent open reduction and internal fixation of the fracture with a proximal humeral locking plate [Figure 3]. After an uneventful immediate postoperative recovery, his functional improvement was limited and his range of movement and pain symptoms deteriorated over the subsequent 6 months despite intensive rehabilitation. Serial radiographs revealed a progressive collapse of the articular head part. This led to protrusion of one of the screws into the articular region 6 weeks postoperatively [Figure 4], which was promptly removed. Over the subsequent months, his fracture continued to collapse. Radiographs at 9 months showed malunion of the fracture, with a bony spur present at the superior part of the head where the collapse segment went on to malunion [Figure 5]. On examination, the patient had 40° forward flexion, 40° abduction and 10° external rotation, with a painful mechanical block to further movement. His rotator cuff appeared clinically intact, with adequate strength otherwise

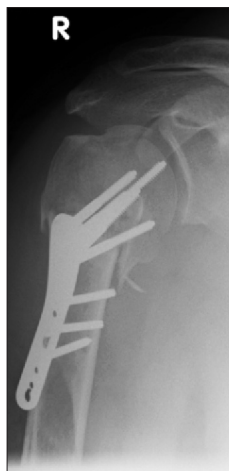
Figure 3: Immediate postoperative fixation

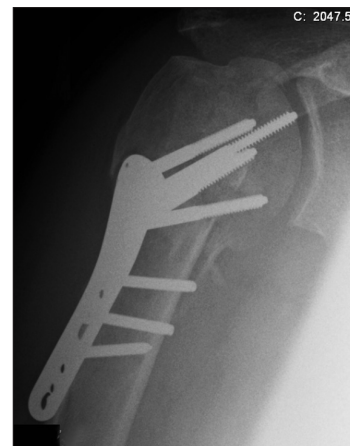
Figure 4: Advanced collapse at 6 weeks. The protruding screw was promptly removed

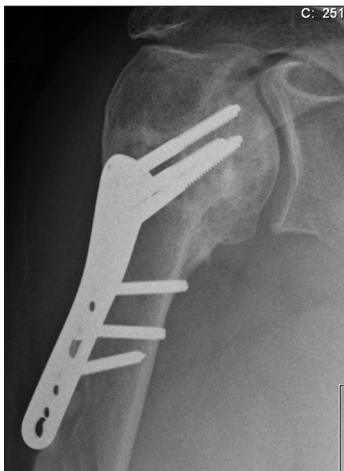
Figure 5: Malunion at 9 months

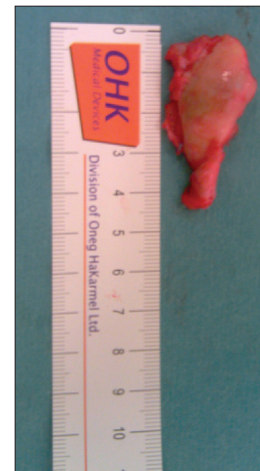
Figure 6: Excised bony spur

and the associated capsule were incised at the lesser tuberosity and lifted off to expose the humeral head. Adequate release of the soft tissues with retraction allowed the bony spur to be easily visualised and brought into the operating field by extension and external rotation. This was removed using a fine saw [Figure 6].

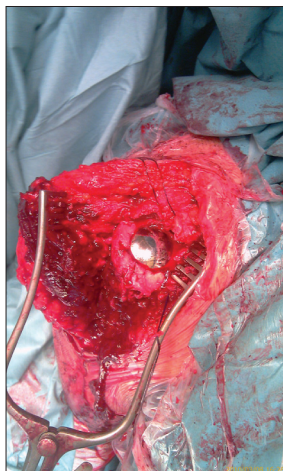
Figure 7: HemiCAP inserted

confirm the fit, ensuring that this was congruent with the edge of the surrounding humeral surface. The appropriate articular component was then placed in its post [Figure 7], restoring a smooth humeral surface at the area where the bony spur was previously present. A full and stable range of movement with no impingement or mechanical block was possible intraoperatively. The incised capsule and subscapularis were then repaired.

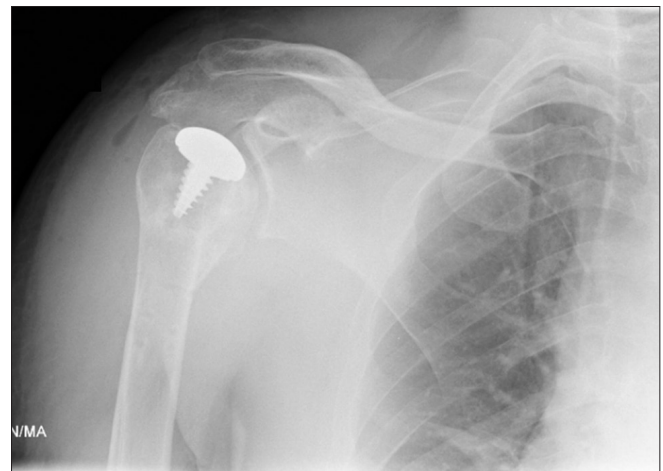
Figure 8: Check radiograph postoperatively

At the 6-month follow-up, an examination revealed 140° forward flexion, 120° abduction and 35° external rotation, and the patient was pain-free. The 12-month follow-up revealed 150° forward flexion, 120° abduction and 35° external rotation, and the patient was pain-free. He had gone back to work full time and had adequate function of his arm. Repeat radiographic assessment showed no loosening or displacement of the prosthesis, no new bony outgrowth and no changes to the opposing glenoid articular surface [Figure 8]. His postoperative Oxford Shoulder Score was 31 (preoperative, 15).
