Article

A Repair Method for Damage in Aluminum Alloy Structures with the Cold Spray Process

Keywords: cold spray process; corrosion resistance; mechanical properties; 7N01

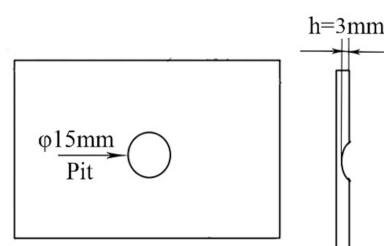
Figure 1. A schematic diagram of the samples with a factitious pit.

The 7N01-T4 aluminum alloy, which is used as a common material for high-speed trains, was chosen as the substrate. The chemical compositions are listed in Table 1. For the purpose of simulating the damages produced in high-speed trains while in motion, factitious pits with a thickness of 3 mm were produced in the 7N01-T4 plates in advance. Figure 1 shows a schematic diagram of the damaged samples.

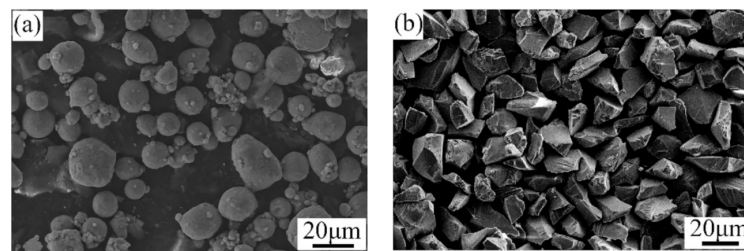
Figure 2. SEM morphologies of the (a) Al and (b) Al₂O₃ powders.

A mixture of pure Al and Al₂O₃ powders was utilized to repair the factitious damages with the cold spray process. The mass ratio of the pure Al and Al₂O₃ powders was 76 to 24. All of the powders were produced by the Tyontech Company Limited in Xi'an in China. Figure 2 shows the SEM morphologies of the Al and Al₂O₃ powders. As depicted, the particles of the pure Al powder were spherical, and the particle size was in the range of 10–30 μm. The particles of the Al₂O₃ powder were angular and had an average size of 20–40 μm.

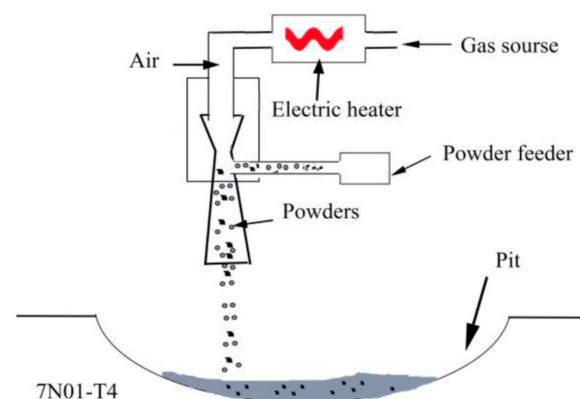
Figure 3. A schematic illustration of the repair process.

Before being repaired, the aluminum alloy plates were fully ground with an angle grinder to remove the surface oxidation film, and were then wiped with acetone. The mixed powders were kept in a holding furnace at 60 °C for 3 h. The samples were repaired with a low-pressure cold spray system (Tyontech Co., LTD, Xi'an, China). A schematic illustration of the repair process is shown in Figure 3. The process parameters were as follows: process gas, air; pressure, 0.6 MPa; preheating temperature, 350 °C; powder feed rate, 25 g/min; gas flow rate, 0.4 L/min. After the repair, the excess parts in the repaired areas were removed to ensure that the surface was absolutely flat. Then, the repaired samples were processed into different sizes for microstructural analyses, mechanical property tests, and corrosion tests.

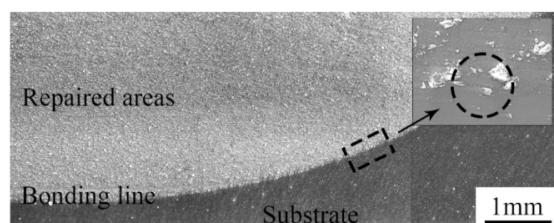
Figure 4. Cross-section of samples repaired with the cold spray process.

The cross-section of the samples repaired with the cold spray process is shown in Figure 4. As can be seen, the repaired areas were relatively dense. There were no visible pores and cracks that penetrated the entire cross-section. Thus, it was not easy for a corrosive medium to directly infiltrate into the inner substrate [21,22]. In addition, a boundary between the repaired areas and the substrate was apparent. The bonding line was along the surface of the pit, that is to say, no metal in the substrate was melted during the cold spray process. The bonding line was not always smooth, and some hollow areas were obvious in some positions. As shown in the magnified image, many angular particles were embedded in the substrate. This illustrates that a good mechanical bond between the repaired areas and the substrate was formed [23].

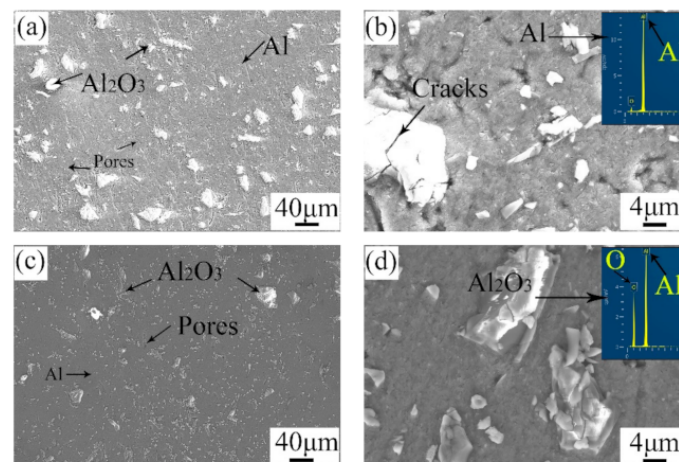
Figure 5. Microstructure of (a,b) the surface and (c,d) the cross-section of the repaired areas.

Figure 5 shows the microstructure of the surface and the cross-section of the repaired areas. By comparison, the microstructure of the surface was similar to that of the cross-section. A mass of angular particles was distributed in the repaired areas. According to the EDS results, the angular particles were Al_2O_3 , and the other zones were pure Al. During the cold spray process, the mixed powders were ejected from the spray gun and hit the substrate violently. Thus, this violent impact caused a plastic deformation in the pure Al particles, as well as the crashing of the Al_2O_3 particles. Consequently, the pure Al particles lost their primary morphology, and many Al_2O_3 particles with small sizes appeared. It is mentioned that there were more tiny Al_2O_3 particles in the cross-section than in the surface. The outer tamping caused a great impact on the inner area. The greater the amount of tamping is, the stronger the impact on the inner area will be [24]. As a result, the Al_2O_3 particles in the cross-section were smaller. Meanwhile, the microstructure in the cross-section was denser than that on the surface. In addition, micro-cracks were observed around the Al_2O_3 particles. The porosity of the repaired areas was analyzed with Image J. The surface porosity and the cross-section porosity were 3.206 and 2.115, respectively.

The results were also in accordance with the microstructure observed in Figure 5a,c. This difference can be attributed to the effect of tamping.

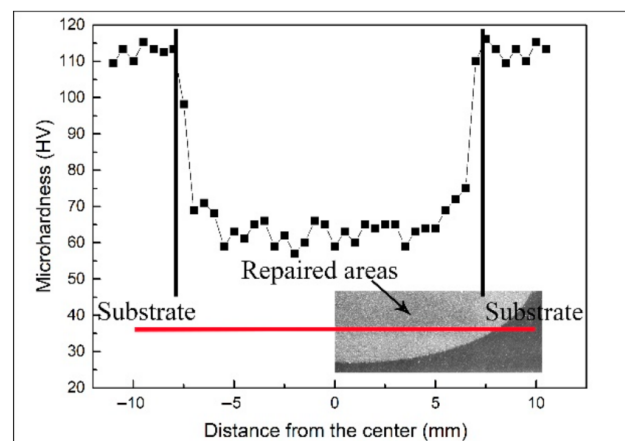
Figure 6. Microhardness of the samples repaired with the cold spray process.

The microhardness is an important indicator for evaluating the mechanical properties of metal. The microhardness of the samples repaired with the cold spray process is shown in Figure 6. The microhardness of the 7N01-T4 substrate was about 113.5 ± 2.2 HV, and that of the repaired areas was in the range of 57.4–63.2 HV. The variation in the microhardness was associated with the microstructure. Many Al_2O_3 particles existed in the repaired areas. Al_2O_3 particles with a high hardness can make tremendous contributions to the improvement of the microhardness. In addition, the impact of the Al_2O_3 particles also caused the work hardening in the deposition [25,26].

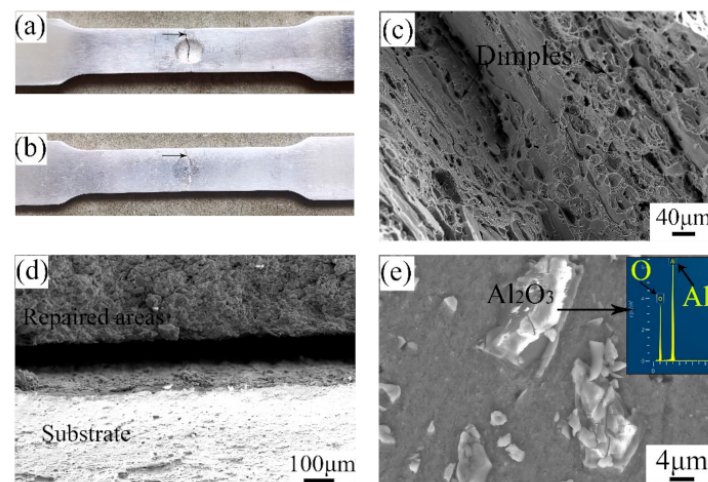
**Figure 7.** Fracture morphologies of the (a,c) UR samples and (b,d,e) CS samples.

Figure 7 shows the fracture morphologies of the UR samples and CS samples. As depicted, the breakages of the samples all happened in the middle of the samples. From the SEM images, it can be seen that there were numerous dimples with various sizes in the UR samples. This illustrates that the fracture mode of the UR samples was that of a ductile fracture. Likewise, the substrate of the CS samples showed a typical ductile fracture on account of the existence of many dimples. By observing the fracture of the repaired areas, the Al_2O_3 particles are clear and distinct. The repair process is actually a deposition process in which the raw powders are combined in the form of a mechanical bond caused by plastic deformation [27]. Therefore, the breakage first happened in the interface between pure Al and Al_2O_3 particles. The fracture mode of the repaired areas in the CS samples was that of a brittle fracture.

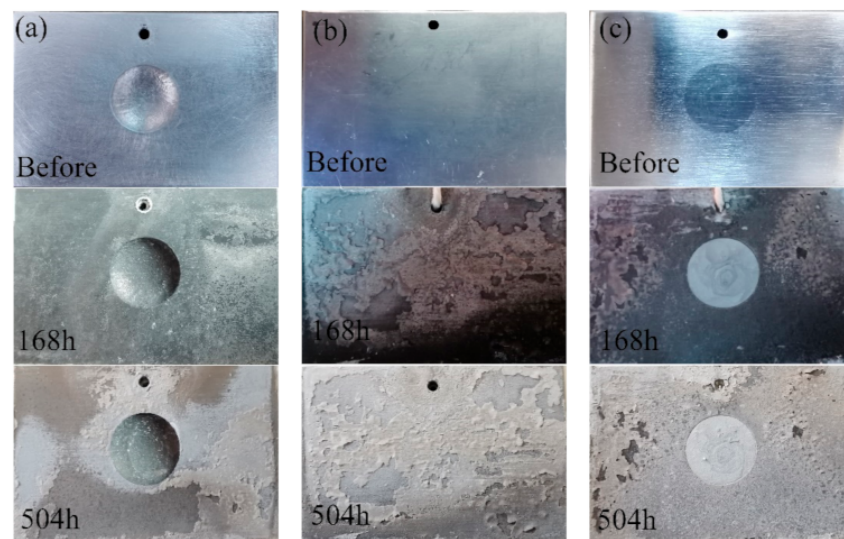
Figure 8. Surface appearances of (a) the UR samples, (b) 7N01-T4, and (c) the CS samples after alternate immersion tests.

Figure 8 shows the surface appearances of the samples after the alternate immersion tests. Clearly, all of the samples lost their metallic luster and looked dark after the alternate immersion tests for 168 h. In addition, some white corrosion products were observed in the substrate. The repaired areas in the CS samples were much brighter and showed a better surface appearance compared with the nearby substrate. After alternate immersion tests for 504 h, the 7N01-T4 samples and the CS samples were mostly covered with white products. The repaired areas in the CS samples still had brighter surfaces. This suggests that the corrosion products on the 7N01-T4 samples and the CS samples had a protective effect. When observing the UR samples, there was only a small quantity of white products in the substrate, far from the pit. The pit was in as terrible of a condition as before. Hence, there were no dense or protective corrosion layers on the surfaces of the UR samples during the corrosion process.

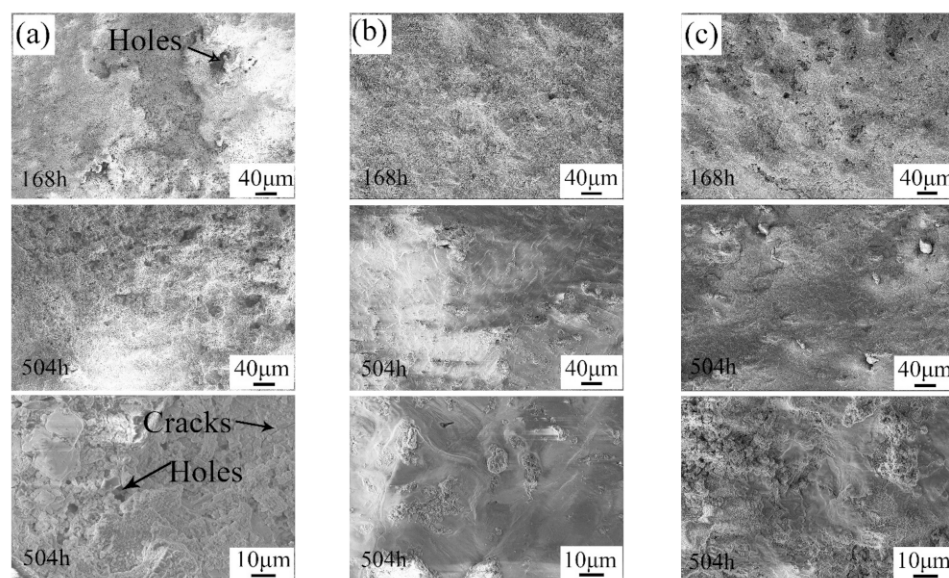
Figure 9. Microstructures of the corrosion layers of (a) the pit in the UR samples, (b) 7N01-T4, and (c) the repaired areas in the CS samples after alternate immersion tests.

The microstructures of the corrosion layers of the samples after the alternate immersion tests are shown in Figure 9. As can be seen in Figure 9a, the surface of the pit in the UR samples was covered with grainy corrosion products. Moreover, the corrosion products were loose, and many holes were clearly observed. In this case, it was easy for the corrosion medium to enter into the inner area. In contrast, the corrosion products on the surface of the 7N01-T4 samples and the CS samples were much denser. Furthermore, it was shown that the corrosion products on the surface of the 7N01-T4 samples and the CS samples linked up after alternate immersion tests for 504 h. As a result, the number of holes decreased. This structure would give tremendous protection to the fresh inner metal [28,29]. However, there were still some holes and cracks in the corrosion products in the UR samples. This also proved that the corrosion products on the surface of the UR samples still had a negative effect on the inhibition of the corrosion process. Based on the above analysis, the UR samples suffered serious corrosion in the positions where the defects were. After being repaired with the cold spray process, the corrosion resistance of the repaired samples was superior to that of 7N01-T4.

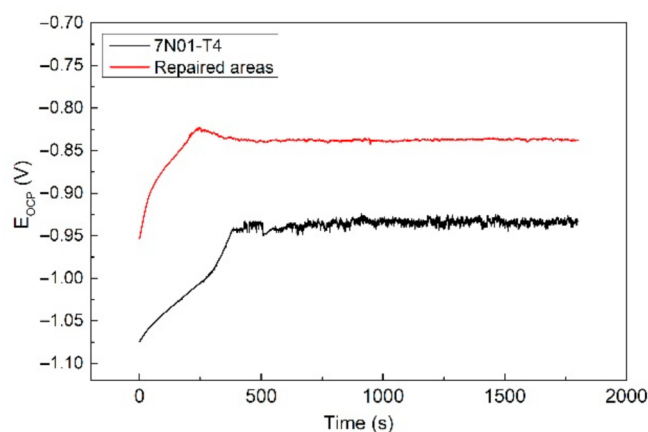
Figure 10. The open circuit potential of the samples before the alternate immersion tests.

Electrochemical tests were conducted in order to study the corrosion behavior of the CS samples. The CS samples for the electrochemical tests were taken entirely from the repaired areas. Figure 10 shows the open circuit potential of the samples before the alternate immersion tests. It shows that the E_{OCP} curves of both samples were similar. The E_{OCP} had a rapid increase in the initial stage and tended to be subsequently stable. The rapid increase in the E_{OCP} could be attributed to the passivation process on the fresh samples. Then, a passive film was formed, resulting in a stable E_{OCP} . By comparison, the E_{OCP} of the repaired areas was apparently higher than that of 7N01-T4. This indicates that the repaired areas had a lower corrosion tendency in comparison to 7N01-T4 [30]. In other words, there would be a potential difference between the repaired areas and the nearby substrate in the CS samples. Thus, there remained a galvanic corrosion between the repaired areas and the nearby substrate. The repaired areas were protected as a cathode, and the nearby substrate was corroded as an anode.

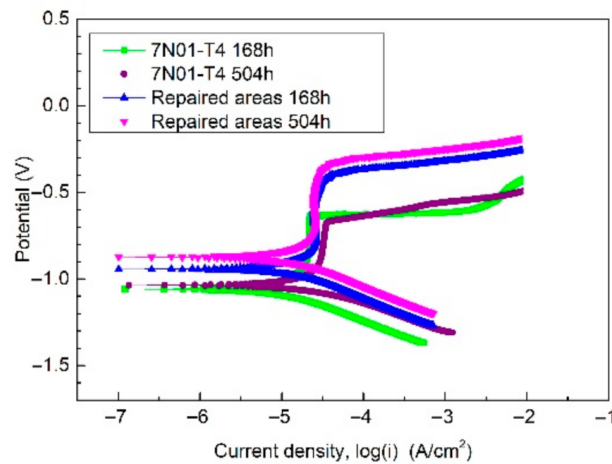
Figure 11. The potentiodynamic polarization curves of the samples after the alternate immersion tests.

Figure 11 shows the potentiodynamic polarization curves of the samples after the alternate immersion tests. Table 4 gives the related electrochemical parameters. As depicted, the repaired areas in the CS samples showed better corrosion resistance compared with 7N01-T4 due to the result that the E_{CORR} was higher and the I_{CORR} was lower after the

corrosion tests not only for 168 h, but also for 504 h. In addition, there was a small increase in E_{corr} and a small decrease in I_{corr} after the alternate immersion tests for 504 h. So, the corrosion products on the samples had a positive effect on preventing the inner substrate from being corroded by the corrosive medium.
