Towards an Understanding of the Effect of Adding a Foam Core on the Blast Performance of Glass Fibre Reinforced Epoxy Laminate Panels

Abstract: This paper presents insights into the blast response of sandwich panels with lightweight foam cores and asymmetric (different thicknesses) glass fibre epoxy face sheets. Viscously damped elastic vibrations were observed in the laminates (no core), while the transient response of the sandwich panels was more complex, especially after the peak displacement was observed. The post-peak residual oscillations in the sandwich panels were larger and did not decay as significantly with time when compared to the equivalent mass laminate panel test. Delamination was the predominant mode of failure on the thinner facesheet side of the sandwich panel, whereas cracking and matrix failure were more prominent on the thicker side (which was exposed to the blast). The type of constituent materials used and testing conditions, including the clamping method, influenced the resulting failure modes observed. A probable sequence of damage in the sandwich panels was proposed, based on the transient displacement measurements, a post-test failure analysis, and cons

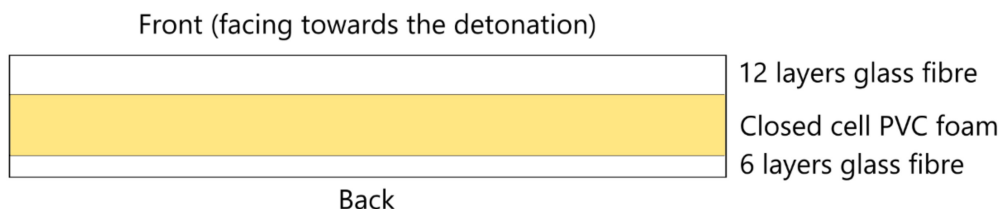
The number of plies for the face sheets was designed to be 2:1 for the front to back face sheet ratio. The sandwich panels had 18 total layers of the same glass fibre system, where 12 layers was used for the front face and 6 layers for the back face of the composite as shown in Figure 1. This was chosen to give an approximate equivalent mass to the 19-layer laminates.

Figure 1. Cross section schematic of asymmetrical sandwich panel.

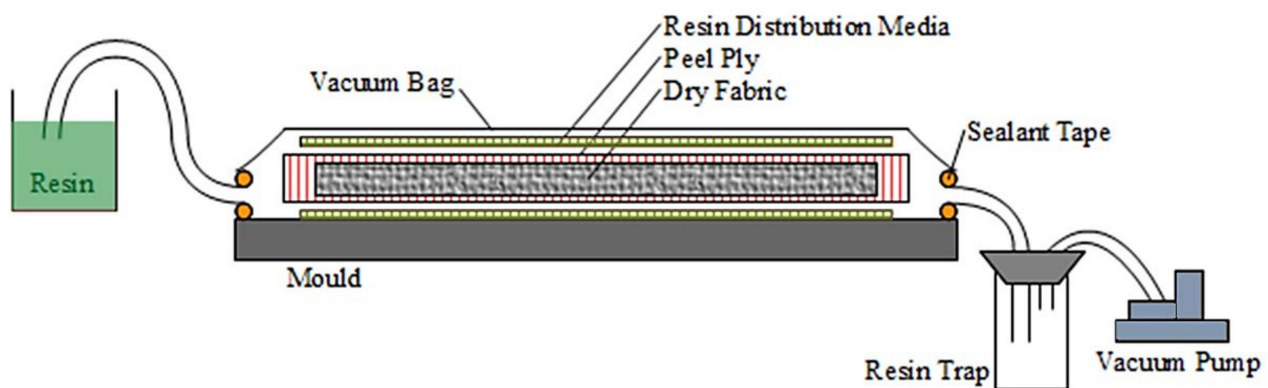
All panels for the blast testing and material characterisation experiments were manufactured from the constituent materials using the Vacuum Infusion (VI) technique. The sandwich panels were made in a single step VI manufacturing process similar to Ref. [11]. The required numbers of layers of woven fabric were laid up on either side of the dry foam core (with release plies and flow promotion media enclosing the overall dry sandwich panel configuration) and enclosed in a vacuum bag while a vacuum was drawn to enable resin flow and ensure compaction. The laminates were manufactured the same way without the core as shown in Figure 2.

Figure 2. Schematic of VI process.

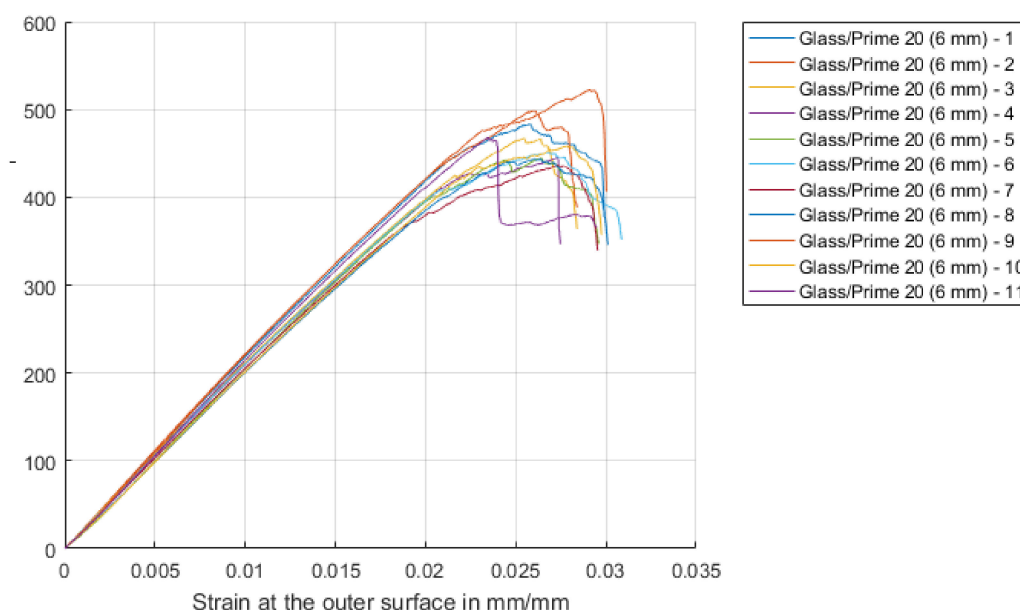
Quasi-static 3-point flexural tests were performed on rectangular strips of the laminates at a constant cross-head speed of 3 mm/min, width: thickness ratio of 13:4 and a span: thickness ratio of 16:1 in accordance with ASTM 7264 [24]. At least five repeat tests were performed. The primary concern was to confirm the consistency of the manufactured specimens, and to provide properties for future modelling and simulation work. The resulting stress-strain curves are shown in Figure 3. The response of the laminates was initially linear followed by a sharp drop in strength after the peak flexural stress was reached, indicating

the material had very limited plastic capacity (as expected). The laminates failed on the compression side, with surface buckling and delamination under the central loading point.

Figure 3. Stress-strain curves obtained from quasistatic three-point flexure tests on GFRP specimens.

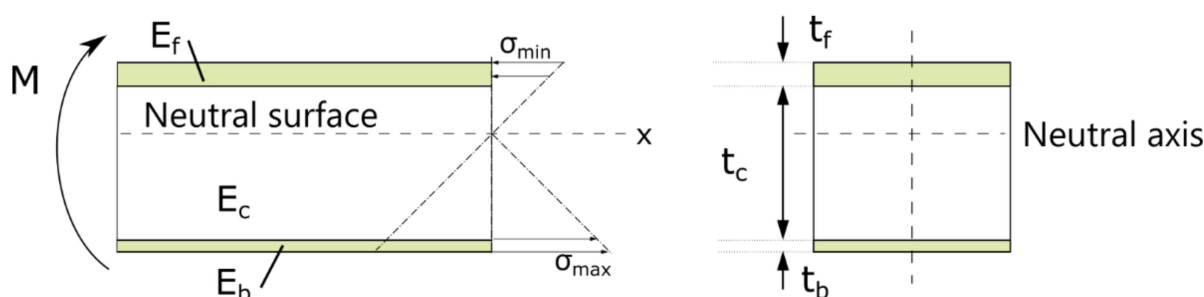
A schematic of the stress distribution of the sandwich beam under pure bending is shown in Figure 4 with the assumption that a linear variation of the strain through the thickness of the neutral axis. The core contribution was ignored as the modulus of the core E_c was likely much smaller than face sheets E_f and E_b . The differences in modulus would have caused the neutral axis to be closer to the top surface, and consequently, the stress on the top surface would be lower than on the bottom surface. Despite this, damage was only observed on the top surface by the loading nose, and no damage was observed on the bottom surface. This suggests that the compressive limit for the top face sheet was lower than the tensile limits of the bottom face sheet with the reduced thickness.

Figure 4. Stress distribution of sandwich beam under pure bending.

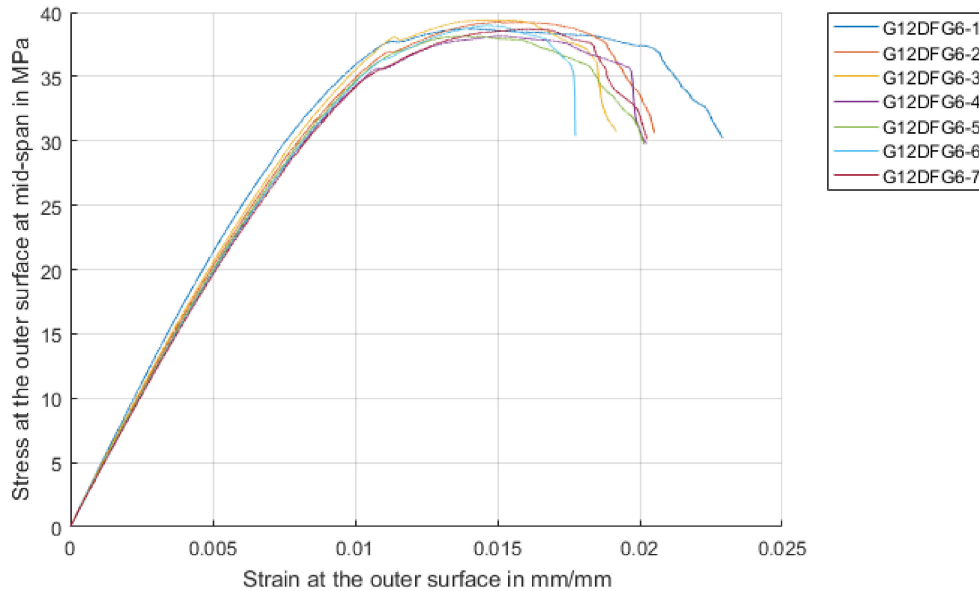
In contrast to the laminates, the response of the sandwich specimens was initially quasi-linear, up to 25 MPa, then the strength appeared to plateau and dropped as shown in Figure 5. The force-displacement curve taken over a longer time span is shown in Figure 6. According to Daniel and Abot [25], the bending behaviour of a sandwich panel is governed

Figure 5. Stress-strain curves obtained from quasistatic three-point flexure tests on sandwich specimens.

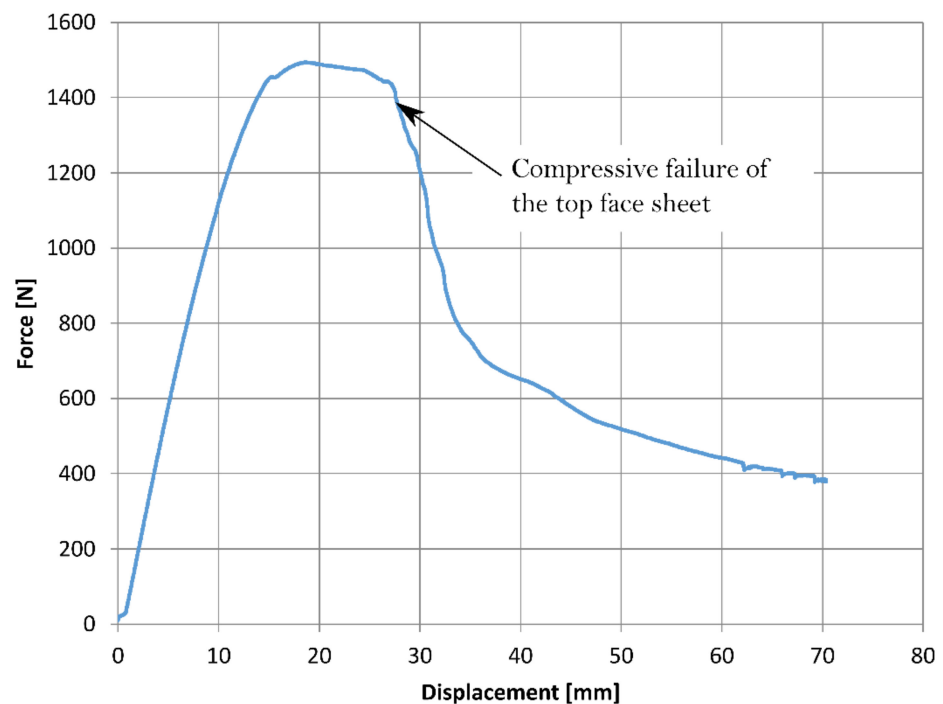
Figure 6. A typical force displacement curve obtained from three-point bend tests on sandwich beams.

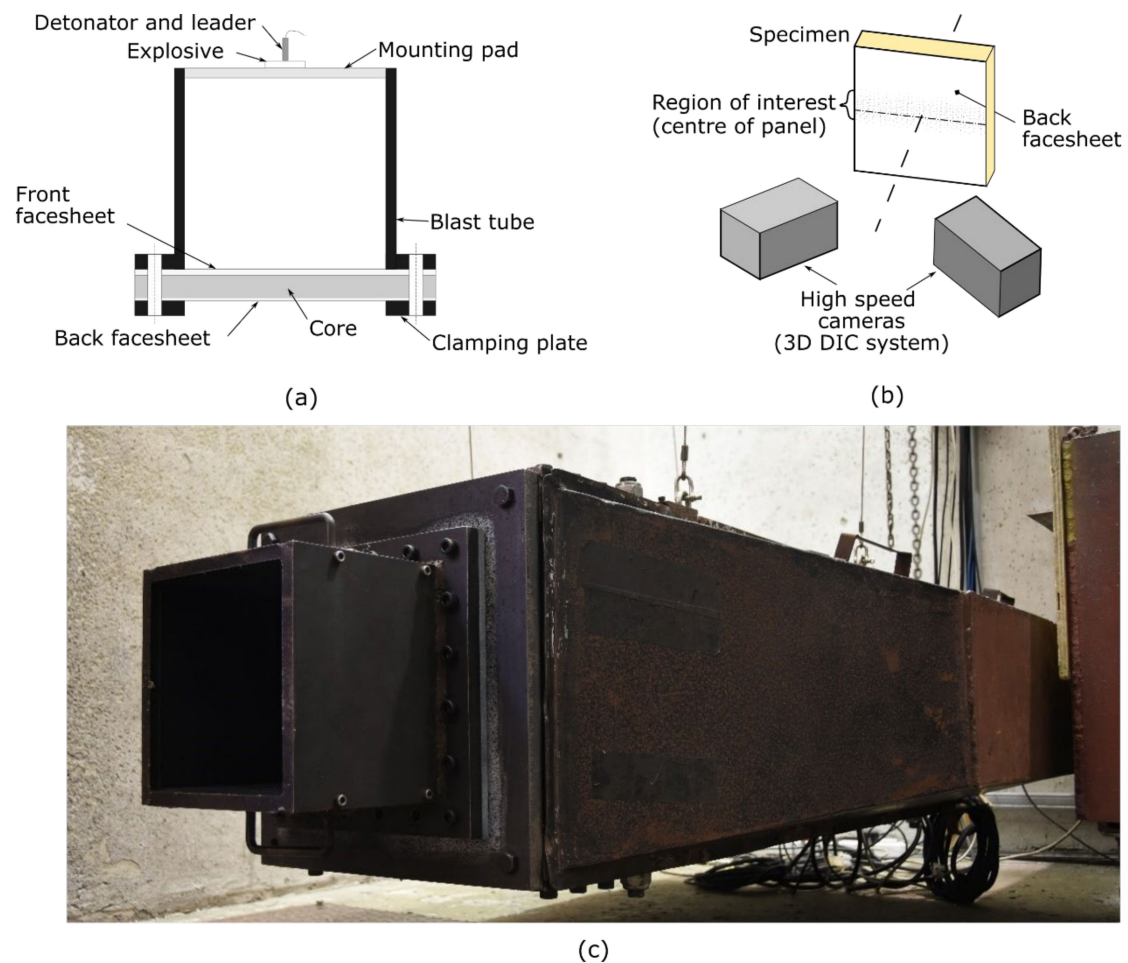
The 300 mm × 300 mm panels were clamped along all four sides, leaving a square exposed area of 200 mm × 200 mm. The front clamp frame was integral with a square section 200 mm long blast tube and the back clamp was mounted onto a pendulum via an adapter plate. According to Nurick et al. [27], the boundary conditions have a significant effect on the damage (such as large inelastic deformation) observed on panels subjected to uniformly loaded air blasts. Therefore, all panels were fully clamped to minimise the variability of the results due to boundary conditions, which is consistent with all prior work on these composites reported by Langdon and co-workers [10,11,28,29]. Explosive disks comprising 40 mm diameter PE4 plastic explosive were mounted on a polystyrene pad at the open end of the tube, ensuring a consistent stand-off distance. Air-blast loading was generated by detonating the disk-shaped PE4 explosive charge at the open end of the tube. The blast tube was employed to increase the spatial uniformity of the loading and to ensure that the impulse applied directly to the panels and that measured by the pendulum were the same. A similar test arrangement was used in Refs. [28,29]. The

impulse was determined from the swing of the single-degree-of-freedom pendulum using a laser displacement sensor. The blast test arrangement is shown in Figure 7.

Figure 7. Schematic of blast experimental arrangement: (a) blast arrangement; (b) DIC testing arrangement; and (c) photograph of enclosed DIC-modified pendulum.

For selected tests where the risk of fragmentation was low, high-speed stereo-imaging equipment was mounted to the pendulum to film the panel response, following reference [30]. The back surface of the middle third of the panels was painted with a black and white speckle pattern. Two high-speed monochrome IDT NRS4 cameras (filming at 30 kfps with an exposure time of $31 \mu\text{s}$) and LED lighting were positioned to provide a clear field of view of the central strip. The stereo-imaging system was calibrated to find the system projection and distortion parameters. A 19×19 pixels subset size and a grid spacing of 4 px were maintained for all tests. Digital image correlation (DIC) software was used to process the images to obtain the out of plane transient displacement across the mid-line of the panels.

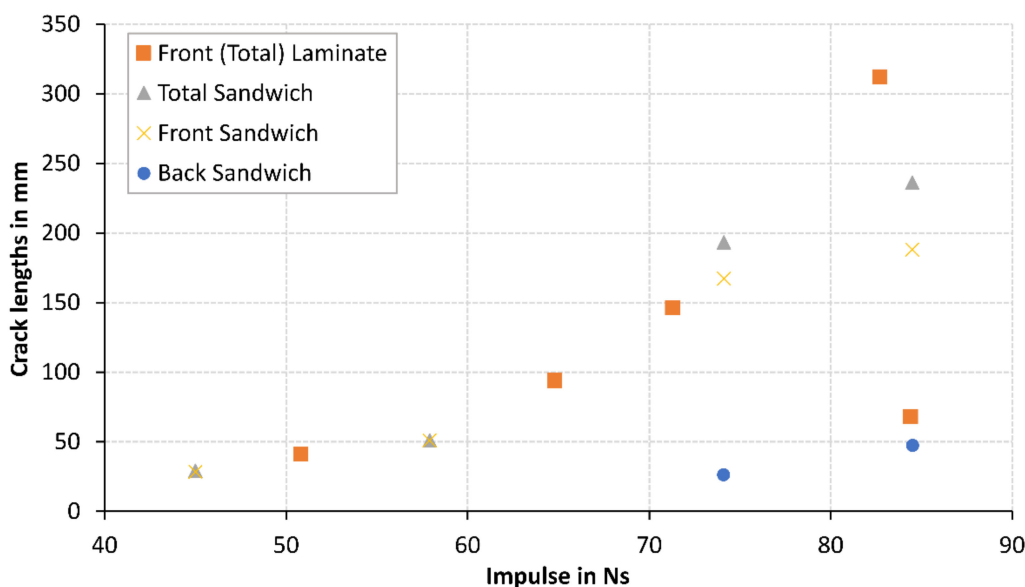
Figure 8. Graph of crack length within exposed area vs. impulse.

the sandwich structure at high impulses as less total cracking in the exposed areas and delamination were observed for a similar impulse GFRP blast tested panel as shown in Figure 8. The laminate G19/P20-6 appeared to have a low delaminated area and total crack length in the exposed area. Upon further investigation of the panel, extensive cracking was found in the clamped area and at the clamp boundary, and this is not recorded in Table 4. When cracks are initiated in other locations (such as the clamped region) it relieved stress in other parts of the structure leading to reductions in cracking in the exposed area as observed experimentally in this case. While we cannot be definitive in the reasons for why cracks should appear more extensive in the clamped region in this particular test, this is likely to be due to inherent variability of composite manufacture and the existence and distribution of small invisible defects in the clamped part of the structure. Furthermore, the measured permanent mid-point deflection was greater for the 35 g G19/P20-6 panel (1.2 mm) compared to the 40 g G19/P20-2 (0.6 mm) panel.

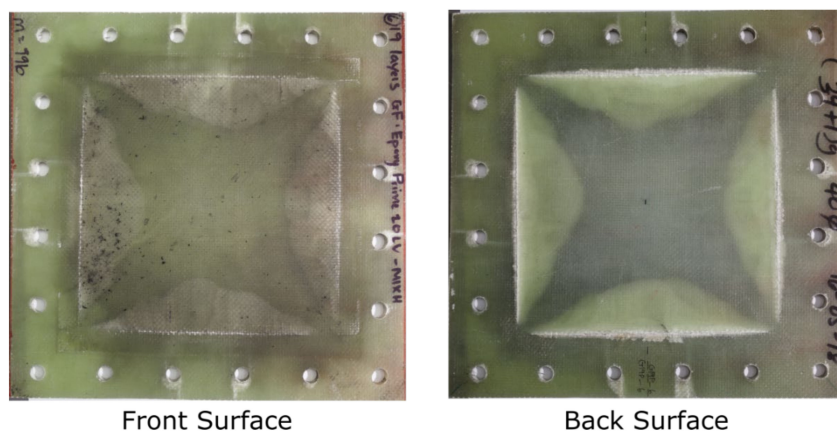
Photographs of the front and back surface of a laminate are shown in Figure 9. The laminates were slightly translucent, so damage or discoloration on one surface may be visible (but slightly obscured) on the other side. The front surfaces were discoloured by the residue from the blast products. The front surfaces of G19/P27-8 and G19/P27-9 were painted black (due to the translucent nature of the panel) for use with the DIC/stereo-imaging system.

Figure 9. Photographs of front and back surfaces of G19/P20-6 laminate panel subjected to an impulse of 84.4 Ns (35 g).

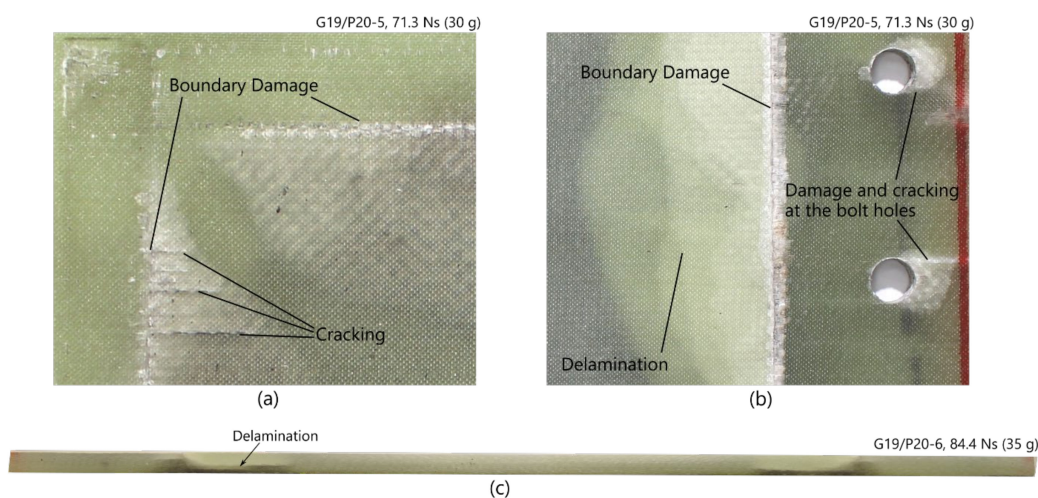
Matrix damage, delamination, and some fibre breakages (cracking) were evident at the edge of the clamped boundary, with selected close-in photographs of typical boundary failures shown in Figure 10. Cracking was also observed on the front exposed area at high impulses.

Figure 10. Damage (delamination, boundary damage, and cracking) observed in laminate panels on (a) front surface of G19/P20-5; (b) back surface of G19/P20-5; and (c) cross section along midline of G19/P20-6.

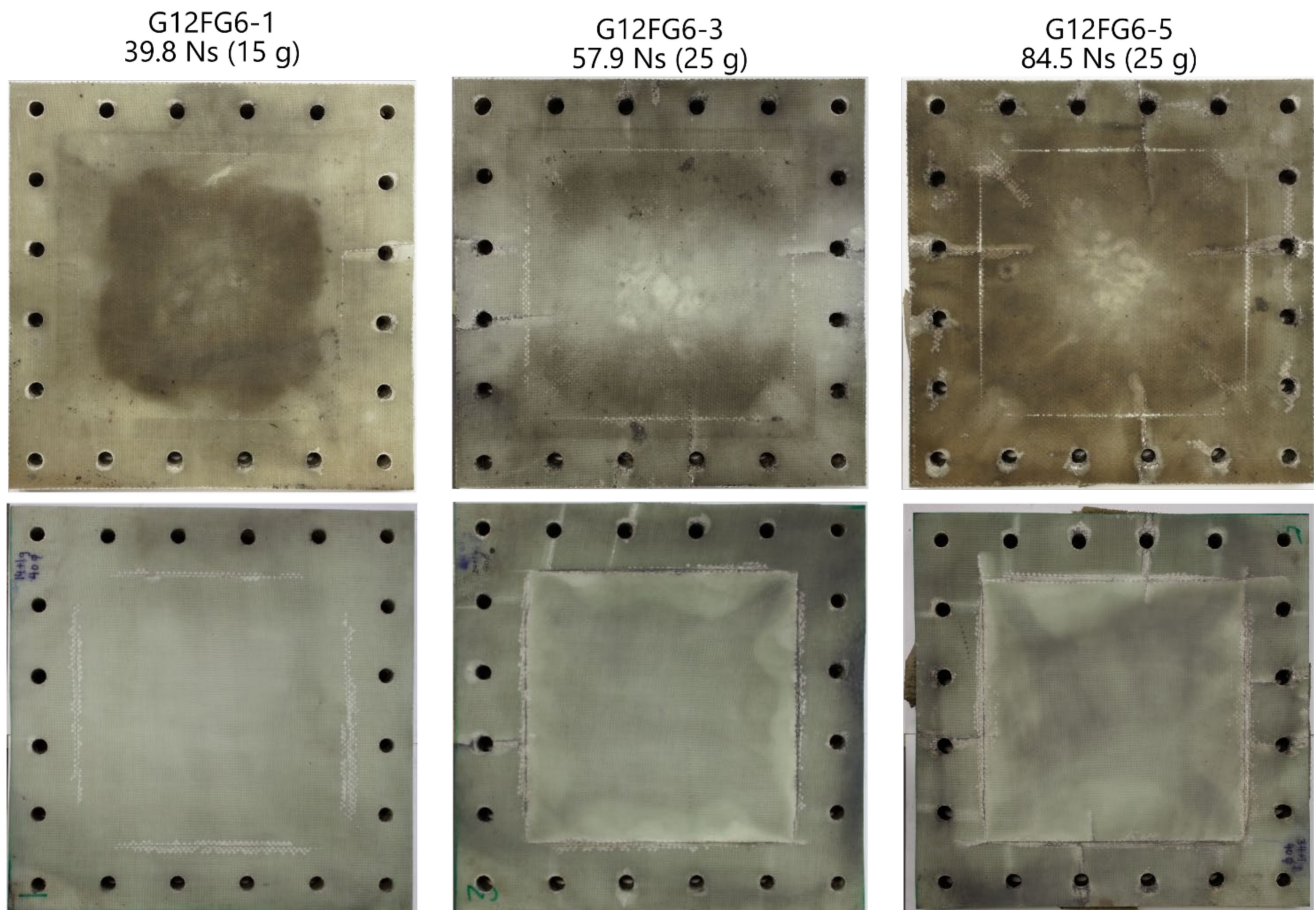
Photographs of the front and back surfaces of selected blast-tested sandwich panels are shown in Figure 11. Again, the glass fibre layers were slightly translucent, however overall, these panels were opaque. The front surfaces were discoloured by the residue from the blast products. The back surfaces of the sandwich panels were painted and speckled for use with the DIC/stereo-imaging system, which was subsequently removed after testing.

Figure 11. Photographs of front (top row) and back (bottom row) surfaces of selected sandwich panels.

Matrix failure was initially observed along the boundary on the back surface of G12FG6-1 (see back surface of G12FG6 in Figure 11). However, this damage was termed as boundary damage. With increasing impulse, matrix failure was also found in the exposed area of the sandwich panels as shown in Figure 12b.

Due to the load dispersing through the sandwich panel, it was expected that the initial damage would occur on the front face sheet and core. However, prominent boundary damage was first observed on the back face sheet (See Figure 11). Only slight damage (a single crack on one bolt hole) was observed on the front face sheet at the same impulse. The stress transmitted onto the back face sheet was large enough to cause significant damage than what would be expected on a symmetric sandwich panel, due to the thickness (and strength) of the back face sheet, along with the boundary opposing the deformation. As the load increased to 20 g, more damage, like cracking and core crushing, was observed on the front face sheet and core.

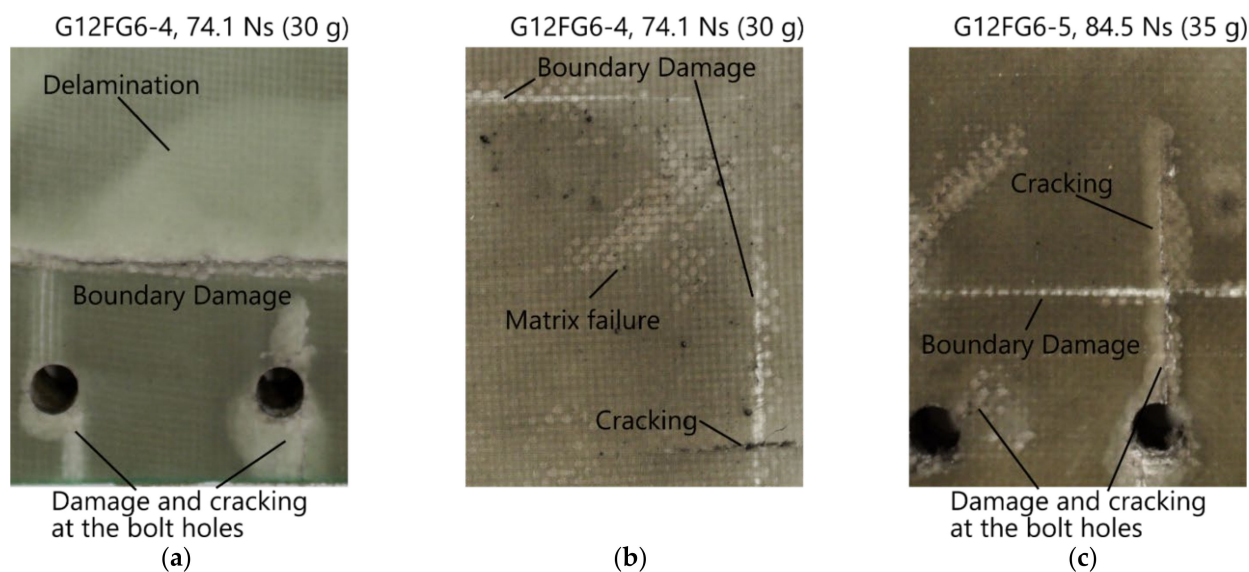
Cracking as a failure mode was initially observed on the front surface of G12FG6-1 at 39.8 Ns, where the cracks appeared to extend from the bolt holes to the exposed area. With increasing impulse, the cracking increased (both the number of cracks and length) and was also observed on the back surface of the panels at an impulse of 57.9 Ns and above. Greater crack lengths in the exposed area were observed on the front face sheet compared to the back face sheet. Photographs of cracking, both in the clamped area and exposed area, are shown in Figure 12.

Figure 12. Damage observed in sandwich panels: (a) back surface of G12FG6-4 (30 g); (b) front exposed area of G12FG6-4 (30 g); (c) front surface of G12FG6-5 (35 g).

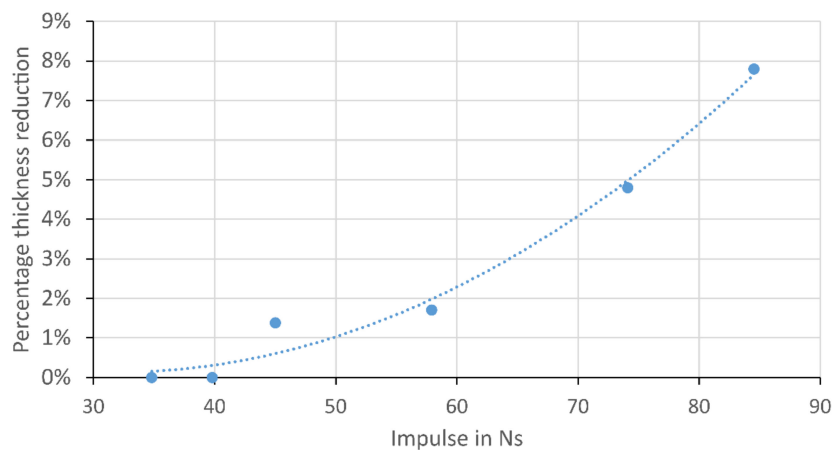
As expected, there was a general trend where the thickness of the sandwich panel in the centre reduced with increasing impulse as shown in Figure 13. At the highest impulse tested at 84.5 Ns, the thickness of G12FG6-5 (35 g) was reduced by 8%. Figure 14 shows the comparison of the cross section along the midline of two sandwich panels, one of which did not appear to have significant damage after testing (G12FG6-6, 11 g). The core of G12FG6-5 (35 g) was crushed due to the blast load and at the edges, core cracking and slight fragmentation were observed. In all the tests performed, no debonding between the face sheets and core was observed. Additionally, it did not appear that either face sheets had significant permanent deformation due to the elastic nature of the composite. The lack of face sheet/core debonding will be of interests to modellers seeking to reduce the complexity of their models, as this appears to be a failure mode that could be neglected for similar cases.

Figure 13. Graph of impulse versus percentage thickness reduction of blast-tested sandwich beams.

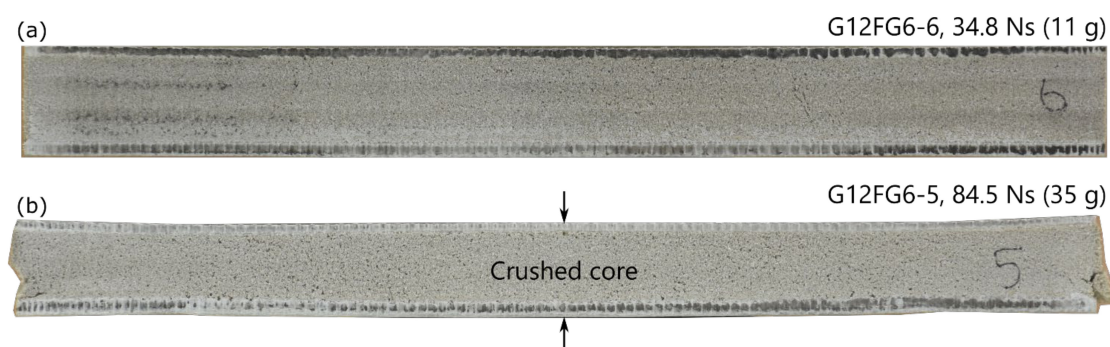
Figure 14. Cross section along midline of sandwich panels (a) G12FG6-6 (11 g) and (b) G12FG6-5 (35 g).

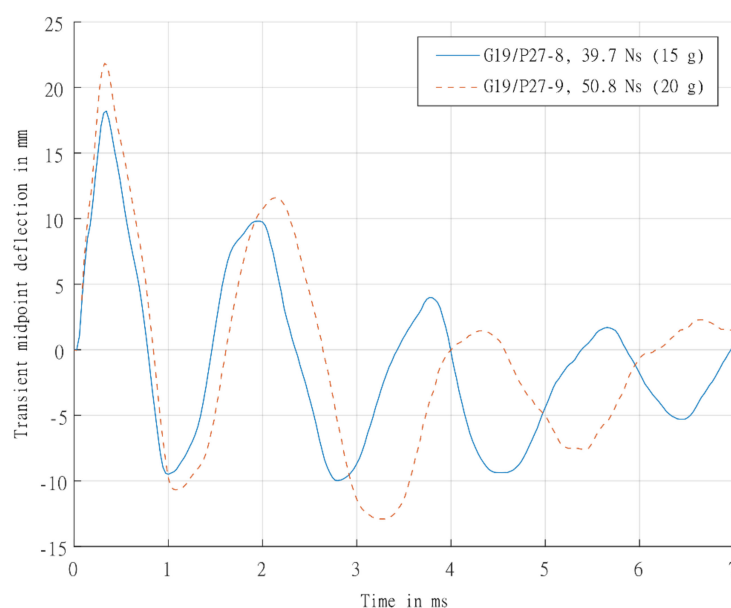
The transient mid-point displacement time histories of the laminates are shown in Figure 15. The transient response was elastic, with an initial steep rise in displacement followed by viscously damped oscillations (for at least 3 cycles). Furthermore, there was no significant permanent displacement. The natural period of vibration (based on the first two full oscillations) for the two panels were 3179 and 3684 rad/s for G19/P27-8 and G19/P27-9, respectively.

Figure 15. Graph showing experimentally determined transient mid-point displacement-time histories for laminate panels G19/P27-8 (15 g) and G19/P27-9 (20 g).

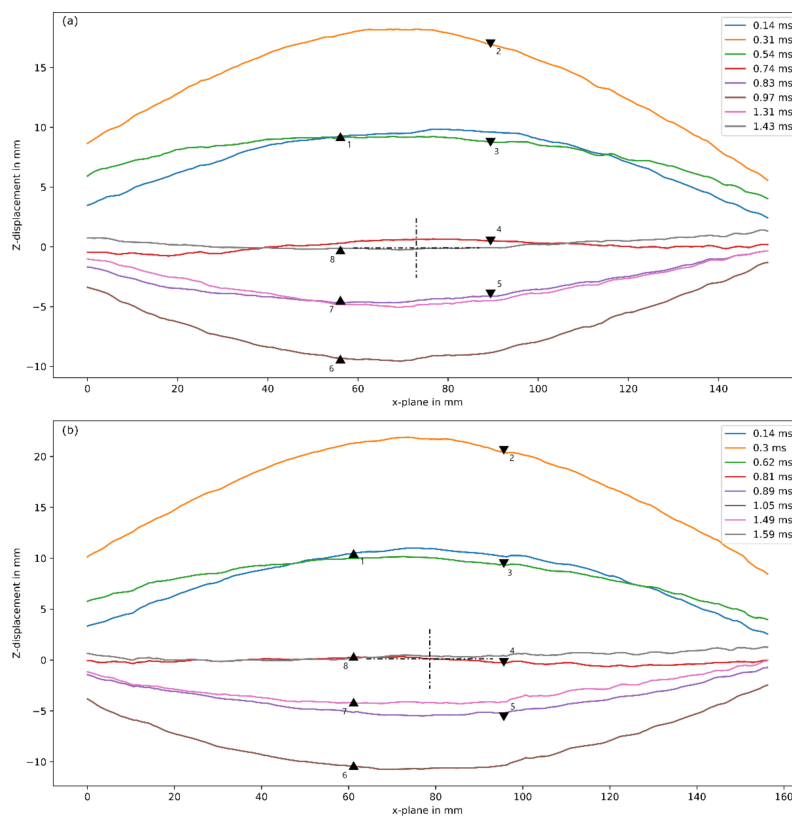
The transient displacement profiles for the GFRP panels tested are shown in Figure 16. A global dome-shaped profile was observed where the peak was found in the central region. The profiles were similar and appeared to overlap each other. Additionally, it seemed symmetric about the y-axis of the centre of the panel.

Figure 16. Transient deformed profiles of selected laminates (a) G19/P27-8 (15 g) and (b) G19/P27-9 (20 g) obtained from DIC analysis, where triangles indicate direction of motion.

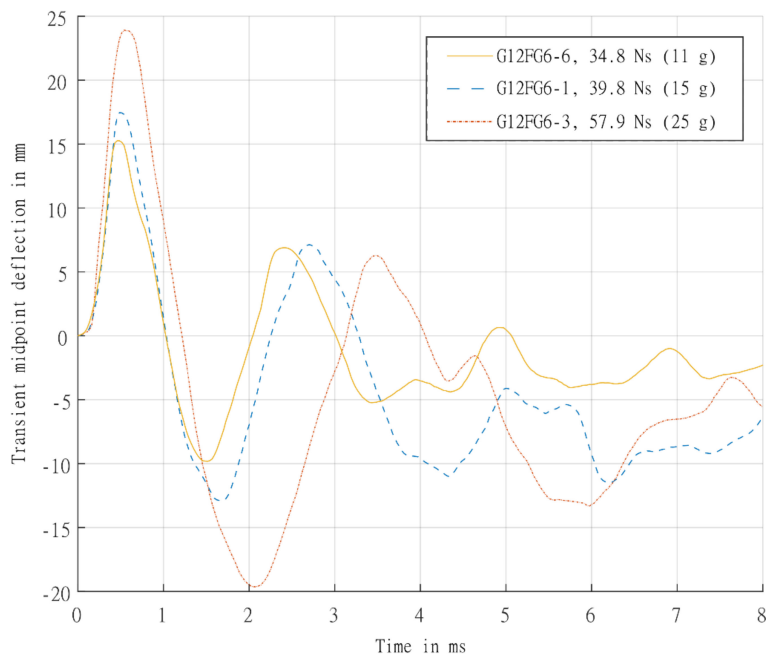
The transient mid-point displacement time histories of the back faces of the sandwich panels are shown in Figure 17. Both types of materials exhibited high peak displacements. However, for the sandwich panel, while there was an initial steep rise, the subsequent fall in displacement was greater than the displacement observed in the GFRPs. During the initial rise, compression loading in the core would suppress the formation of core cracking despite the high shear loads generated. The rebound possibly caused the core to go through tension after the initial compression, which may result in core thickness recovery and, while not observed on the panels tested, interface bond failures. The minor damage on the cores observed from these tests also suggested that the rebound tensile stress did not exceed the tensile strength of the core.

Figure 17. Graph showing back face sheet experimentally determined transient mid-point displacement-time histories for sandwich panels G12FG6-6 (11 g), G12FG6-1 (15 g), and G12FG6-3 (25 g).

Additionally, the following peak displacement observed appeared similar for the different sandwich panels and lower than the laminates despite different impulses. A comparison of the time histories between a laminate and sandwich panel tested at similar impulses is shown in Figure 18. The peak displacement is very similar in both panels, with a possible slight delay in the sandwich panel (due to the additional time taken for the waves to traverse the increased panel thickness and extra interfaces). The post-peak oscillation response of the back face of the sandwich structure seems more complex than the relatively simple viscously damped elastic vibration in the laminate tests, as load from the blast was not directly applied to the back face sheet. It was transferred to the back face sheet after the stress wave had passed the front face sheet, through the core and the core was compressed. Therefore, the intensity of the load transmitted would be dependent on the stiffness of the front face sheet and core compressive properties. The load would be dispersed differently between the front face sheet and back face sheet. It was postulated that different deflections for the front and back face sheet would be observed, unlike the almost identical front and back face sheet mid-point deflections found by Wang

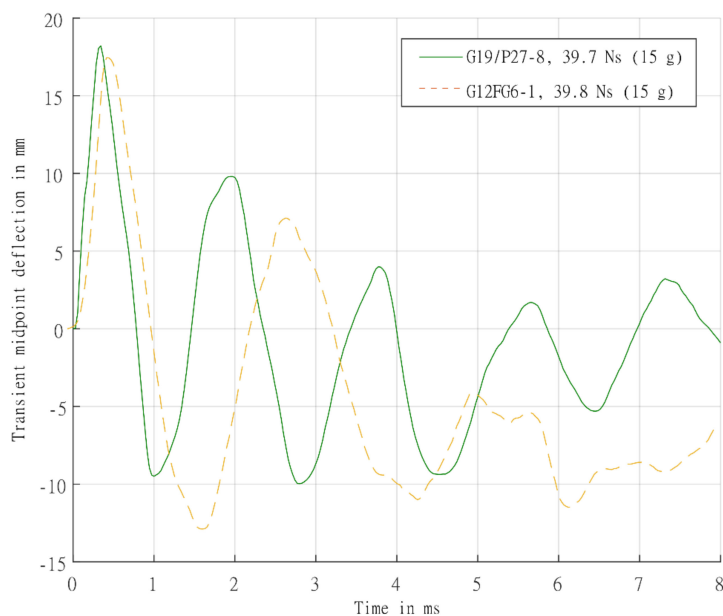
Figure 18. Comparison of experimentally determined transient mid-point displacement-time histories for back surface of laminate panel G19/P27-8 and sandwich panel G12FG6-1, both tested at 15 g.

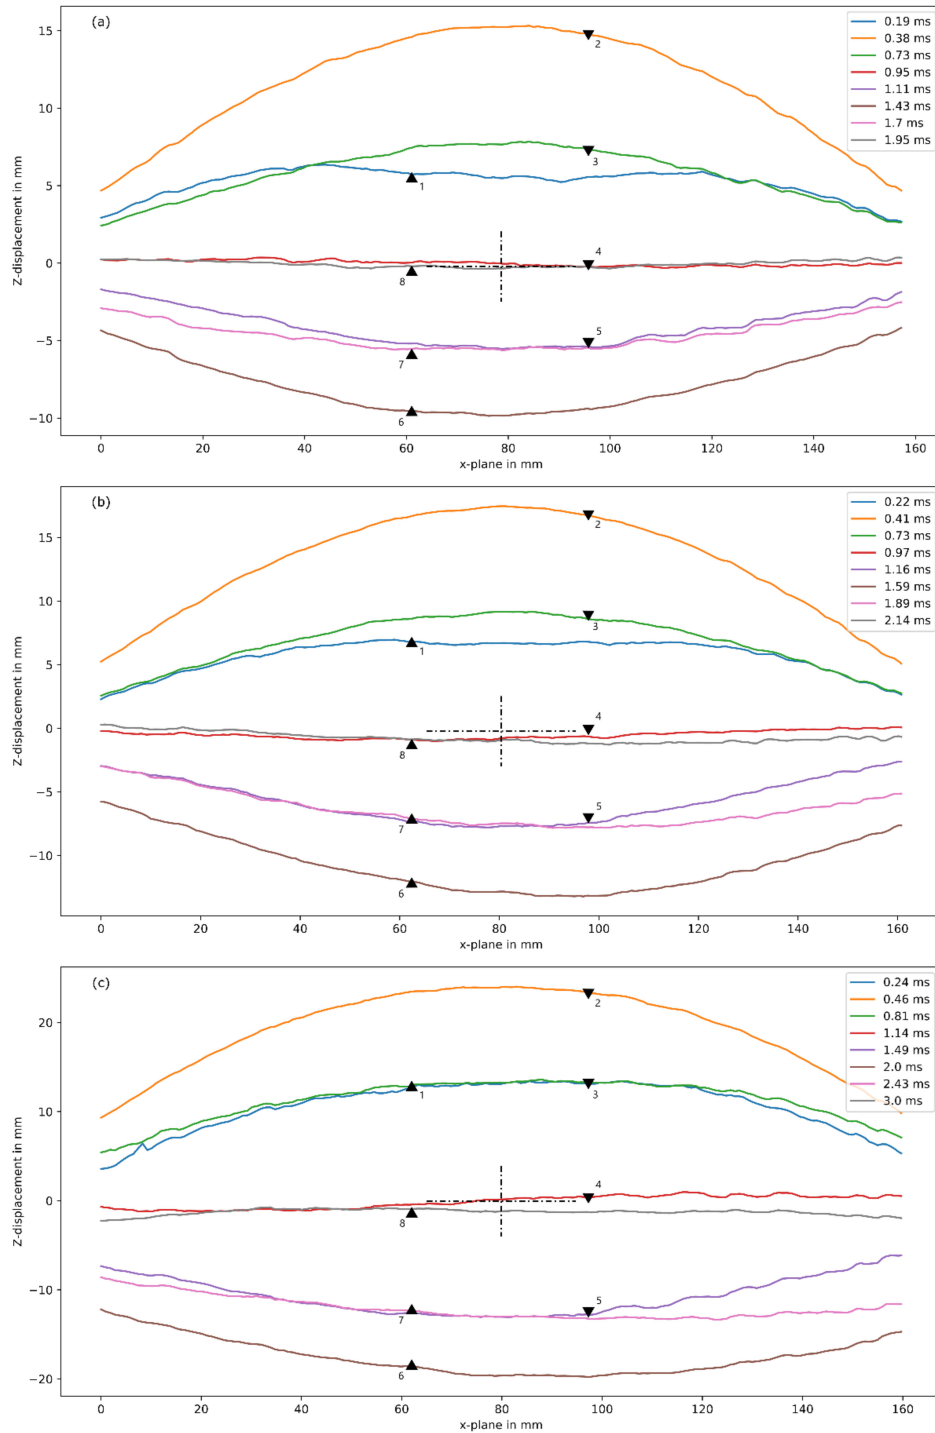
The transient displacement profiles for the sandwich panels tested are shown in Figure 19. A key difference in the displacement profiles between the two materials was profile 1 (indicated by the blue line), when the panel initially deforms. Unlike the GFRP,

the mid-section of profile 1 was flat. Once the panel reached its peak displacement, the profiles were global dome-shaped and resembled profiles found in the GFRPs.

Figure 19. Transient deformed profiles of (a) G12FG6-6 (10 g), (b) G12FG6-1 (15 g), and (c) G12FG6-3 (25 g), obtained from DIC analysis, where triangles indicate direction of motion.

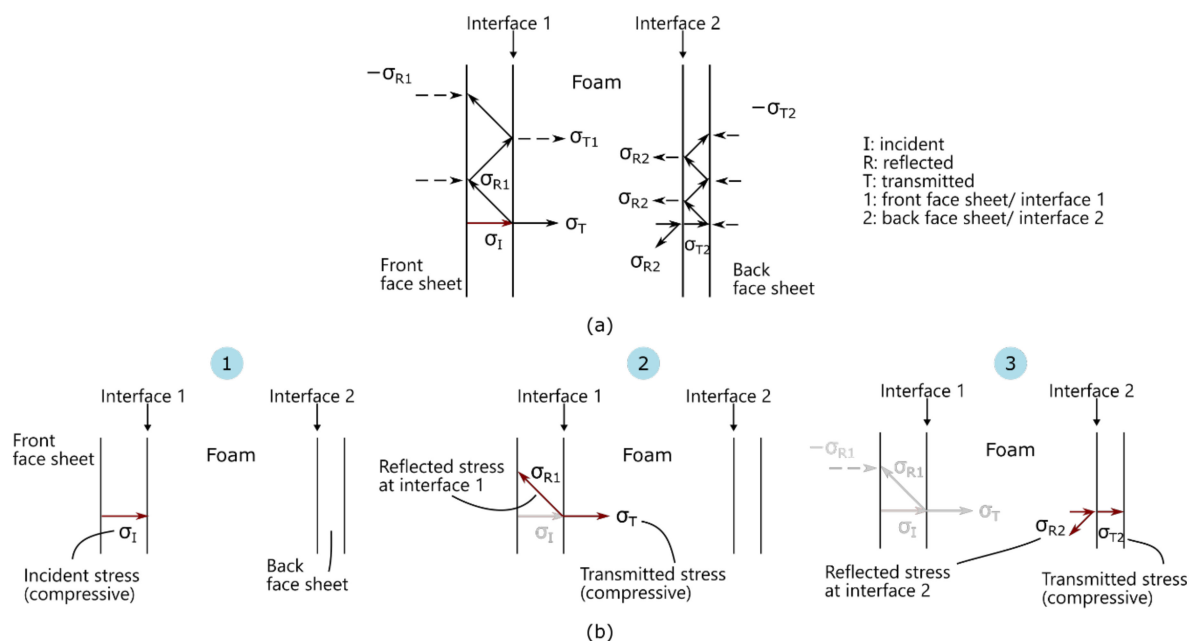
Figure 20. Schematic of Phase I: through-thickness wave propagation where (a) overview of transmitted and reflected waves in sandwich structure and (b) propagation of stress waves through different layers.

Assuming that most of the damage occurred in Phase I and Phase II, the probable sequence of damage for the asymmetric sandwich panels would be as shown in Table 5 and illustrated in Figures 20 and 21.

Phase I	<ol style="list-style-type: none"> 1. Through-thickness incident stress wave transmitted in the front face sheet as shown in Figure 20b(1) [31,32]. 2. Initial compression of the (foam) core due to the transmitted compressive stress wave from the blast shown in Figure 20b(2) [31]. 3. Boundary damage occurred on the back face of the sandwich panel due to the compressive stress wave and impulsive transverse shear reaction forces (Figure 20b(3)). Delamination also possibly occurred due to reflected tensile stress waves in the face sheet shown in Figure 20a.
Phase II	<ol style="list-style-type: none"> 4. The front face deformed, subsequently caused the core and rear face to deform. 5. Bending and shear loads, as the panel deformed, caused damage in the different parts of the sandwich panel. Primarily, delamination extending from the boundary towards the centre occurred on the rear face sheet (Figure 21a) due to its thickness (relative low strength and stiffness). At high impulses, compressive stresses on the front face sheet appeared to cause cracking and matrix failure, extending from high stress concentration areas such as bolt holes and clamped boundary as shown in Figure 21b. Further core compression would occur due to high shear loads.

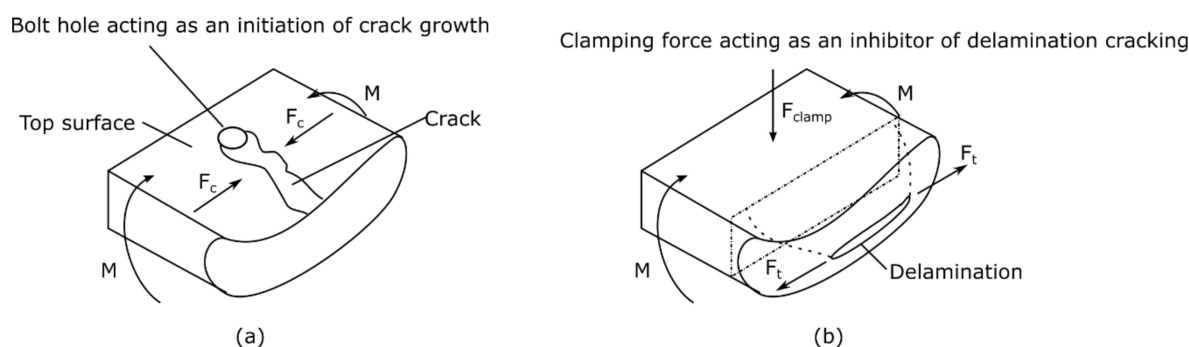
Figure 21. Reaction at boundaries of (a) front face sheet and (b) back face sheet due to global bending.

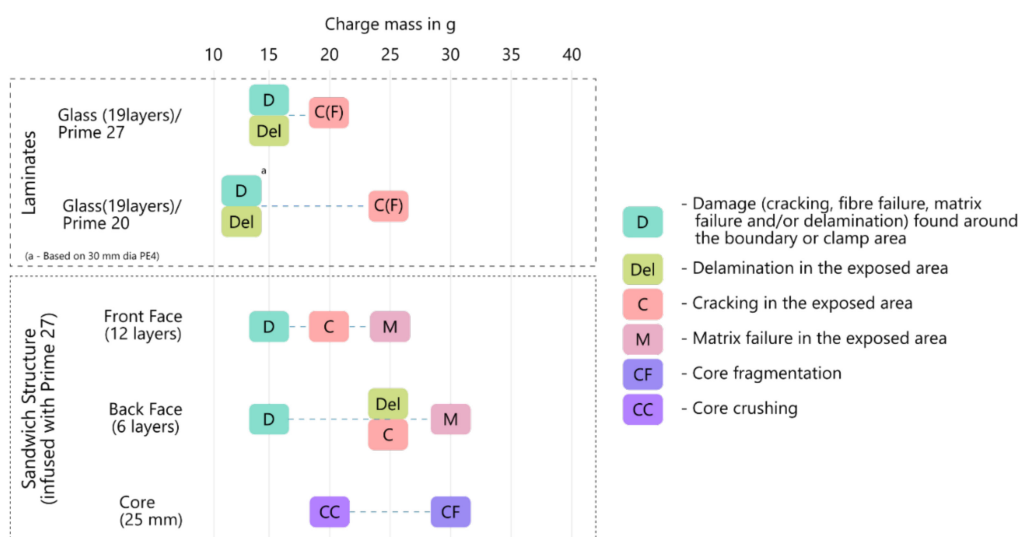
Figure 22. Failure mode initiation chart for laminates and sandwich structure tested.

A failure initiation chart, shown in Figure 22 was used as indicators of the onset of a failure mode for a range of charge masses, similarly done in Ref. [13]. Dotted lines between different failure modes were used to show the combination of failure modes at higher charge masses.

In comparison to the laminates, back face sheet delamination initiated at a higher charge mass (of 25 g). Additionally, boundary damage and delamination were observed at similar loads on the GFRPs. Yet, there was a significant difference when the two types of damage were observed on the back face sheet. Cracking and boundary damage on the front face sheet occurred at the same charge mass as the Glass (19 layers)/Prime 27 laminates. Cracking also only occurred on the front surface of laminates. It might be possible that the cracking was caused by compressive loading as the panel deformed from a stress concentration spot (like a bolt hole or imperfection in the composite) and could be similar to face sheet wrinkling. For the sandwich panel, the critical stress for wrinkling was dependent on the core stiffness as well as the face sheet properties which was further described in Ref. [9].
