Article

Promising Results of the Comparison of Coatings on Aged Bridges and of Same Coatings in Laboratory

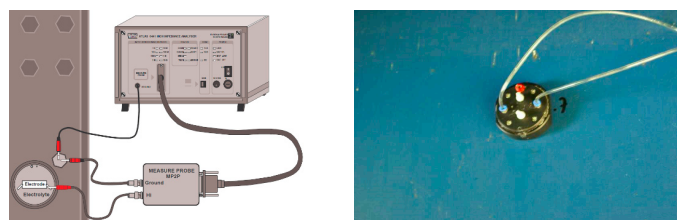
Figure 1. Set-up of the EIS measurement device.

In selected places with different corrosive exposures, the coatings were tested by electrochemical impedance spectroscopy in order to determine their barrier properties and to check whether there were undercoating corrosion processes. This type of research has been performed on bridge structures by the authors since 2000 [11], and their use has become a valuable and widely used tool for assessing coatings and the degree of advancement of underpaint corrosion processes [12–15]. The measurements were carried out using the Atlas analyzer (ATLAS 0441 High Impedance Analyser, Atlas-Sollich, Gdansk, Poland) in a two-electrode system, in a 3.5% sodium chloride solution, within a frequency range of 10⁵ Hz to 10^{−2} Hz. The working electrode was the sample itself and the counter electrode was a platinum mesh. The connection diagram is shown in Figure 1. The impedance spectra were analyzed using the ZView 4 fitting procedure (Scribner Associates Inc., Southern Pines, NC, USA). The results are presented as the logarithm of the impedance modulus as a function of the frequency. The value of the logarithm of the impedance modulus at a frequency of 0.1 Hz allows us to determine the protective properties of the paint system. Table 3 shows the EIS measurement sites.

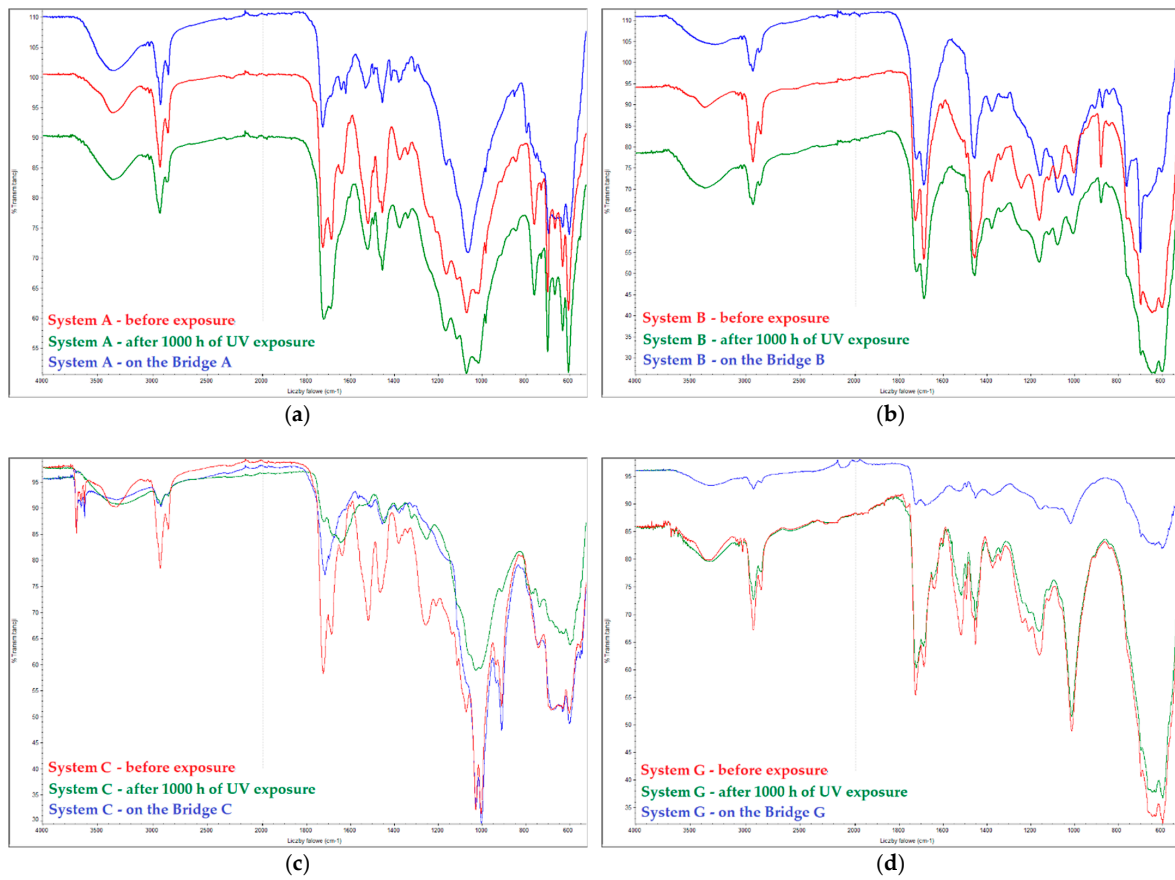
Figure 2. Spectra of topcoats in coating systems: (a) system A; (b) system B; (c) system C; (d) system G. Red line, before exposure; green line, after 1000 h of exposure in the UV chamber; blue line, on bridges.

The results of the tests on the degradation in the form of chalking of coatings made in the laboratory and the ones removed from bridges are presented in Table 6 and Figures 2 and 3. The degree of chalking determined for coatings applied on bridges does not always coincide with the degree defined in the laboratory for the respective systems. The degree of chalking in some cases is greater in natural conditions than it is in the test chamber (Table 6). After over a dozen years of service, the structure of coatings on bridges looks similar to the structure of coatings exposed during 1000 h in a UV chamber. The bands generated by coatings exposed to natural atmospheric conditions on bridges remain the same or disappear in the same way as in the laboratory conditions (Figure 2).

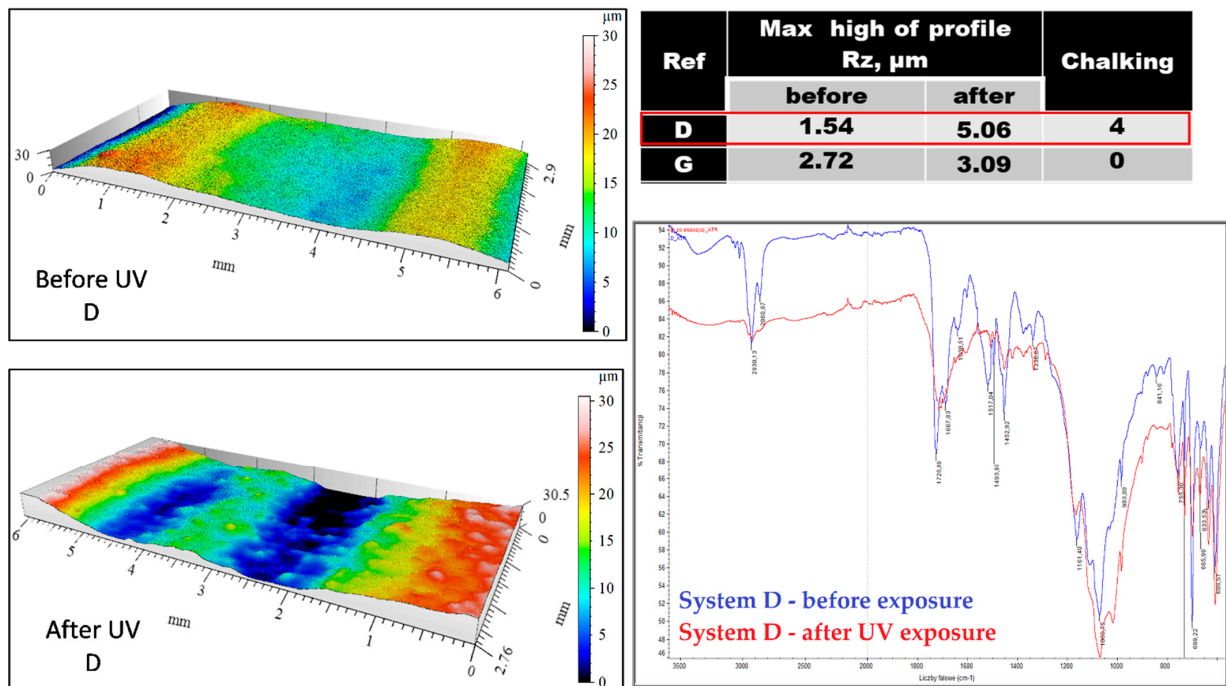
Figure 3. Surface profile and structure of the coating D before and after exposure to UV: greater change in roughness → changes in the FTIR spectrum.

The roughness of the coatings after exposure varies to a different degree, depending on the coating system, in agreement with both chalking and changes in the binder structure (Figures 3 and 4). A large change in the surface profile of coating D corresponds to a high degree of binder degradation (Figure 3), while the lack of changes in the structure of the coating G agrees with an insignificant change in the surface profile (Figure 4).

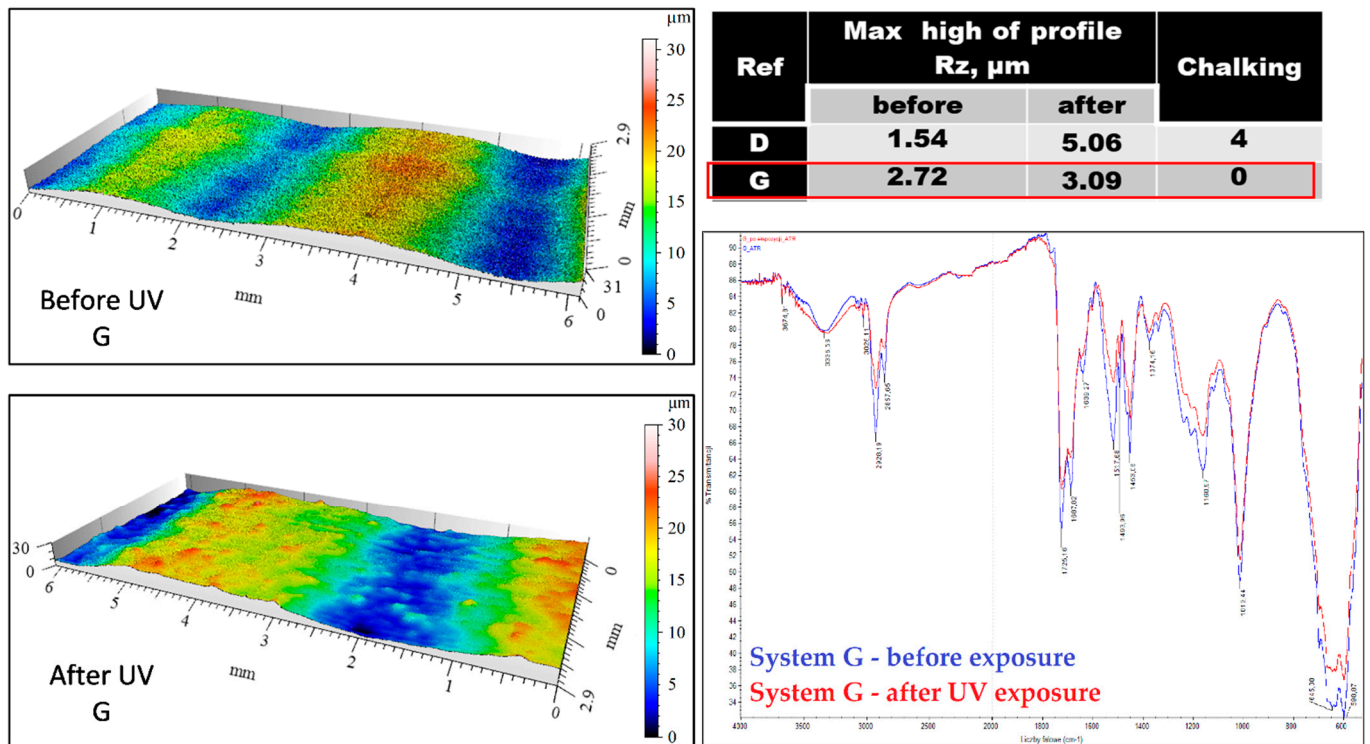
Figure 4. Surface profile and structure of the coating G before and after exposure to UV: smaller change in roughness → identical spectrum with spectrum before exposure.

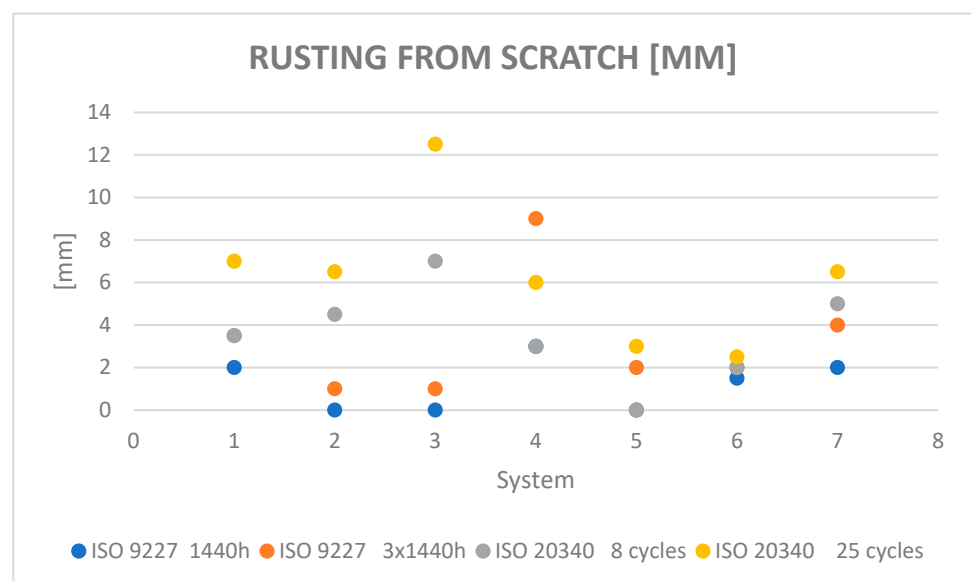
Figure 5. Rusting from the scratch measured according to ISO 4628-8:2012 [8].

The results of corrosion and blistering of the coatings around the crack according to ISO 4628-8:2012 [8] are given in Figures 5 and 6. Other damages during exposure in the salt chamber were not found.

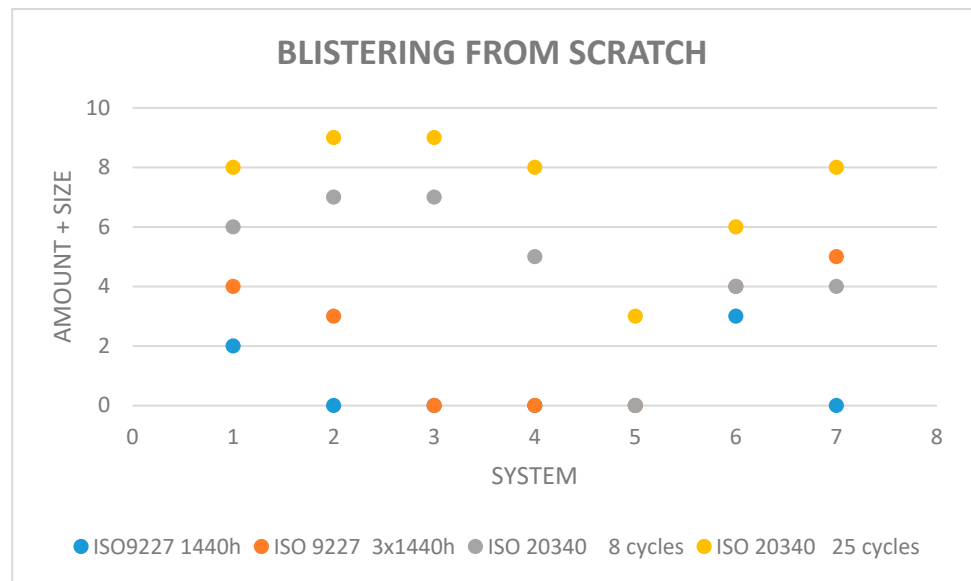
Figure 6. Blistering from the scratch measured according to ISO 4628-8:2012 [8].

Looking at the results of accelerated tests in the salt spray chamber and in variable cycles, it can be seen that no corrosion changes occurred on the tiles without scratch in the analyzed period. There were also no differences in the results of corrosion tests between flat and T-shaped plates, as illustrated, for example, in Figure 6.

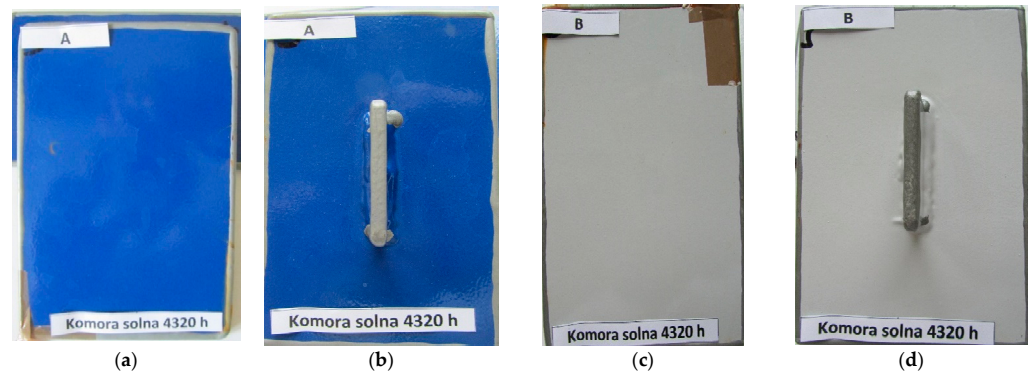
Figure 7. The appearance coatings without scratches after 4320 h of exposure in a salt spray chamber: (a,b) system A; (c,d) system B.

Figure 7 shows an example of the appearance of the coatings without the scratch after 4320 h of salt spray testing. The same is true for the other systems and tests, where no differences were found between the results for flat and T-shaped plates. The appearance of A and B system coatings with scratches after 4320 h of exposure in a salt spray chamber are presented in Figure 8.

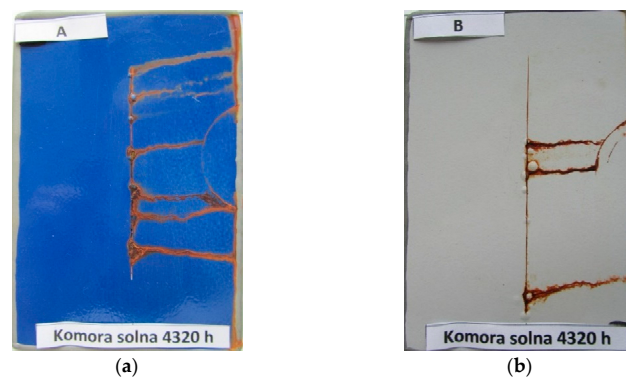
Figure 8. The appearance of coatings with scratches after 4320 h of exposure in a salt spray chamber: (a) system A; (b) system B.

Different failures appear around the scratches, as shown in the example of coating systems A and B (Figure 7). In any case, the damage is greater for the tests in alternating cycles than for the tests in the salt spray chamber, even over extended periods of time.

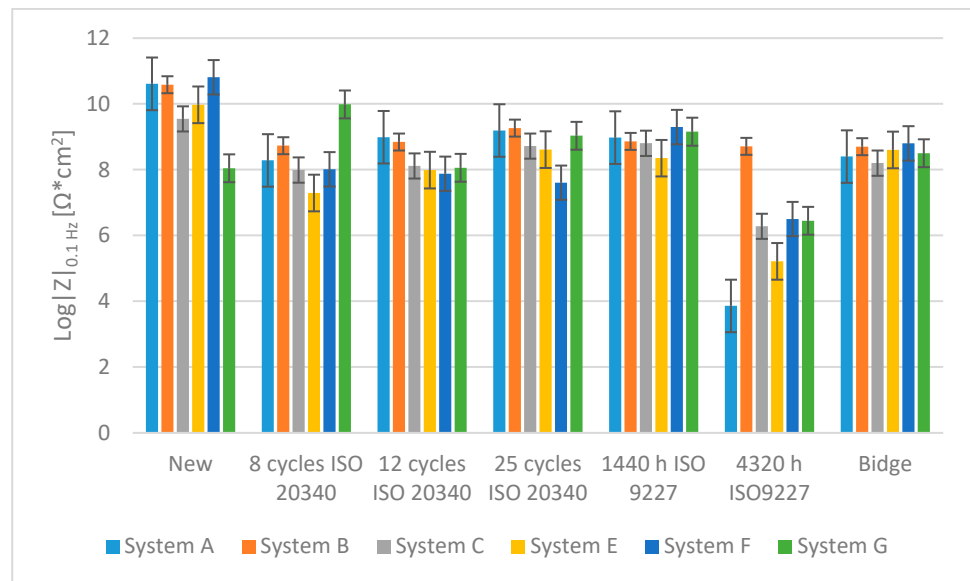
Figure 9. Values of $\log |Z|_{0.1 \text{ Hz}}$ before accelerated tests, after accelerated tests and on the bridges.

Figure 9 summarizes the measurement results of $\log |Z|$ at 0.1 Hz for new systems, for systems after various accelerated tests and for systems on the bridges.
