EDITORIAL COMMENT

Leaflet Injuries After Percutaneous Edge-to-Edge Repair

A Challenge to Avoid*

Francesco Maisano, MD

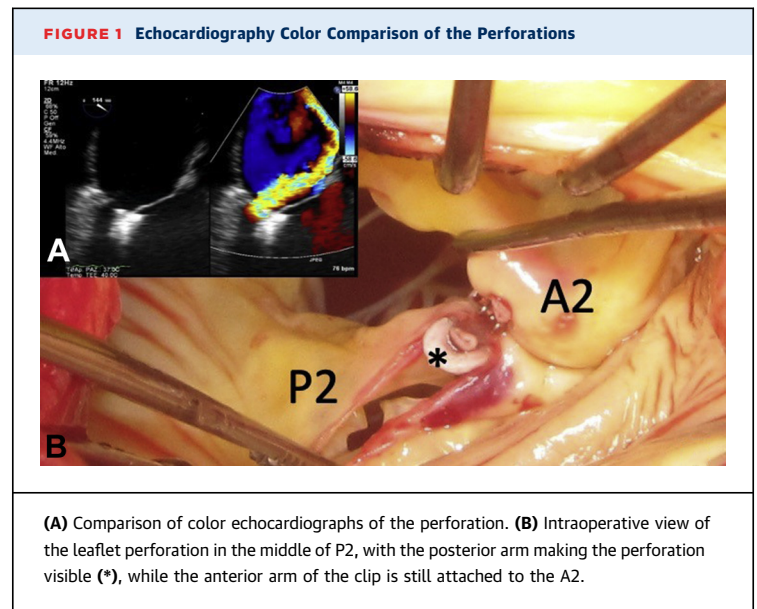
after, it was realized that the patient had developed severe afterload mismatch with low arterial pressure. For that reason, the anesthesiologist supported the patient with multiple doses of epinephrine. Finally, the patient responded with recovery of left ventricular function, which was shortly associated with severe systemic hypertension. Recurrent severe MR was observed, initially interpreted as the consequence of the increased afterload. Soon after, the systemic pressure decreased, but the pulmonary pressure increased significantly, with persistent severe MR. For the first time, technicians were confronted with the scenario of an intraprocedural leaflet perforation following catheter-based edge-to-edge repair (Figure 1) requiring immediate surgical bailout.
