Article

Very High Cycle Fatigue Behavior of Additively Manufactured 316L Stainless Steel

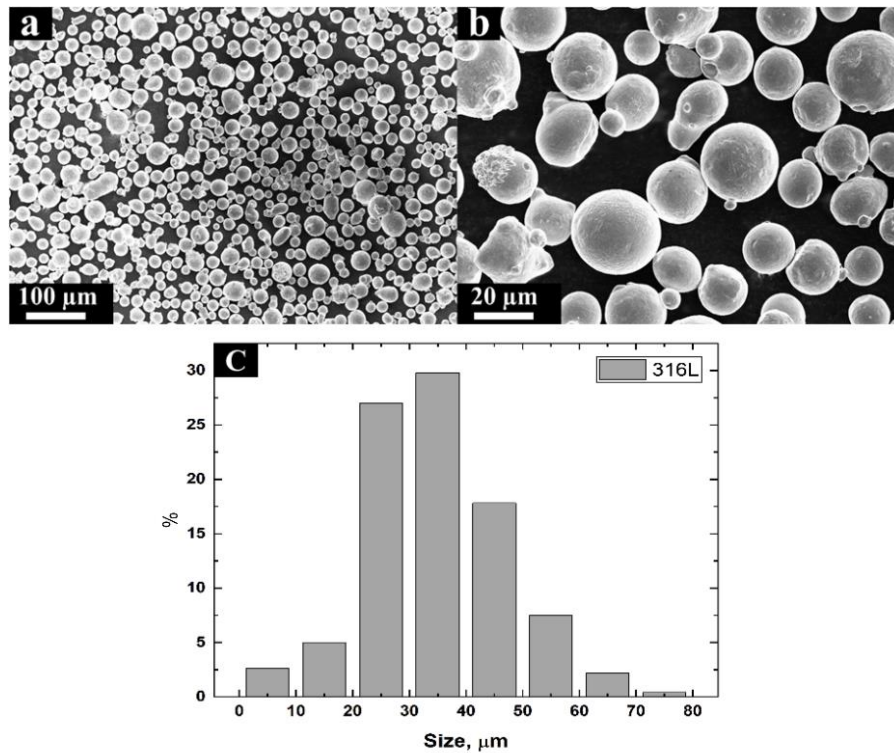
Figure 1. The 316L stainless steel powder used for the L-PBF process, (a) magnification $\times 413$; (b) magnification $\times 2000$; (c) size distribution (the number below the chart shows the medium particle size in the range).

Cylindrical bars, 100 mm in length and 13 mm in diameter, were vertically built by Trumpf TruPrint 1000 (Ditzingen, Germany) facilities, with the process parameters given in Table 1. The laser has a Gaussian profile with a focusing spot of 55 μm . The 316L stainless steel powder particles had a spherical shape with a diameter of 20–50 μm (Figure 1c) [11]. It was observed that some large particles agglomerated with dust-like “satellites” as a result of collisions that were apparently caused by the gas atomization process [32] (Figure 1a,b).

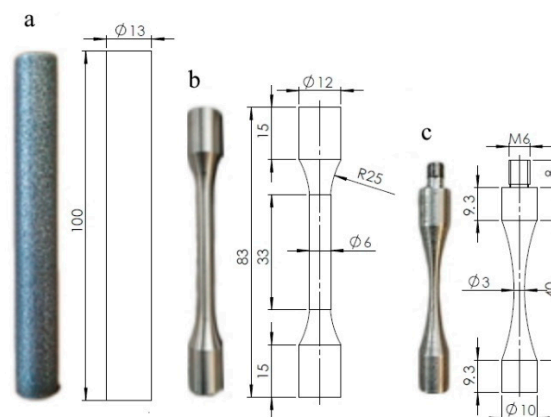
Figure 2. The test specimens with dimensions: (a) as-built cylinder; (b) a specimen for static and conventional fatigue tests; (c) a specimen for VHCF tests. All dimensions shown are in millimeters.

The shapes and dimensions of the printed bars and test specimens milled from the cylinders by the CNC machine are shown in Figure 2. The specimens for the static tensile test were machined to the same shape as conventional fatigue specimens (Figure 2b). No specimens were heat-treated. Static tensile tests were performed at room temperature according to ISO 6892 [33] using an Instron 5969 electromechanical machine with 50 kN load capacity. Five specimens were tested at a loading rate of 2 mm per min. The obtained tensile properties are given in Table 2.

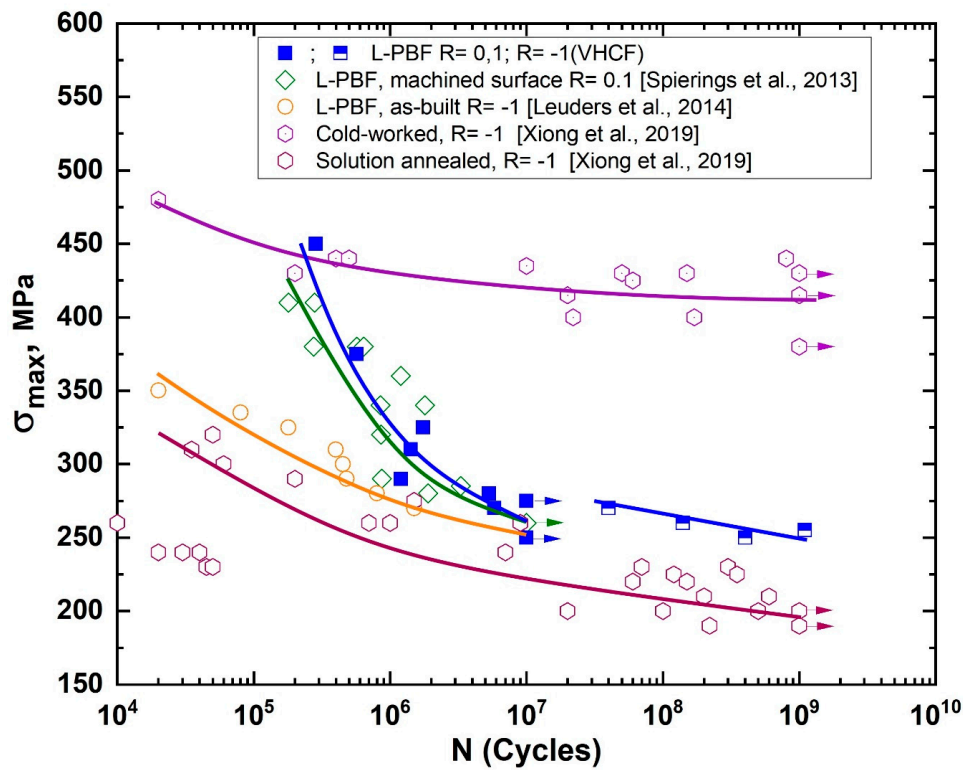
Figure 3. S–N diagram of the L-PBF 316L stainless steel specimens, as well as the data obtained by Spierings et al. [35], Leuders et al. [36], and by Xiong et al. [41] for cold-worked and solution-annealed 316L SS. The points indicated by the arrows correspond to specimens that were not disrupted during the tests.

The fatigue tests were carried out for high and very high cycle fatigue regimes (HCF and VHCF, respectively). The S–N diagrams (maximum cyclic stress versus number of cycles to failure) were obtained, as given in Figure 3. The HCF tests were performed with $R = 0.1$, and the VHCF tests were performed for fully reversed loading with $R = -1$. The results of conventional fatigue tests of L-PBF 316L stainless steel obtained by Spierings et al. [35] for $R = 0.1$ and Leuders et al. [36] for $R = -1$ are also plotted in Figure 3 and concatenated to the results of the present study. It was seen from the figure that the HCF data obtained herein for $R = 0.1$ lies within the data given in [35]. However, as recently discussed by Zhang et al. [37], the stress-based transformation of fatigue data from $R = 0.1$ to $R = -1$ is questionable for AM 316L stainless steel utilizing traditional models [38–40].

As shown in Figure 3, the plotted S–N data corresponding to cold-worked specimens [41] shows higher endurance at similar stress levels than the data in the plot obtained for the AM specimens in HCF [36] and VHCF regimes. However, the AM specimens demonstrated almost the same fatigue behavior as the specimens heat treated at $1120 \text{ }^\circ\text{C}$ for 7.5 min followed by water quenching [41]. This indicated that the difference could be explained by assuming features of the damage-to-failure mechanism of the AM and routinely manufactured 316L stainless steel under fatigue loading.

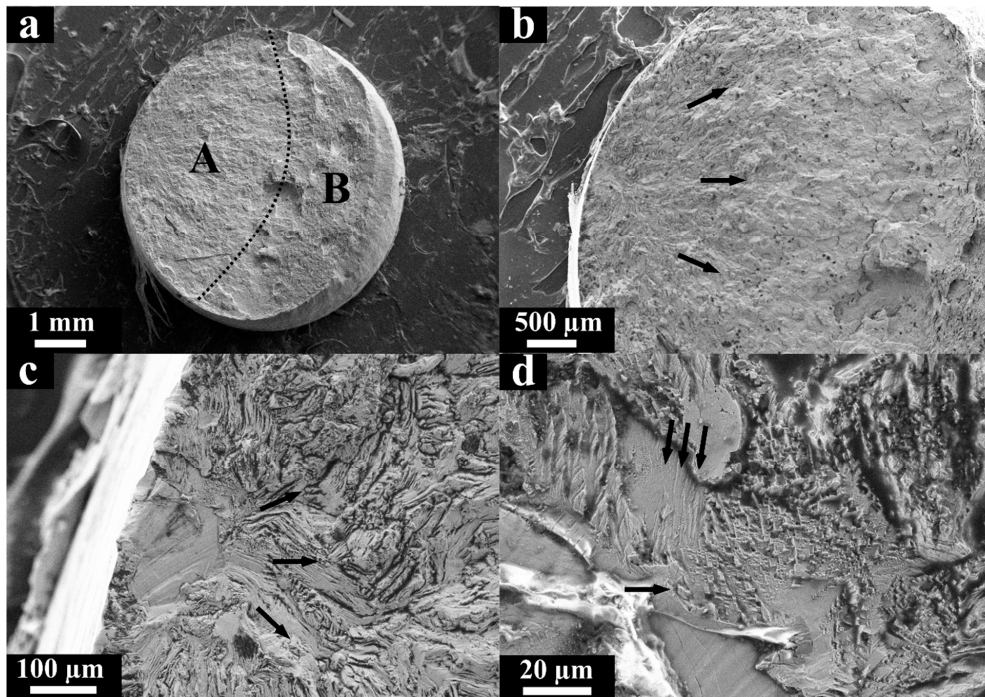
Figure 4. SEM micrographs of the fracture surface of the L-PBF specimen after loading in the high cycle fatigue (HCF) regime ($\sigma_{max} = 310$ MPa and $N = 1.41 \times 10^6$ cycles), (a) the characteristic failure zones; (b) the direction of the fatigue crack propagation (zone A); (c) the crack nucleation site; (d) fatigue striations.

Figure 4 shows the fracture surface corresponding to the specimen tested in the HCF regime under average stress level $\sigma_{\text{max}} = 310 \text{ MPa}$ and $N = 1.41 \times 10^6$ cycles before rupture. The fracture surface (Figure 4a) consisted of a fatigue crack propagation zone (A) and a final rupture zone (B). The direction of the crack propagation is indicated by arrows in Figure 4b nearest to the outer surface of the specimen where the fatigue crack nucleated (Figure 4c). The fatigue crack nucleation site (Figure 4c) and its propagation path (Figure 4d) are characterized by a rather complicated viscous relief of the fracture surface, caused by a mixed mode that combines shear and detachment. Fatigue striations (Figure 4d) were observed along with the elongated comb formations, which corresponds to the intermittent propagation of the fatigue crack, which is typical for ductile metallic materials. The distance between the individual striations at this stage was approximately $2 \text{ }\mu\text{m}$.

Unlike the HCF regime at the average stress level, typical fatigue striations (Figure 4d) were not observed on the fracture surface of the HCF specimen at highest stress level, which is probably related to a higher rate of fatigue crack propagation [42]. Few unmelted particles ≈ 30 μm in size were detected at the nucleation area where crack propagation zone A2 increased (Figure 5b). At the same time, zone A1 propagated from the outer surface as well, where the AM process defects were not observed.

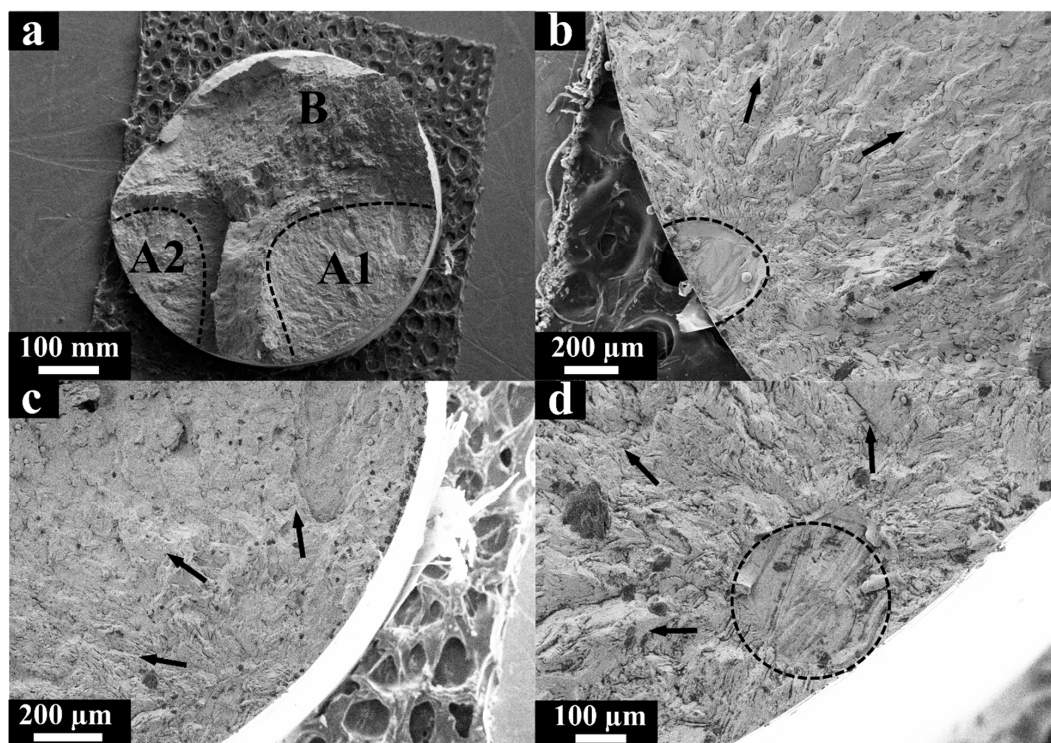
Figure 5. SEM micrographs of the fracture surface of the LPBF specimen after loading in the HCF regime ($\sigma_{\max} = 450$ MPa and $N = 2.23 \times 10^5$ cycles), (a) zones of failure; (b) direction of crack propagation (zone A2); (c) the direction of crack propagation (zone A1); (d) the site of crack initiation (zone A1).

SEM images of the fracture surface obtained in the HCF regime with the highest stress level $\sigma_{\max} = 450$ MPa and $N = 2.23 \times 10^5$ cycles before rupture are given in Figure 5. It was observed that two separate fatigue cracks initiated growth from the outer surface of the specimen (Figure 5b,d). Therefore, two crack propagation zones, A1 and A2, grew until the final rupture at zone B (Figure 5a), which increased according to the applied stress and was proportionally larger than the appropriate rupture zone (Figure 4a) observed in the HCF regime. The sizes of zones A1 and A2 are smaller than the size of zone A produced in the HCF regime (Figure 4a), where the specimen ruptured at low stresses. In other words, the ratio of the crack initiation and propagation zones to the final fracture zone decreased as the stress level increased, which corresponds to previously reported observations [42,43].

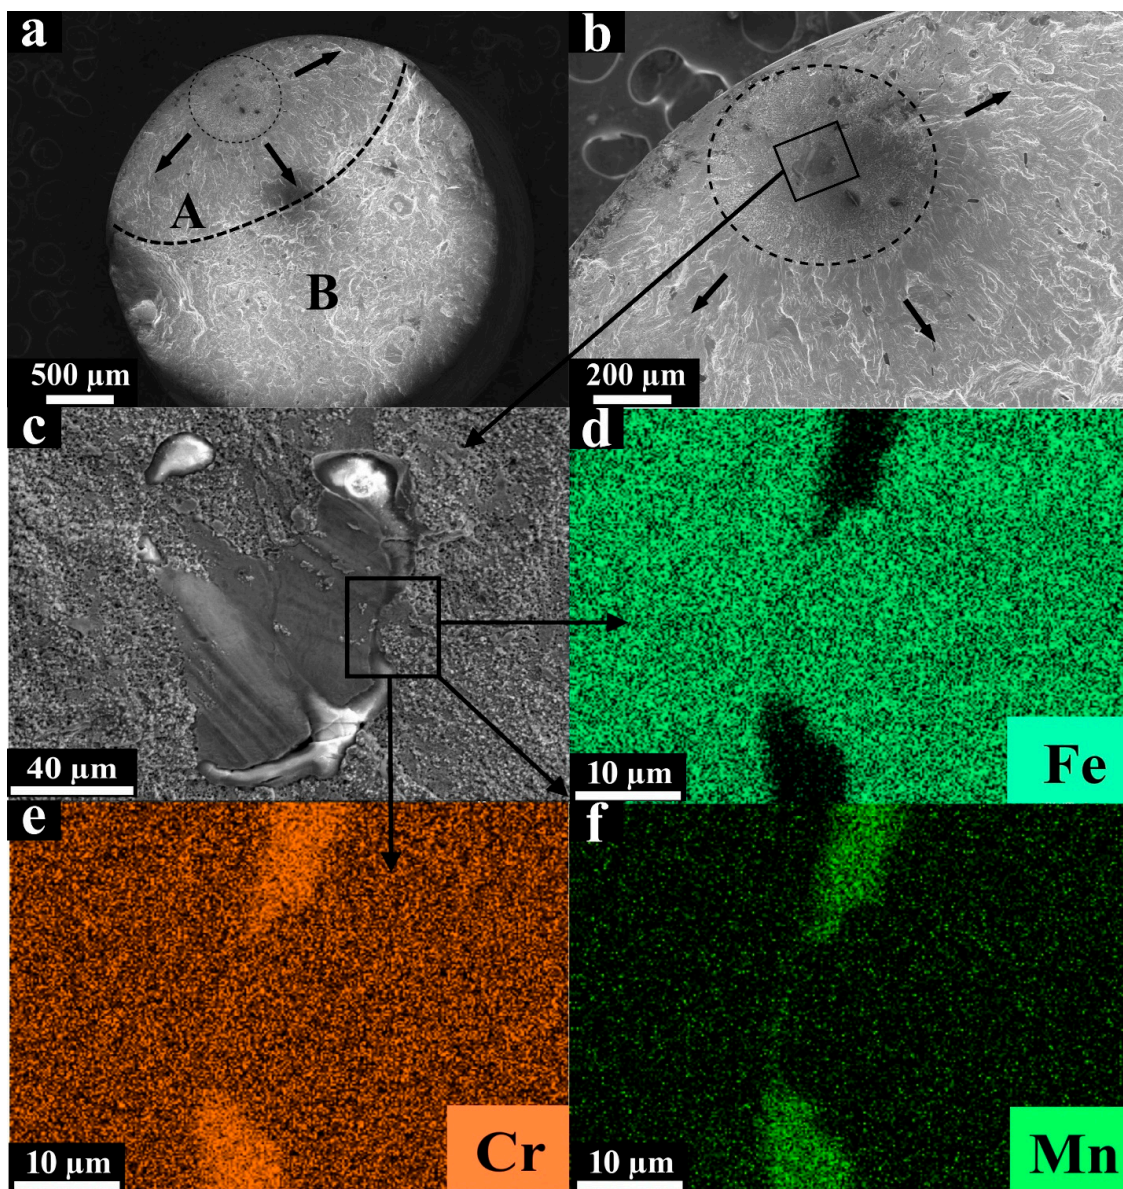
Figure 7. SEM micrographs of the fracture surfaces after loading in the VHCF regime ($\sigma_{\max} = 260$ MPa, $N = 1.5 \times 10^8$ cycles) of the L-PBF specimen with the assumed fusion defect, (a) zones of failure; (b) crack initiation site; (c) internal defect; (d) iron distribution; (e) chromium distribution; (f) manganese distribution.

Another characteristic of the VHCF fracture surface is shown in Figure 7a–c. The characteristic size and morphology of the FGA observed there (Figure 7b,c) are similar to those of the FGA surrounding the nonmetallic inclusion mentioned above. Herein, EDX analysis of the defect zone was also performed to identify this type of defect. The boundaries of the defect were enriched by chromium and manganese, and at the same time, a lack of iron was observed there in comparison with the nominal material surrounding the defect. Therefore, the defect was assumed to be an unmelted particle or due to a lack of fusion.
