# Effect of Benzotriazole on the Localized Corrosion of Copper Covered with Carbonaceous Residue

**Abstract:** Carbonaceous residues on copper pipes during the manufacturing process are known to be one of the main causes of pitting corrosion on copper pipes. This study examined the corrosion-inhibiting effect of benzotriazole (BTA) on C12200 copper pipes with carbonaceous film in synthetic tap water. In the absence of BTA, localized corrosion mechanisms due to galvanic corrosion, crevice corrosion, and oxygen-concentration cell were proposed in the boundary part of the carbonaceous film on the copper through X-ray photoelectron spectroscopy (XPS), scanning electron microscopy (SEM) with energy dispersive spectrometer (EDS) analyses. Electrochemical tests showed that BTA inhibits corrosion by forming Cu–BTA complexes on all over the copper surface where carbonaceous film is present. BTA mitigates galvanic corrosion and crevice corrosion at the boundary of the carbonaceous film and suppresses the formation of oxygen-concentration cells through the formation of a Cu–BTA complex.

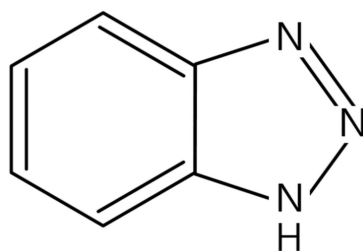
**Figure 1.** Molecular structure of benzotriazole.

The most widely used method for preventing copper corrosion is the addition of corrosion inhibitors. Benzotriazole (BTA) is one of the most effective corrosion inhibitors for copper, and many studies have been conducted on BTA. Figure 1 shows the chemical structure of BTA. When copper is immersed in a solution containing BTA, it is believed that BTA forms a protective layer in the solutions [7]. The corrosion-inhibiting mechanism of BTA is generally accepted as the formation of a protective layer on the Cu surface by the formation of a Cu–BTA complex by a Cu–N bonds in BTA [8,9]. Although there is controversy regarding BTA inhibiting mechanisms, many researchers have studied BTA as an effective inhibitor for different conditions. Walker showed that inhibiting efficiency (*IE*%) was 100% when 1 mM BTA was added under dilute seawater solution, dilute NaNO<sub>2</sub> solution, and dilute NaCl solution conditions [10]. Musiani showed that BTA was less effective at a low pH level [11]. P. Yu researched the inhibition efficiency of BTA on copper in deionized water. When BTA concentration exceeded 8 ppm in deionized water, *IE*% exceeded 80% [12]. Ross and Berry investigated BTA inhibitory effectiveness under 10% H<sub>2</sub>SO<sub>4</sub>, low or high flow rate solution [13]. In addition, many studies on the inhibition efficiency of BTA under various conditions were conducted [7,9,14–16].

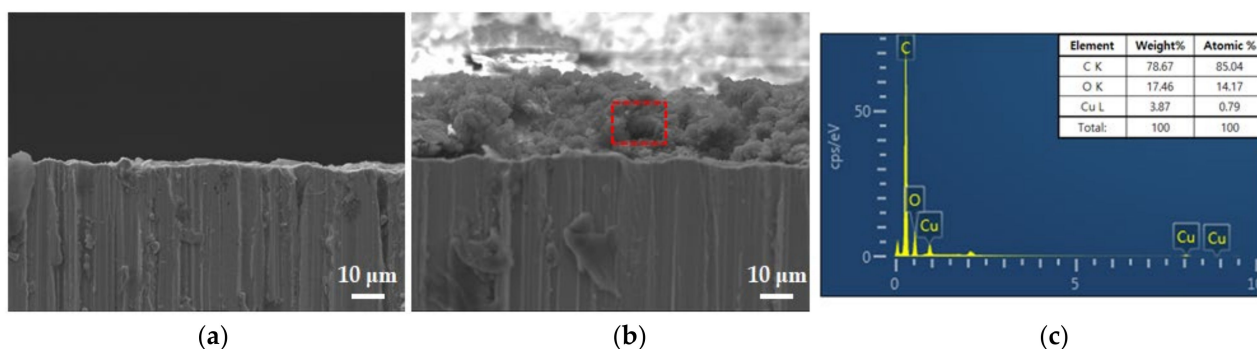
**Figure 2.** Cross-sectional SEM images of the specimens; (a) SEM images of specimen 1 (1000 $\times$ ); (b) SEM images of the carbonaceous film on specimen 2 (1000 $\times$ ); (c) EDS result of the carbonaceous film (red dotted-box).

The cross-section of the copper-coated with the carbonaceous film was analyzed using SEM/EDS. Figure 2a is the cross-sectional image of the copper part, and Figure 2b is the cross-sectional image of the carbonaceous film part on the copper. The carbonaceous film formed on the copper surface has a thickness of 20  $\mu$ m. EDS data indicate that the carbonaceous film is composed of C and O in the drawing lubricant components (Figure 2c). Figure S2 is a cross-sectional electron probe micro analyzer (EPMA) image which was observed near pitting corrosion of a copper pipe for a sprinkler used for 11 years. Figure S2a shows that the carbonaceous film is formed with a thickness of 10–20  $\mu$ m. Figure S2b shows that the carbonaceous film has the same composition as drawing lubricant components, which is C and O. This means that carbonaceous residues are present on copper pipes in real field and consistent with the carbonaceous film formed on the specimens in the experiments.

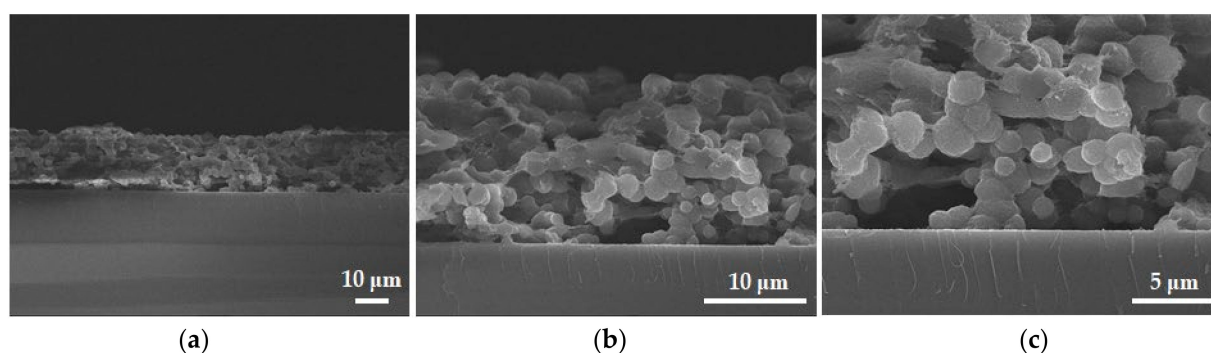
**Figure 3.** Cross-sectional SEM images of carbonaceous film on Si wafer; (a) 1000 $\times$ ; (b) 3000 $\times$ ; (c) 5000 $\times$ .

In Figure 3, the carbonaceous film is not completely adsorbed on the substrate and has a granular form and a porous structure with hollow parts. This may cause localized corrosion by crevice corrosion at the boundaries and defects of the carbonaceous film.

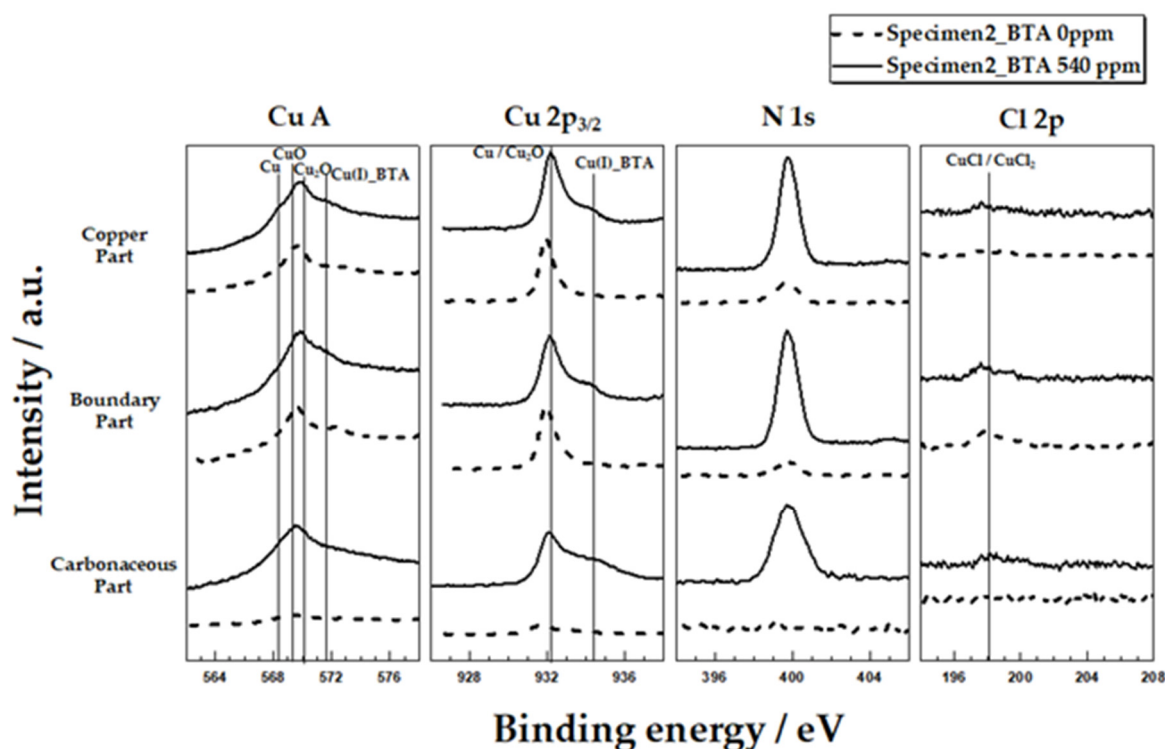
**Figure 4.** Cu LMM X-ray induced spectra and Cu 2p<sub>3/2</sub>, N 1s, and Cl 2p XPS spectra recorded at the surface of copper after 24-hour immersion in synthetic tap water at 25 °C based on the presence and absence of BTA.

Figure 4 shows the XPS analysis of specimen 2 after immersed in synthetic tap water for 24 h with and without the addition of BTA 540 ppm. Based on the existence of the BTA, each analysis was conducted on the three parts in specimen 2 to confirm the change in the copper corrosion surface layer due to the carbonaceous film. Since XPS analyses were performed with different specimens under different conditions, only qualitative analyses were performed. Regardless of the presence or absence of BTA, the first peak was observed in the range of 569.4–569.8 eV in the Cu LMM Auger spectra at all three parts. This corresponds to the results in a previous study, where the center of the Cu LMM Auger peak was 568.2 eV, the center of the Cu LMM Auger peak for CuO was 569.2 eV, and the center of the Cu LMM Auger peak for Cu<sub>2</sub>O was 570 eV [25–27]. W Liu et al. suggested that the Cu LMM Auger peak in the range of 569–570 eV was due to the formation of CuO/Cu<sub>2</sub>O [26]. Figure S3 shows the Cu LMM Auger spectra and deconvoluted results for the copper surface in the presence and absence of BTA. From the results, it can be inferred that the specimen surface is composed of Cu, CuO and Cu<sub>2</sub>O, regardless of the presence or absence of BTA. Similarly, in the Cu 2p<sub>3/2</sub> XPS spectra, the first peak was observed at 932.2 eV, whereas the Cu 2p<sub>3/2</sub> peak of Cu<sub>2</sub>O was observed at 932.5 eV, and the Cu 2p<sub>3/2</sub> peak of Cu was observed at 932.7 eV [29–31]. Cu and Cu<sub>2</sub>O appear to exist on copper surfaces regardless of the existence of the BTA. The observation of copper peaks in the carbonaceous parts may be due to the oxidation of copper through the porous structure of the carbonaceous film.

The second peak was observed at 571.8 eV in the Cu LMM Auger spectra in the three parts of specimen 2 with BTA. Similarly, a second peak was observed at 934.4 eV in the Cu 2p<sub>3/2</sub> XPS spectra. This is consistent with the observations in previous studies, where the Cu(I)-BTA peak was observed at 571.8 eV in the Cu LMM Auger spectra and 934.8 eV in the Cu 2p<sub>3/2</sub> XPS spectra [25,30]. This peak was not observed in specimen 2 without BTA. In addition, N 1s XPS peak, which is a component of BTA, was observed at 399.5 eV in three parts of specimen 2 in the presence of BTA [32]. This means that Cu–BTA complex is well formed on all parts in the specimen with carbonaceous film.

The Cl 2p XPS spectra were analyzed to confirm localized corrosion caused by the carbonaceous film. Unlike other parts, 198 eV of the Cl 2p peak was detected in the boundary parts of specimen 2 [32]. Cl 2p peak results that the generation of CuCl and CuCl<sub>2</sub> increased at the boundary of the carbonaceous film. It is known that the formation of CuCl and CuCl<sub>2</sub> increases at the Cl concentration increasing site, causing localized corrosion [4]. That is, it was estimated that the formation of CuCl and CuCl<sub>2</sub> increased with the increase in the Cl concentration in the boundary part.

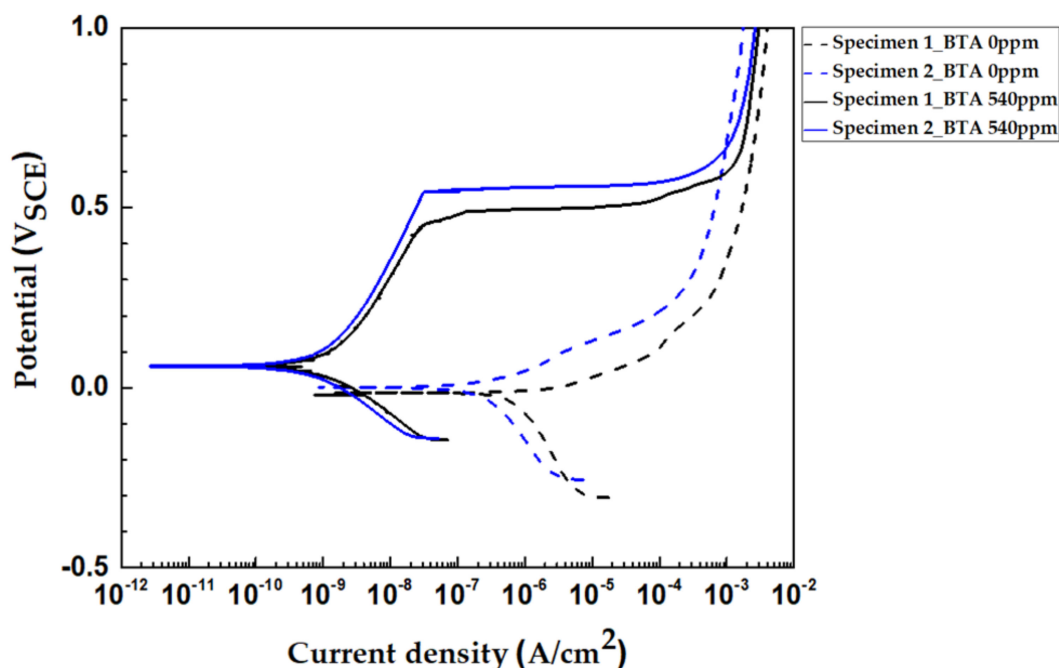
**Figure 5.** Potentiodynamic polarization curves for specimen 1 and specimen 2 in synthetic tap water at 25 °C according to the presence and absence of BTA.

Figure 5 shows the potentiodynamic polarization curves for specimen 1 and specimen 2 in synthetic tap water at 25 °C in the presence and absence of BTA. When BTA was added to the solutions, a more noble corrosion potential and the lower corrosion current density were observed. This could be due to the Cu–BTA complex formation, as BTA was adsorbed on the copper surface. Generally, the Cu–BTA complex formation acts as a mixed-type inhibitor to retard the oxidation of copper and reduction in oxygen [7,9]. The breakdown potential ( $E_b$ ) seen in the BTA-added specimens indicated that the Cu–BTA complex has an effective passive property [9]. Notably, the Cu–BTA complex acts more effectively as an anodic corrosion inhibitor [32]. In Figure 5, the apparent increase in the anodic Tafel

slope value and shift in corrosion potential ( $E_{corr}$ ) to the noble direction is due to the more effective reduction in the anodic reaction than in the cathodic reaction.

Table 4 lists the electrochemical parameters that were obtained from polarization curves on specimen 1 and specimen 2 in synthetic tap water at 25 °C with the BTA presence and absence. Regardless of the presence or absence of BTA, as shown in Figure 5 and Table 4, specimen 2 had a lower corrosion current density ( $i_{corr}$ ) and similar or higher  $E_{corr}$  compared to specimen 1. Raman and Zhang reported that  $i_{corr}$  is decreased and  $E_{corr}$  adjusted more toward a positive direction when metal is coated with a graphene or carbon layer [35,36]. They suggested that the carbon layer or graphene reduced the dissolution of metal, thereby decreasing the corrosion rate by 2–3 times, and increased corrosion resistance, thereby moving  $E_{corr}$  toward a more positive direction. In specimen 2, only half of the area was coated with the carbonaceous film, so it can be expected that  $i_{corr}$  is reduced to half value. The  $i_{corr}$  of specimen 2 was approximately half relatively to that of specimen 1 regardless of the existence of BTA in the solution.

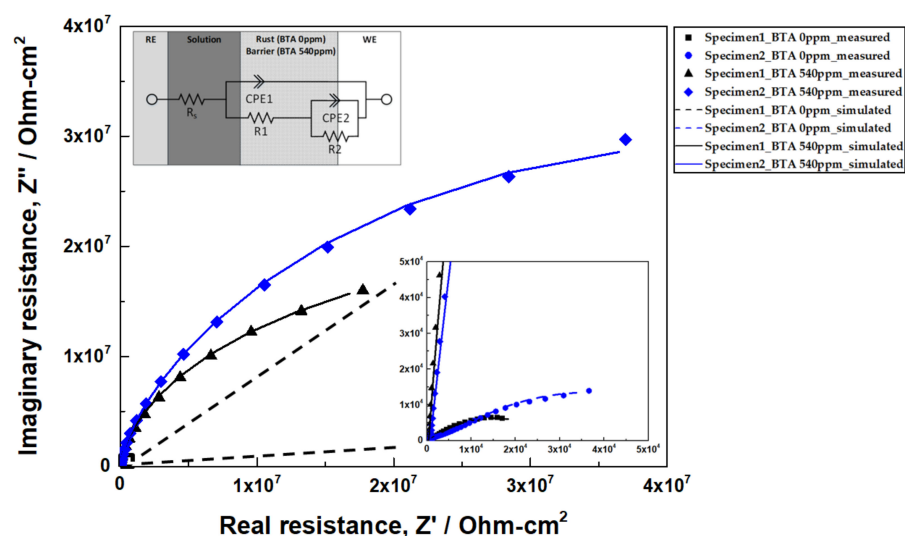
Figure 6. Nyquist plots for specimen 1 and specimen 2 and equivalent circuit for fitting in synthetic tap water at 25 °C based on the presence and absence of BTA.

Figure 6 shows the Nyquist plots that were obtained for specimen 1 and specimen 2 in synthetic tap water in the presence and absence of BTA. When BTA is added, it is shown in Figure 6 that both specimen 1 and specimen 2 increased the capacitive loop as well as corrosion inhibition efficiency. Figure 6 also shows the equivalent circuit for copper based on the presence and absence of BTA [29,32,37]. The proposed equivalent circuit fits well with EIS data. The equivalent circuit comprised the following elements.  $R_s$  is the solution resistance.  $R1$  is the resistance due to defects in the layer formed over copper or the formation of ionic conduction paths through pores. In the absence of BTA, resistance is due to copper oxide, and in the presence of BTA, resistance is due to Cu–BTA complex formation [29,32,37].  $CPE1$  is the barrier capacitance corresponding to  $R1$ ,  $R_{ct}$  is the charge transfer resistance, and  $CPE2$  is the capacitance due to the electric double layer generated at the interface between the rust/ barrier and metal substrates. The constant phase element (CPE) is a non-ideal capacitor with a varying  $n$ , expressed by Equation (2) [9,25,36,38]

where  $Y_0$  is the magnitude of the CPE, and  $n$  is a parameter by frequency dispersion. The parameter  $n$  is affected by non-homogeneity and surface roughness [9]. When  $n = 1$ ,  $Q$  represents the ideal capacitor  $C$ , and when  $n = 0$ ,  $Q$  becomes a simple resistor. Parameter  $n$  generally has a value of 0.5–1, and  $n = 0.5$  indicates a process in which copper ions are diffused through the pores of the oxide layer [9,25]. Table 5, which is calculated from EIS data, shows that the value of  $n_1$  is close to 0.5 for both specimen 1 and specimen 2 in the absence of BTA, and the value of  $n_1$  is close to 1 for both specimen 1 and specimen 2 in the presence of BTA. It can be regarded as the diffusion of copper ions through the defects of a copper oxide layer in the absence of the BTA, and formation of the Cu–BTA complex in the presence of the BTA. The Cu–BTA complex formation acts as an ideal capacitor and a barrier.

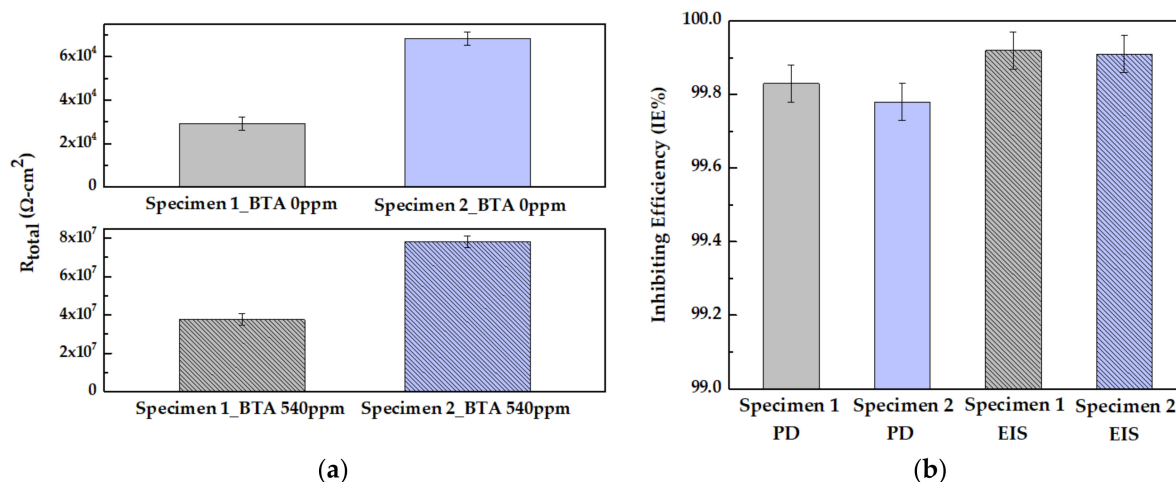
**Figure 7.** (a) The value of the total resistance of copper as a function of BTA; (b) The inhibiting efficiency ( $IE\%$ ) of copper as a function of BTA from potentiodynamic (PD) polarization curve and EIS.

In Equation (3),  $R_{total}$  has a direct correlation with corrosion resistance [35]. In Equation (4),  $R_{total}$  and  $R_{total}^0$  are total resistance in the presence and absence of BTA, respectively. Figure 7a shows the  $R_{total}$  value based on the presence or absence of BTA in specimen 1 and specimen 2. Both the  $R_{total}$  and  $R_{total}^0$  of specimen 2 increased by approximately 2 times compared to the resistances of specimen 1. Half of the specimen 2 was coated with a carbonaceous film. It can be expected that the area coated with a carbonaceous film of specimen 2 has high resistance, so that, only the area uncoated with the carbonaceous film is measured [35,36]. Therefore, the resistance of specimen 2 is doubled compared to specimen 1 because only half area of the specimen 1 is measured. Figure 7b shows the  $IE\%$  obtained from PD and EIS for copper based on the presence and absence of BTA. The  $IE\%$  values obtained from PD and EIS show a tendency to slightly decrease the efficiency in specimen 2. This is presumed to be due to the changes in the Cu–BTA complex formation by the carbonaceous film of specimen 2. According to the XPS results, the Cl concentration increased at the boundary of the carbonaceous film of specimen 2. The alteration in the corrosive environment at the boundary may change the mechanism of the Cu–BTA complex formation. However, the  $IE\%$  of specimen 2 from PD and EIS data shows very high efficiencies of 99.78 and 99.91%, respectively. Therefore, BTA corrosion inhibitor is sufficient to suppress corrosion in copper covered with the carbonaceous film.

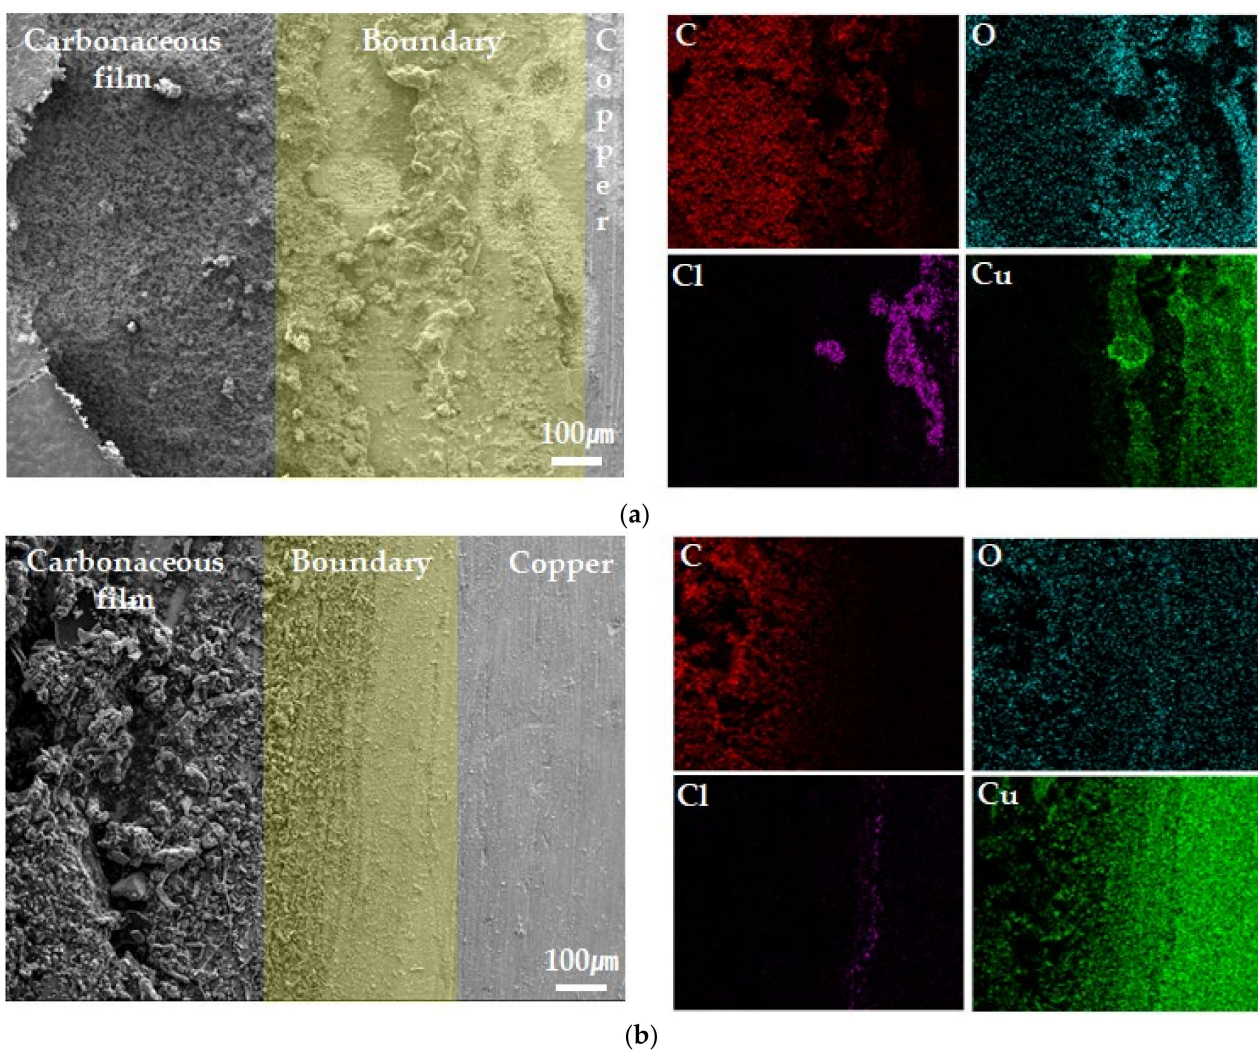
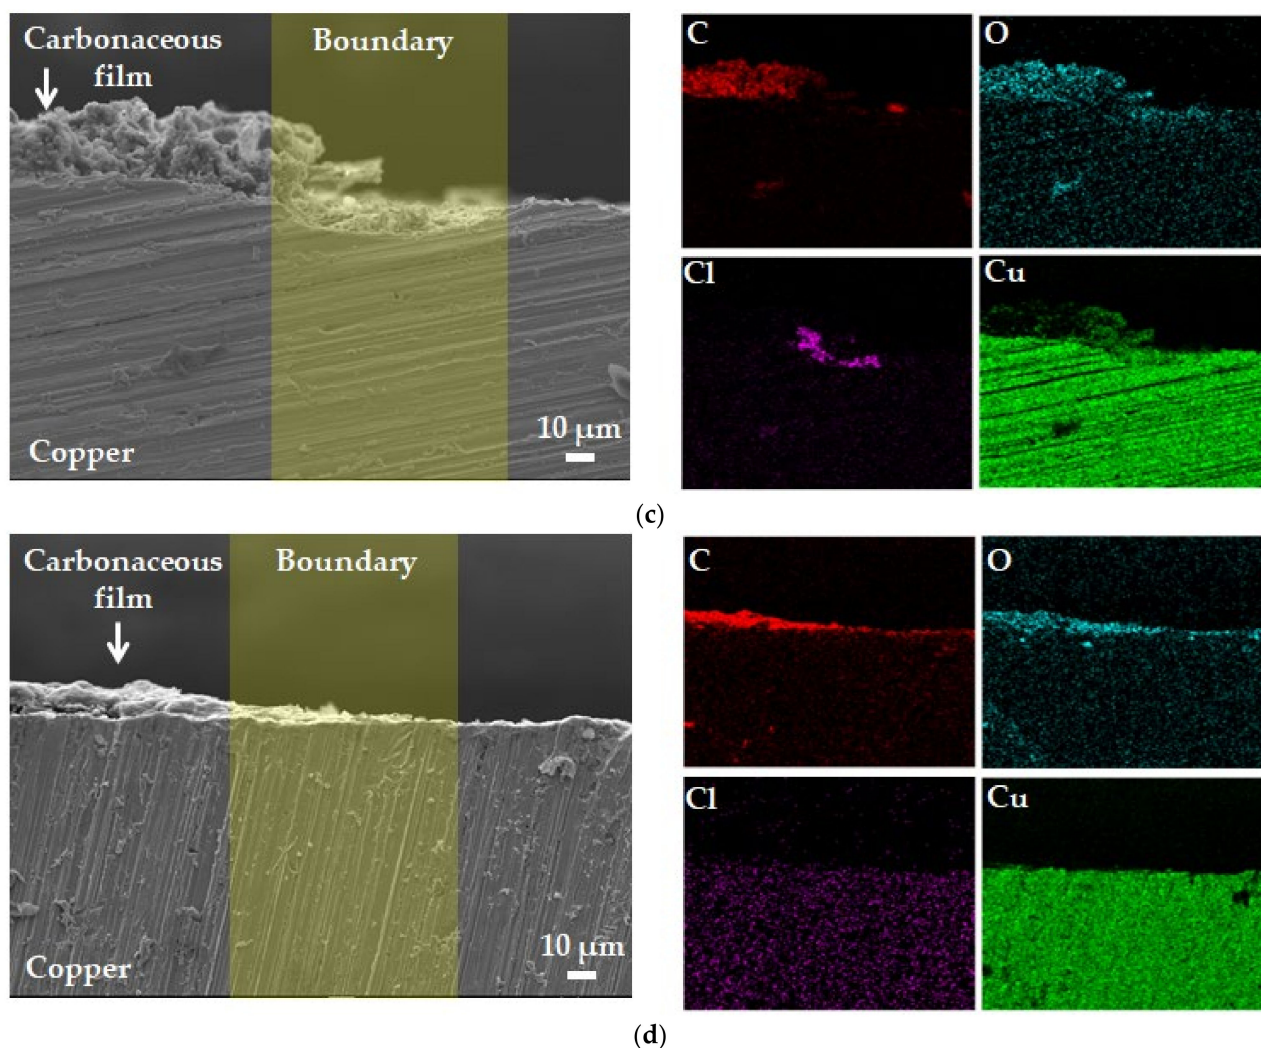
**Figure 8.** EDS mapping analysis of the copper-carbonaceous film boundary parts of specimen 2 after potentiostatic polarization test based on the presence or absence of BTA; (a) surface analysis of specimen 2 without BTA; (b) surface analysis of specimen 2 with BTA; (c) cross-section analysis of specimen 2 without BTA; (d) cross-section analysis of specimen 2 with BTA.

Figure 8 shows the results of the element mapping analysis of the specimen 2 after potentiostatic polarization test as the BTA presence and absence. Uniform corrosion occurred in the copper part or carbonaceous film part of the specimen 2 when BTA was not added, whereas the corrosion behavior was different in the boundary part of the specimen 2. Figure 8a,b shows EDS mapping analyses of the boundary part of the surface section of the specimen 2 based on the absence and presence of BTA, respectively. Under both conditions, C and O, constituents of the drawing lubricant, were detected in the carbonaceous film part. Cu and O were detected in the copper part. This is because  $\text{Cu}_2\text{O}$  was formed in the copper part [29]. However, in Figure 8b, only a little of the O element is detected in the Cu part compared to that shown in Figure 8a. This is because the formation of  $\text{Cu}_2\text{O}$  was restricted due to the formation of the Cu–BTA complex [7,32].

Depending on the presence and absence of BTA, EDS mapping analysis is utilized to exhibit the distribution of Cl at the boundary part of specimen 2. In Figure 8a, a large number of Cl elements are detected at the boundary part of specimen 2. As Cu was also detected in the Cl region, it appears to be due to the formation of CuCl and CuCl<sub>2</sub>. However, in Figure 8b, the Cl element is hardly detected at the boundary of specimen 2. In Figure 8c, which is a condition in the absence of BTA, localized corrosion occurred at the boundary of the carbonaceous film, and the Cl element was concentrated in that part. However, in Figure 8d, which is a condition in the presence of BTA, localized corrosion did not occur at the boundary of the carbonaceous film, and a Cl element was not concentrated. When BTA is added, it appears that the formation of the Cu–BTA complex limits the formation of CuCl and CuCl<sub>2</sub> and prevents the concentration of Cl. The related corrosion mechanisms are proposed below.

When BTA is added to the solution, the concentration of Cl in the boundary part disappears and corrosion acceleration does not occur, as shown in Figure 8b,d. Figure 9b is a schematic diagram of the corrosion prevention mechanism at the boundary part with BTA. When BTA is added to the solution, a Cu–BTA complex is formed at the boundary of the carbonaceous film to prevent localized corrosion. Many researchers have reported that Cu–BTA protective layer was formed by BTA even in solutions containing  $\text{CuCl}$  and  $\text{CuCl}_2^-$  [7]. Modestov et al. proposed that BTA acts in a chloride solution according
