Data Article

# Dataset on open/blind hole-hole interaction in barely visible impact damaged composite laminates

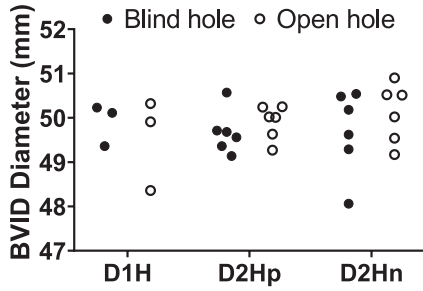
Fig. 1. Dot plot of the BVID diameter versus the blind and open hole setup.

Fig. 1 shows the dot plot of the BVID diameter created by quasi-static indentation (QSI) in CFRP specimens. The quantitative structural data namely BVID diameter and the drilling-induced hole damage size can be found in the respective spreadsheet in the supplementary excel file (Data\_Mech\_Struct). Fig. 2 shows the schematic of hole setups and crack propagation around holes, and thermographs showing the typical structural failure around the blind holes and open holes in BVID before and after compression-after-impact (CAI) test. The complete dataset of the thermographs and digital images showing the structural failures can be found in the MS PowerPoint file (Images\_of\_hole.ppt). The video clips that shows crack propagation around the holes on the surface of the laminates during in-plane compression test was recorded, and the video clip can be found in the supplementary folder (Compression\_test\_clip.zip).

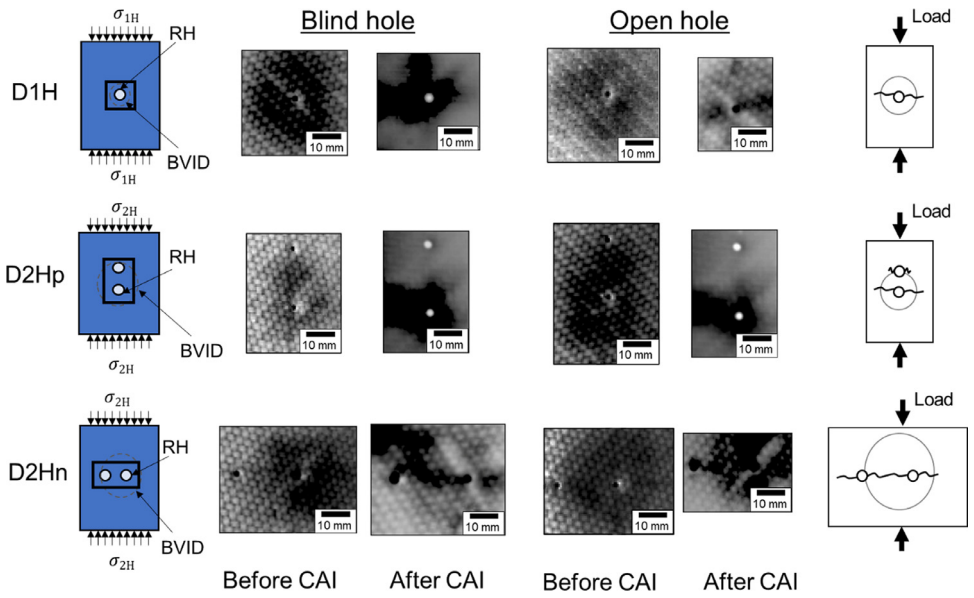
Fig. 2. Schematics showing the hole setups and loading direction (first column) and crack propagation after test (last column). Thermograph showing structural failure around holes in BVID before and after compression after impact (CAI, i.e. in-plane compression) tests by using infrared thermography.

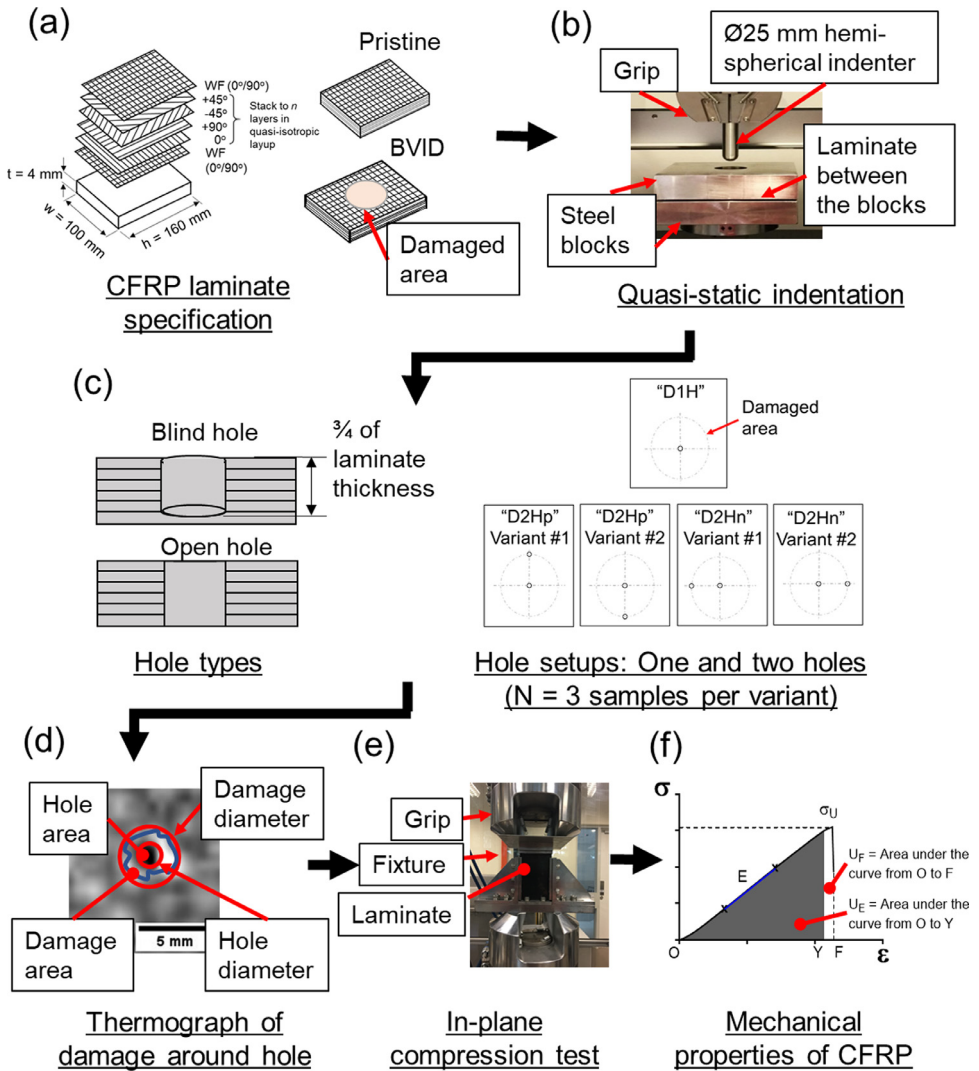
**Fig. 3.** Experimental flow diagram. (a) CFRP laminate specification. (b) Quasi-static indentation. (c) Schematics of the hole types (blind and open hole) and the hole setups (single and binary-hole setups,  $N=3$  samples per variant) in BVID specimens. (d) Thermograph of the damage around the hole. (e) In-plane compression test. (f) Deriving of laminate mechanical properties from a stress-strain curve after in-plane compression test. Symbols:  $\sigma_U$  denotes compressive strength.  $\epsilon$  denotes strain.  $U_E$  denotes modulus of resilience.  $U_F$  denotes fracture toughness.  $E$  denotes stiffness.

The data presented in Section 2 were derived from a series of experimental activities. Fig. 3 presents the diagram of the experimental workflow. The detailed information of (a) specifications of the CFRP laminate, (b) creating BVID using QSI, (c) process of drilling holes and hole setups, (d) inspection of BVID and hole damage using infrared thermography, (e) in-plane com-

Fig. 3(a) illustrates the schematics of the 24-ply CFRP laminates used to derive for the mechanical test data. More information regards to the specification of the 24-ply CFRP laminates could be found in another data article [3].

With regard to the BVID specimens, the CFRP laminates were subjected to impact damage using quasi-static indentation method (QSI), following the ASTM methods [4]. Fig. 3(b) shows the experimental setup of the QSI method. Of note, an impact energy of about 12J was exerted into the CFRP samples during QSI; the imparted energy was deemed as the range of energies associated to BVID as reported in a literature [5].

Fig. 3(c) illustrates the schematics of the different hole types (blind hole and open hole) and hole setups (1H, 2Hp, and 2Hn). The holes were created by mechanical drilling using a 2-mm diameter drill bit. The different treatments to the CFRP laminates namely hole types and hole setups were related to resin-injection method used to repair BVID CFRP laminates. Several literatures reported that the blind holes [6,7] and open holes [8] were used as a preparatory steps for their repair method; but the structural effects of the CFRP laminates when such holes were introduced into the damaged site and the arrangement of the holes for the purpose of repair were not reported. With regard to the hole setup (1H, 2Hp, and 2Hn), the process of mechanical drilling of a single circular holes into the CFRP laminates removed fibres and matrix resulted in weak interfacial properties [9]. When a load was applied, the crack propagation occurs longitudinally along the weak interface; whereas at the strong interface, the cracks propagate across the fibres until the specimens failed completely [9]. Dependant on the parameters (namely the loading axis, and the specimen geometry and specification), the cracks growth may spread parallel or normal to the loading and fibre directions [9]; therefore, the two-holes setup was arranged in parallel (2Hp) or normal (2Hn) to the axis of the applied load were employed to derive for the structural and mechanical data.

Fig. 3(e) shows the experimental setup of the in-plane compression test used to derive the dataset of the mechanical properties of the CFRP samples. The in-plane compression test follows a ASTM protocol [10]. The data recorded from the mechanical test consists of the load relative to the change in displacement ( $\Delta L$ ). Fig. 3(f) shows a typical stress-strain ( $\sigma-\epsilon$ ) curve of the CFRP specimens with hole. The load and displacement data obtained was used to derive for the
