Study of the Structural Mechanical Properties of Drainage Canals Rehabilitated by Spraying Method

Abstract: A large number of drainage pipes and canals in China have been in disrepair for a long time and there have been problems such as leakage and corrosion. In response to these problems, this paper studies a non-excavation technology for repairing the arched canal structure—the in-situ spraying method. To study the influence of the original canal structure on the mechanical characteristics of the lining structure by in-situ spraying and the restraint effect on the lining structure, a field model test with a similar ratio of 1:2 was conducted in the field test pit. By conducting four stages of three-point concentrated load loading tests, the mechanical characteristics of the lining structure were investigated to reveal the influence of the canal structure on the force of the lining structure. The test results show that: the maximum crack width of the newly added lining structure is 0.27 mm and the normal service ultimate bearing capacity of the arched structure repaired by H-70 reaches 150 kN; comparing the loading test and the numerical simulation results, the difference between

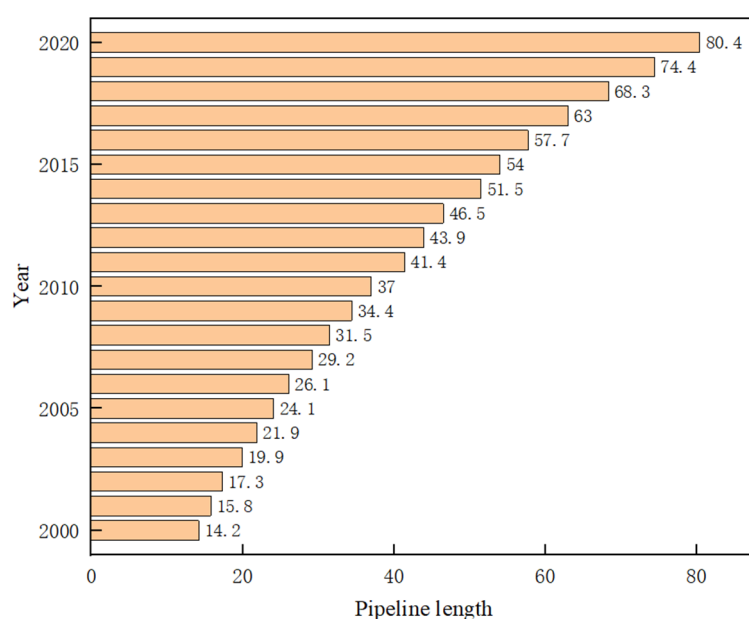
Figure 1. Urban drainage pipeline length [1].

The underground pipeline network is an important infrastructure to ensure the normal operation of a city. As shown in Figure 1, by the end of 2020, the total length of urban drainage pipes in China had reached 80.27 million kilometers [1].

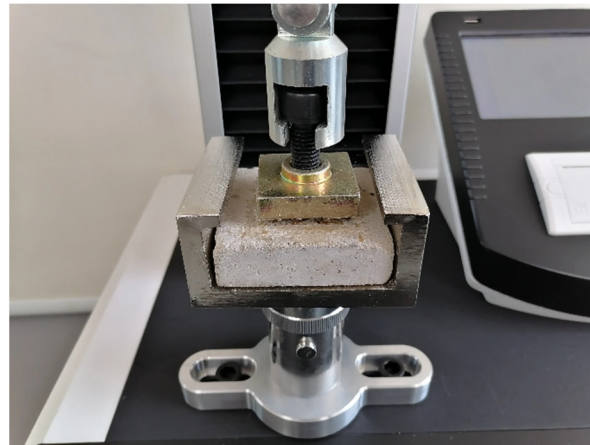
Figure 2. Tensile adhesive strength test.

According to JGJ/T 70 [25], mortar blocks of 70 mm × 70 mm × 6 mm in size were prepared with 10 specimens. The surface of each cured specimen was coated with epoxy resin and the fixture was adhered to the specimen and cured further for 24 h. After the specimen was removal, it was placed on the tensile adhesive strength test machine. Then subject is set to the loading speed of (5 ± 1) mm/min. The test is shown in Figure 2.

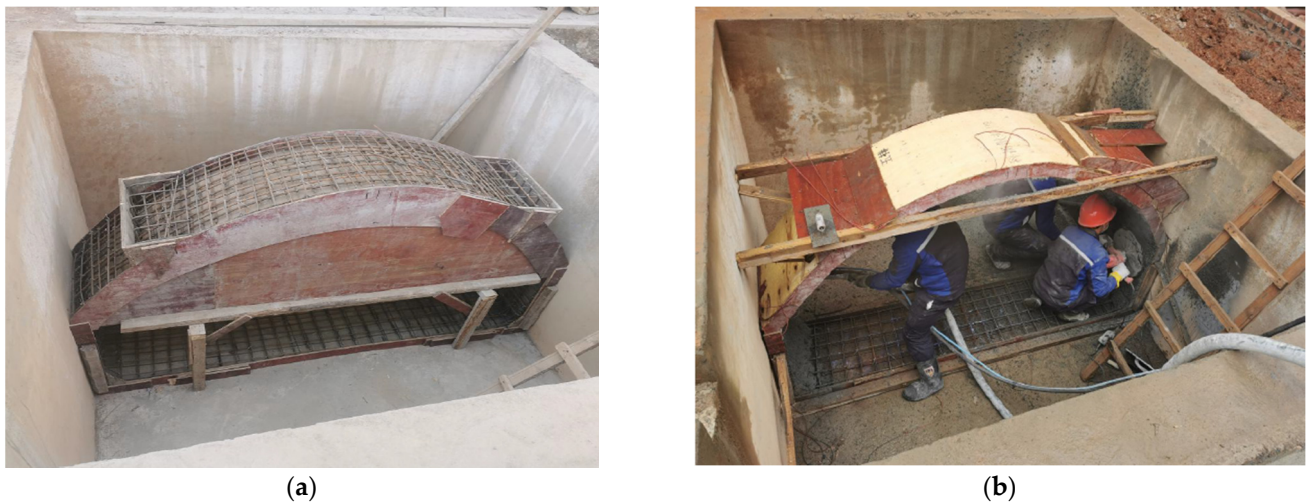
Figure 3. Test model. (a) assembling reinforcement; (b) spraying concrete.

To approximate the boundary conditions of the actual project, an existing 2500 mm × 2500 mm × 1700 mm test foundation pit on the test floor was used. As is shown in Figure 3, the whole test foundation pit site consists of backfill. The sidewall of the test foundation pit is 240 mm thick sintered ordinary brick and the soil in the local area behind the sidewall at both ends of the model specimen is backfilled twice.

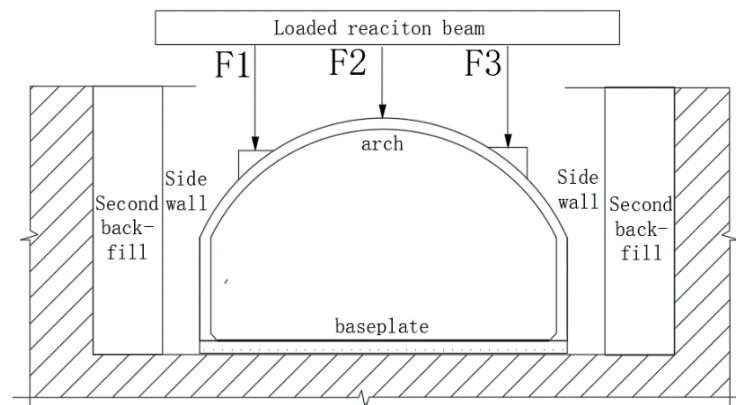
Figure 4. Stress diagram of test model. F1 is the loading point at the arch quarter span; F2 is the loading point at the midpoint of the arch; F3 is the loading point at the three-quarter arch span.

In this experiment, a three-point concentrated load was selected. The stress diagram of the test model is shown in Figure 4. Three concentrated loads were applied to three positions on the upper arch structure by using the jack. The location and size of the concentrated loads were determined according to the principle that the bending moment and axial force of the lining structure are close under the action of uniform load and concentrated load (the vertical resultant force of the two is equal and the left and right loads are symmetrical). The loading ratio of the concentrated loads was $F_1:F_2:F_3 = 2:1:2$.

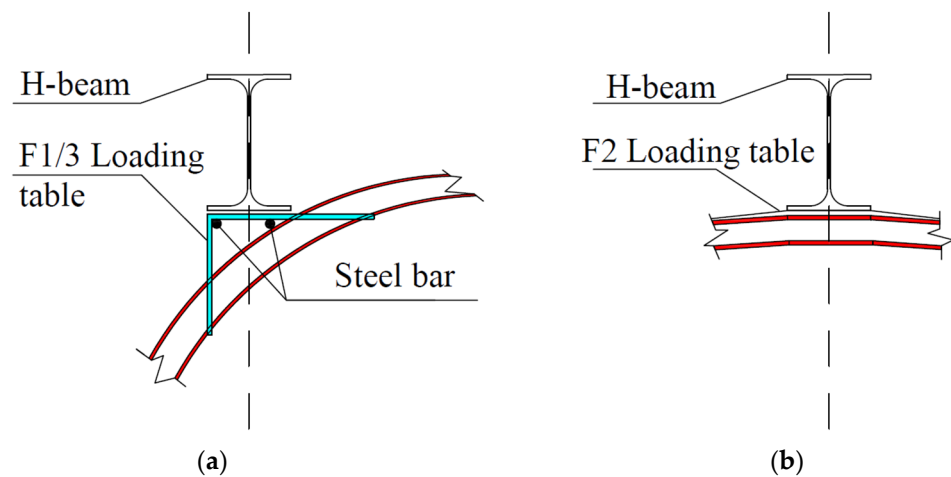
Figure 5. Stress diagram of test model. (a) F1/F3 loading table; (b) F2 loading table. F1 is the loading point at the arch quarter span; F2 is the loading point at the midpoint of the arch; F3 is the loading point at the three-quarter arch span.

Since the upper arch structure is curved, in order to facilitate loading, a loading table was constructed at the loading point, as shown in Figure 5. To avoid local concrete crushing, additional reinforcement was added to the table and a H-shaped steel distribution beam was set. To ensure full contact between the distribution beam and the loading table, a layer of fine quartz sand was evenly laid on the contact surface.

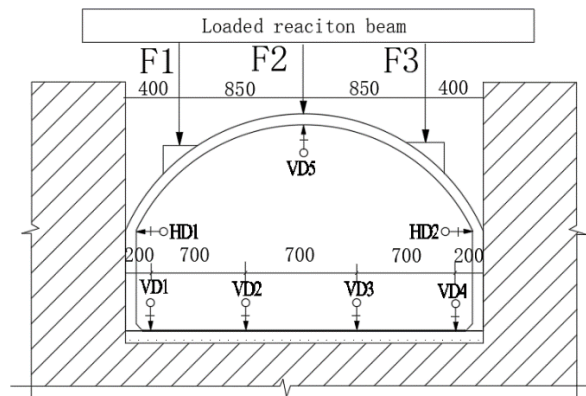
Figure 6. Displacement measuring points. F1 is the loading point at the arch quarter span; F2 is the loading point at the midpoint of the arch; F3 is the loading point at the three-quarter arch span; VD1, VD2, VD3 and VD4 are bottom vertical displacement measuring points; VD5 is the vertical displacement measuring point of the midpoint of the arch; HD1 and HD2 are horizontal displacement measurement points on both sides of the arch foot.

The displacement measuring points were arranged as follows: (1). the vertical displacement of the floor; (2). the horizontal displacement of the side wall top; (3). the vertical displacement of the vault. The specific displacement measuring points are shown in Figure 6. VD and HD represent vertical displacement and horizontal displacement, respectively.

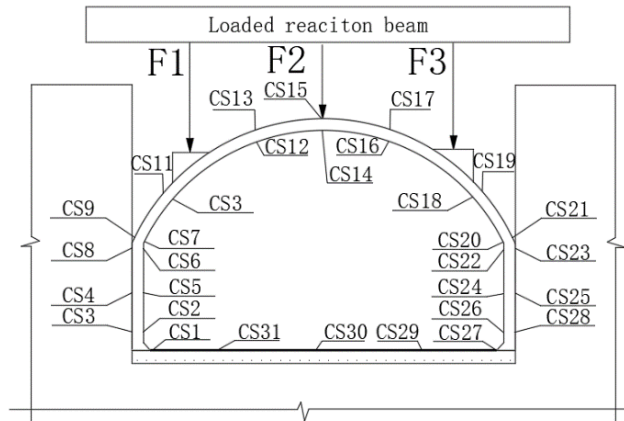
Figure 7. Strain measuring points. F1 is the loading point at the arch quarter span; F2 is the loading point at the midpoint of the arch; F3 is the loading point at the three-quarter arch span; CS1–CS28 are strain measuring points at different positions of the lining structure.

The concrete strain is arranged on the surface of the central line of the plate. The specific measuring points are shown in Figure 7. CS represents the number of measuring points for the concrete strain.

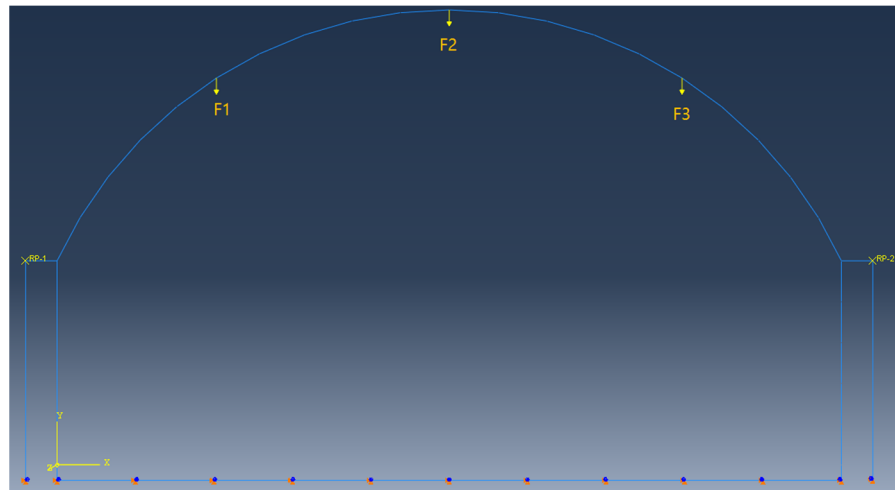
Figure 8. Strain measuring point. F1 is 40 kN; F2 is 50 kN; F3 is 100 kN; RP-1 and RP-2 are the reference points for the contact between the stiff pole and the canal structure.

As shown in Figure 8, the load was defined as a three-point loading method and the corresponding load in the D10 stage of the test was taken. In the D10 stage, F1 was 40 kN, F2 was 50 kN, and F3 was 100 kN. The boundary conditions were set to constrain the degrees of freedom in three directions of the arch and side wall corners and the bottom plate constrained the degrees of freedom in the horizontal direction.

The model adopted B21 beam elements. The upper arch was divided into 36 units, the sides were divided into 24 units, and the base plate was divided into 50 units.

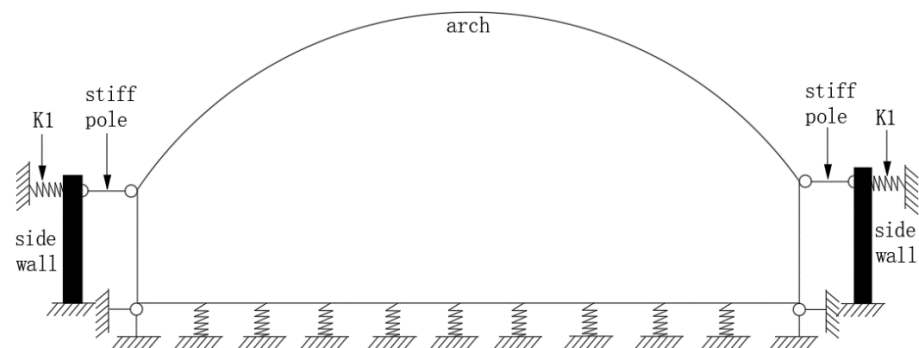
Figure 9. Simplified sketch. K_1 is the horizontal soil spring; arch is the The arch is the lined super-structure; side wall is the hypothetical canal structure.

From the displacement measured by the test, it can be seen that the vertical displacement at both ends of the bottom plate was very small, so it was simplified as a hingeless support. The side wall was simplified as a vertical cantilever component and the side wall and the lining structure were connected with rigid rods (only under pressure). The horizontal soil spring K_1 was applied to the top of the brick side wall and the vertical soil spring K_2 was applied to the middle area of the bottom plate. The calculation diagram is shown in Figure 9.

The soil spring stiffness was calculated according to the proportional coefficient value of the horizontal resistance coefficient of the foundation. The m was taken as $10,000 \text{ kN/m}^4$. The horizontal soil spring stiffness K_1 was approximately $21,250 \text{ kN/m}$ and the vertical soil spring stiffness K_2 was approximately 2125 kN/m .

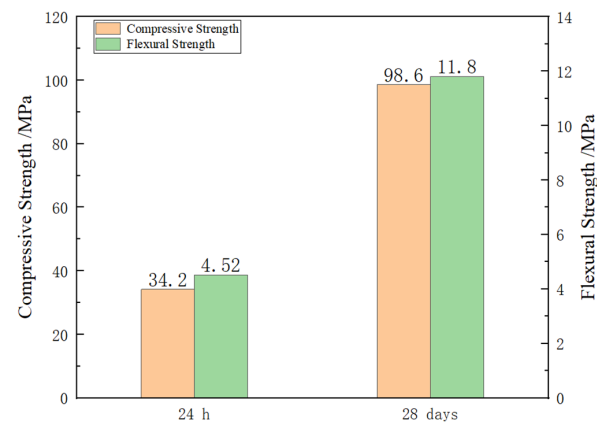
Figure 10. Compressive and Flexural Strength.

The test results of material strength are shown in Figure 10. The compressive strength of the specimen after curing for 24 h was high, indicating that it can be rapidly hardened under standard curing conditions and has high early strength. Due to the addition of reinforced fiber, the specimens reached a high strength level after 28 days. Because the drainage pipeline was in a long-time wet environment and was subjected to the cyclic effect of traffic loads, there was a high requirement for the bending resistance of the pipeline. The

material has high early strength and high flexural strength, which can quickly harden and repair under the conditions of the wet inner surface of the pipeline. It has a certain strength to ensure the normal operation of the repaired pipeline in a short time.

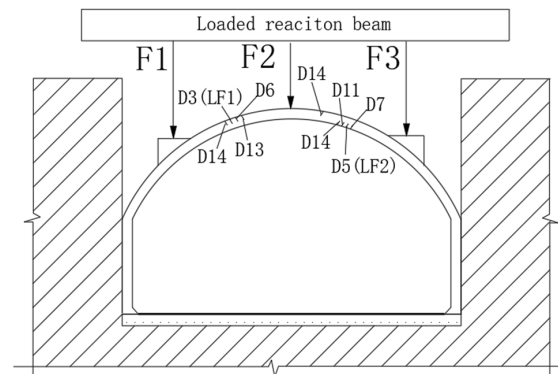
Figure 11. Crack location.

When the fourth stage D3 load was applied, the first micro-crack was found on the top surface of the arch between F1 and F2. The width of the cracks was 0.07 mm, marked as LF1. The maximum width of LF1 was 0.13 mm under the D5 load and a micro crack was found on the inner surface of the arch between F2 and F3. The crack width was 0.02 mm, marked as LF2. When the D6 level load was applied, new cracks appeared near LF1 and

LF2 and the original crack width increased. The maximum width was 0.16 mm on LF1. In the process of loading to D11, there were new cracks between F2 and F3. When loading to D14, a micro crack was found on both sides of the arch surface. After unloading, the crack closed well and the relative position of the crack is shown in Figure 11.

From the perspective of the entire crack development, the cracks between F1 and F2 were on the outer surface of the arch and the cracks between F2 and F3 were on the inner surface of the arch in the early stages. Only when the maximum load was D14, did a micro crack appear on the outer surface of the arch, indicating that the bending moment direction of the crack area on both sides was opposite.

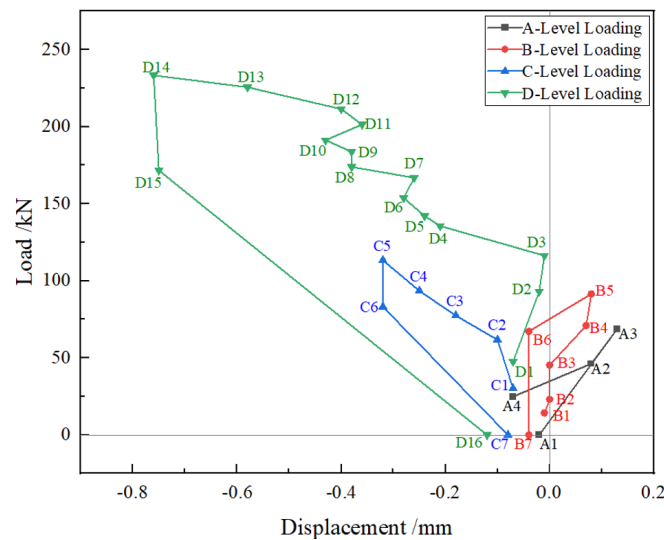
Figure 12. Load-displacement curve of vault.

The load-displacement curve of the vault is shown in Figure 12. The measured vault displacement was mostly positive in the first two stages and negative in the second two stages. Due to the asymmetric load on the left and right sides, the surrounding soil constraints are complex. In the first two stages, the vault moved to the left side significantly and was greater than the vertical deflection. It can be seen from the curve in the figure that during the loading process of the fourth stage, in stages D3, D7, and D11, there was obviously a slow platform, which is consistent with the time of the cracks observed before. The stiffness of the component decreases after the cracks appear. The maximum displacement of vault vertex is 0.76 mm, which is 1/3092 of the net span (2350 mm).

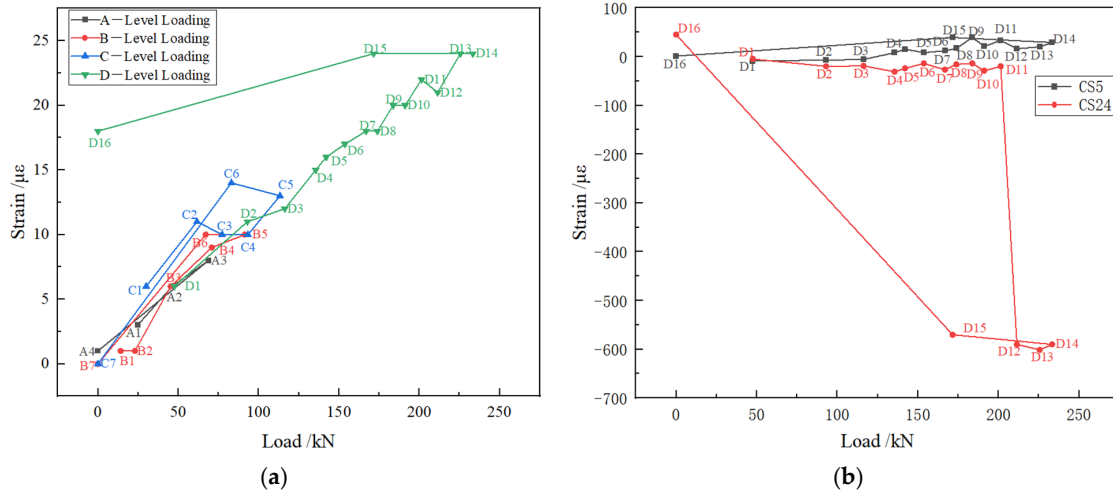
Figure 13. Strain of floor and side wall. (a) strain of floor; (b) strain of side wall.

From Figure 13, it can be seen that in the four stages of loading process, the trend of the bottom plate strain with the load was basically the same. The overall strain of the bottom plate was small and in the tensile state and the maximum tensile strain was $24 \mu\epsilon$. Figure 13b shows the variation of the left and right wall strains with the load in the fourth stage. Loading to the fourth stage, the measuring point CS5 on the left wall had always been tensile strain, while the measuring point CS24 on the right wall produced compressive strain and the strains on both sides were similar. When the load reached the D11 stage, the strain at the right wall measuring point increased sharply, reaching the maximum of $610 \mu\epsilon$.

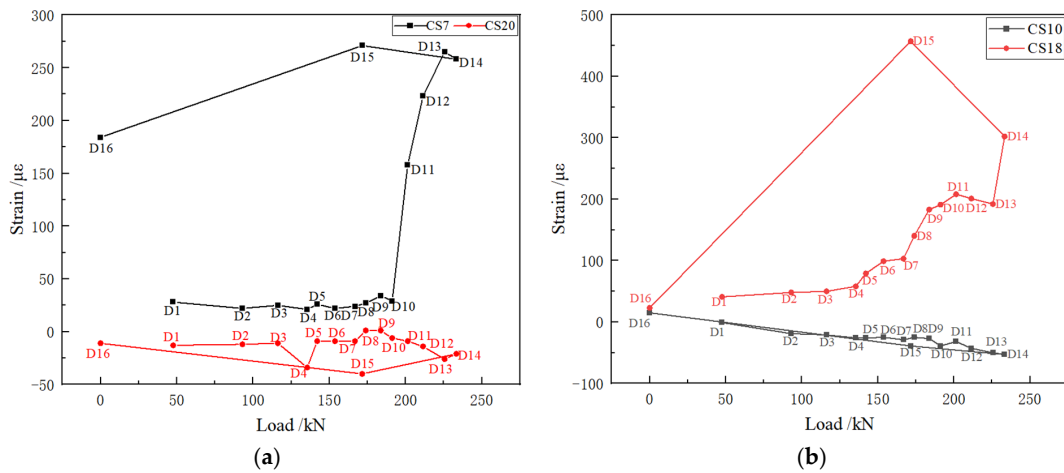
Figure 14. Arch strain curve. (a) CS7 and CS20 strains; (b) CS10 and CS18 strains; (c) CS15 strain.

Figure 14a–c shows the strain changes of the arch toe, arch waist, and vault of the lining structure. It can be seen from Figure 14a that in the early stage of loading in the fourth stage, the strains of the left and right arch feet were similar. The compressive strain appeared on the left side and the tensile strain appeared on the right side. When loaded to the D10 stage, the strain of the right arch toe suddenly increased. After this stage, cracks appeared in the concrete near the arch toe. With the increase in load, the cracks expanded further and the cracks closed after unloading, resulting in this strain trend. As shown in Figure 14b, the strain trend of the arch waist was basically the same as that in Figure 14a.

However, after the D4 stage, the strain of the right arch waist increased rapidly due to multiple cracks between F2 and F3. After unloading, the strain decreased greatly, indicating that the cracks near the right arch waist were closed well. Comparing the strain trends of Figure 14a,b, two arch toes and two arch waists, it can be found that the strain of the arch waist is larger than that of the arch toe, indicating that the constraint effect of the sidewall on the arch toe is more obvious.

It can be seen from Figure 14c that the strain trend of the vault was consistent in the four stages of loading. With the increase in load, the compressive strain of the vault increased. When the load reached stage D5, the concrete near the vault cracked and the strain increased sharply. Since no cracks continued to appear near the vault, only the crack propagation stage existed and the strain increase trend decreased.

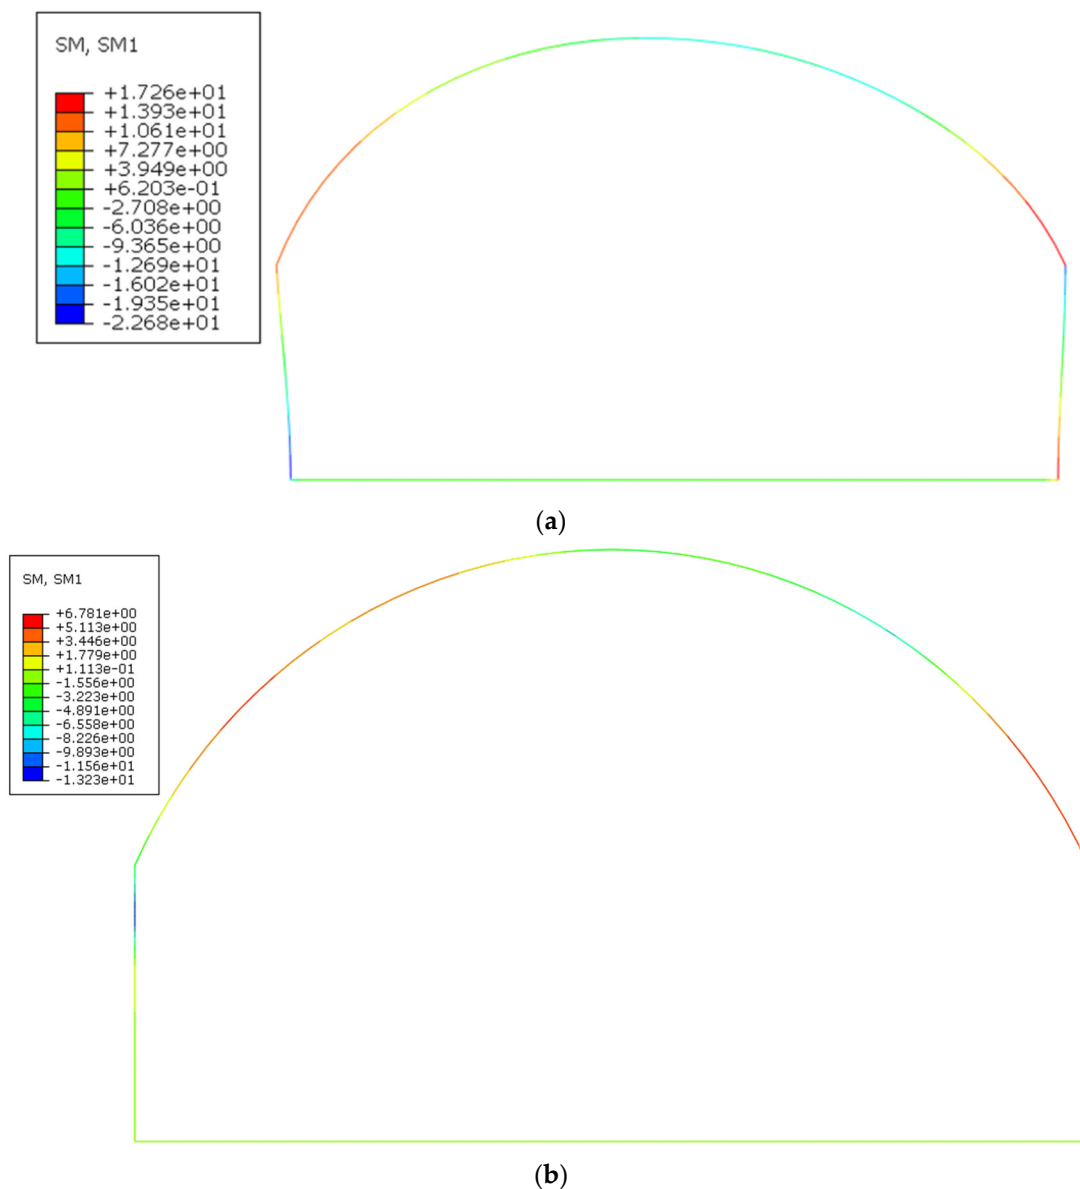
Figure 16. Simulation results of bending moments. (a) No side wall; (b) Side wall.

Figure 16 shows the bending moment diagram of the lining structure with and without side walls. It can be seen from the figure that the bending moment at the position of F3 was the largest and the bending moment at the outer side between F1 and F2 and the inner side between F2 and F3 was larger. During the test, cracks appeared in these areas. Comparing Figure 16a,b, the bending moment of the vault was reduced from 12.69 kN·m to 4.303 kN·m. The bending moment of the arch foot was reduced from 17.26 kN·m to 4.252 kN·m, which indicated that the side wall had a more obvious constraint effect on the arch foot.
