# Evaluation of the Fatigue Behaviour and Failure Mechanisms of 52100 Steel Coated with WIP-C1 (Ni/CrC) by Cold Spray

The present work aims to assess the effect of coating 52100 steel with a 0.5 mm thick Ni/CrC mixture by using cold spray technology on the fatigue life of the combined material system. To this end alternating—symmetrical axial stresses are applied on coated, cylindrical specimens. This subjects the sample to compression and tensile cycles. The tensile side of the cycle is useful to study the endurance of the coating. The cylindrical shape ensures that the stresses introduced into the sample are uniform throughout the cross-section of the sample. Thus, any defects that will lead to the onset of fatigue can be highlighted. The mechanical behaviour of the coated material system, the coating, the interface area, the crack initiation area and the regions of stable or unstable crack propagation are investigated. The paper also compared the fatigue resistance of 52100 steel given in reference [21] and the behaviour of the coating assembly presented in this paper, respectively, coating 52100 steel with a Ni/CrC mixture by using the cold spray technology.

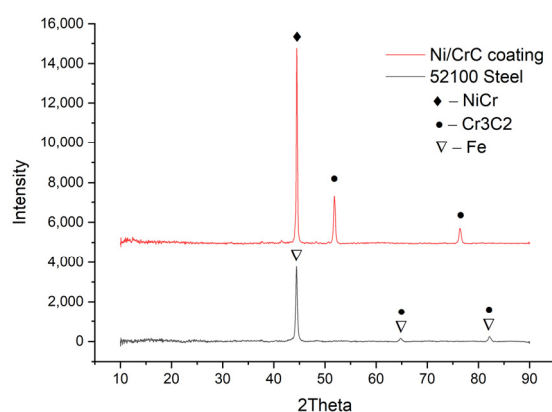
Figure 1 presents the diffractograms for the base and coating material. Knowing the chemical composition of the powder [20], the predominant phase of NiCr (cubic structure -ICDD 96-901-2971) was obtained at a 2 Theta angle of approximately  $44^\circ$  and the secondary phase of  $\text{Cr}_3\text{C}_2$  (cubic structure-ICDD 96-901-1599) at a 2 Theta angle of approximately  $53^\circ$  and  $77^\circ$ . In the case of the basic material, the predominant phase is Fe (cubic structure -ICDD 96-901-6602), around the 2 Theta angle of  $45^\circ$ , and the secondary phases contain Fe and  $\text{Cr}_3\text{C}_2$  at the 2 Theta angles of  $65^\circ$  and  $83^\circ$ .

**Figure 1.** XRD pattern of coated sample and the base material.

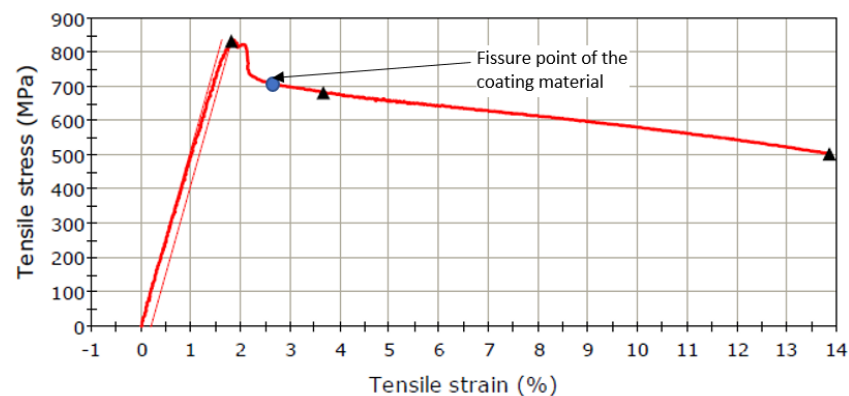
**Figure 3.** Characteristic stress-strain curve, specific to a coated sample.

Both from the examination of the fractured sample (Figure 4b) and from the stress-strain curve given in Figure 3 the following observations can be made: (i) the shape of the stress-strain curve is dominated by the behavior of the base material, 52100-steel; (ii) the elastic region is relatively wide; high values of the load are reached on a linear path and the yield point is close to the maximum stress; (iii) a material hardening region is not observed; after reaching the offset yield point,  $R_{p0.2}$  or  $\sigma_{p0.2}$ , the material undergoes a pronounced elongation, but without further increase of stress; (iv) on the stress-strain curve, the cracking point of the coating material was marked, which was determined by the study of the videos captured during the test, as explained above; this point corresponds to a strain of 2.64%; (v) cracking of the coating material does not occur in the elastic region of the stress-strain curve; (vi) the strain at which the cracking of the coating material takes place can be obtained locally, where a microcrack is initiated in the base material and where, under the conditions of existence of a stress concentrator (crack for example), the local deformations become large; (vii) given that the total strain is 14%, the base material undergoes significant plastic deformation, hence the contraction is observed in Figure 4b; (viii) the coating material suffers significant damage; (ix) it is found that the  $\sigma_{p0.2}$  is 831 MPa, a value from which it starts to decrease in fatigue loading.

The ASTM E466-15 standard is used for fatigue testing. The shape and dimensions of the samples are shown in Figure 2a. The fatigue tests were conducted after a symmetrical, alternating cycle. For the fatigue testing, the initial load must be in the elastic region (Figure 3). The fatigue test is carried out on nine samples, starting with a load value corresponding with the stress close to the yield limit and continuing by decreasing the load. The first maximum stress was 76.5% of the yield limit value  $\sigma_{\max} = 0.765$ ,  $\sigma_{p0.2} = 636$  MPa. Table 2 shows the maximum stress values used in the tests.

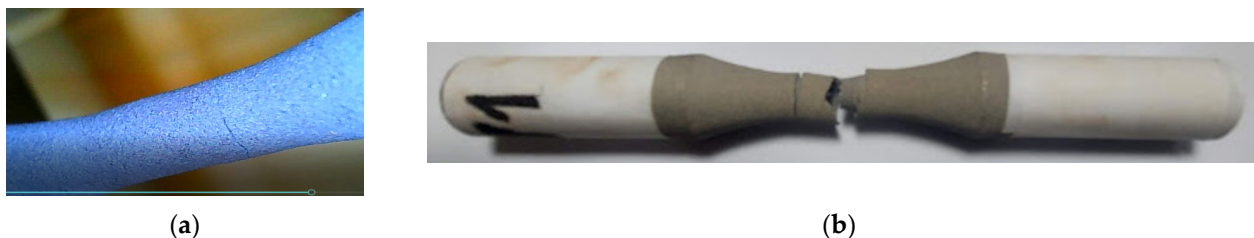
The static loading was performed on a universal testing machine, Instron 8801 (Instron, Norwood, MA, USA) (Figure 2c). An extensometer was mounted in order to measure strain accurately (Figure 2c). Since the total deformation of the sample was not very large, it was possible to acquire data with the extensometer until the sample broke. A video of the calibration area was made for capturing the moment of the appearance of the crack in the

coating material (Figure 4a). The point on the stress-strain curve indicating the moment of the appearance of the crack was found by overlapping the time signatures of the video and that of the extensometer data. A broken coated sample can be seen in Figure 4b.

**Figure 4.** Sample subjected to static tensile load. (a) Image from the video that captures the moment of cracking of the coating material at the static tensile load; (b) broken sample after static tensile.

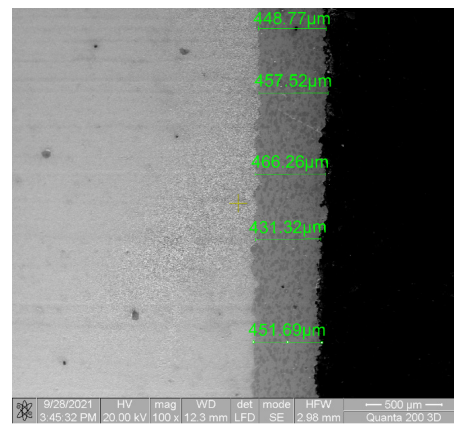
The fracture surfaces were investigated at macro- and micro-scales by using optical and scanning electron microscopy. Observations of fracture of the coating material in different areas of the surfaces are presented. It is expected that the base and the coating materials will experience different strain levels where  $\epsilon_{\text{base}} > \epsilon_{\text{coating}}$ . Significant damage to the coating material could be expected to occur, given that the two materials deform differently, and large deformations occur at higher values of the stress cycles. In order to be able to observe this, images were taken from the fatigue test, from the central and calibration areas of the samples. From the SEM images (Figure 5) the grip of the coating material on the base material was a good one and there were no significant differences in the fatigue behaviour of the coating and base material.

**Figure 5.** SEM image with cross-section at the interface between the base and the coated materials.

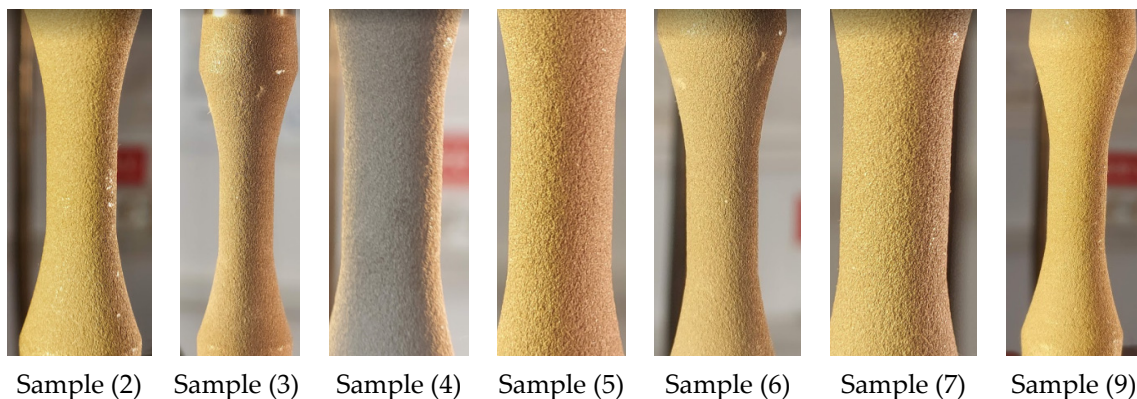
As can be seen in Figure 6, no damage to the coating material was observed even at more than five million cycles, nearly up until fracture. The macroscopic image analysis shows a very good behaviour of the coating material during the test where the material experienced both tensile and compressive strains.

**Figure 6.** Outer surface during fatigue tests—different samples, near fracture point.

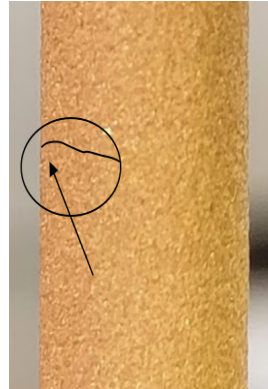
The moment of propagation of the fatigue crack is captured in Figure 7. It is known that, depending on the material, a relatively large number of fatigue cycles may be required to initiate a crack. After initiating the crack, depending also on the value of the tensile stress, the number of cycles for fatigue crack propagation may vary. In Figure 7, the visible crack (below the hand drawn line) is the one propagated by fatigue; a relatively small number of cycles were required until the final, sudden breakage of the sample soon after this crack appeared. From this figure, it can be observed a macroscopic propagation of the crack and the sample is close to the final breakage. No detachment of the coating material, near the front of the propagated crack, is seen. As a result, the propagation of the crack in

the coating material follows the same path as in the base material, without any collateral damage to the coating material. From a macroscopic point of view, the coating behaves well during cyclic tests with alternating, symmetrical, axial loading.

**Figure 7.** The appearance of fatigue cracks during fatigue loading.

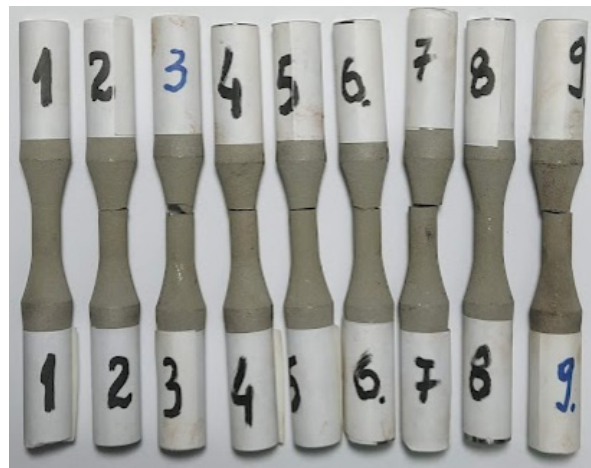
For the fatigue analysis, 9 samples of 52100 steel were used as the base material, (Figure 8), coated using the method presented above. Samples 1 and 8 did not break even after 5 million cycles, as a result, the test was stopped, and the samples remained unbroken. The other samples fractured at different values of loads and number of cycles. In what follows observations about each sample are presented in detail.

**Figure 8.** Samples after loading by alternate-symmetric fatigue tests.

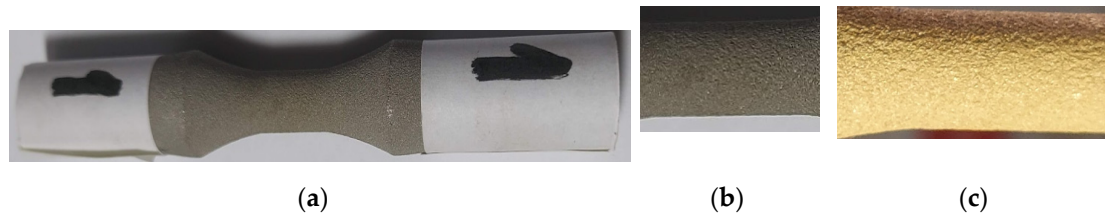
Samples 1 and 8 did not break even after more than five million cycles of stress reversals. Examining the outer surface of the sample, no damage to the coating material was found (Figure 9). For Sample 1, the coefficient resulting from the ratio of the test loads to the yield limit is:  $K_{\sigma F} = \sigma_{test} / \sigma_y = 438 / 831 = 0.53$ . As a result, we can state that when the loading is at 53% of the yield limit, and if the sample doesn't fracture, the coating material withstands high values of the number of cycles, not causing significant damage to the surface. This statement must be taken with caution, since it is not known what happens at the interface between the two materials, in the area where the first plastic deformations

**Figure 9.** Macroscopic appearance of the outer surface after fatigue stress—Sample 1  $\sigma_{max} = 420$  MPa,  $N = 5,519,600$  cycles. (a) the unbroken sample after more than 5 million cycles ( $8\times$ ). Macroscopic image of the surface for (b)  $32\times$  and (c)  $45\times$  magnification. Sample 8 had a similar appearance.

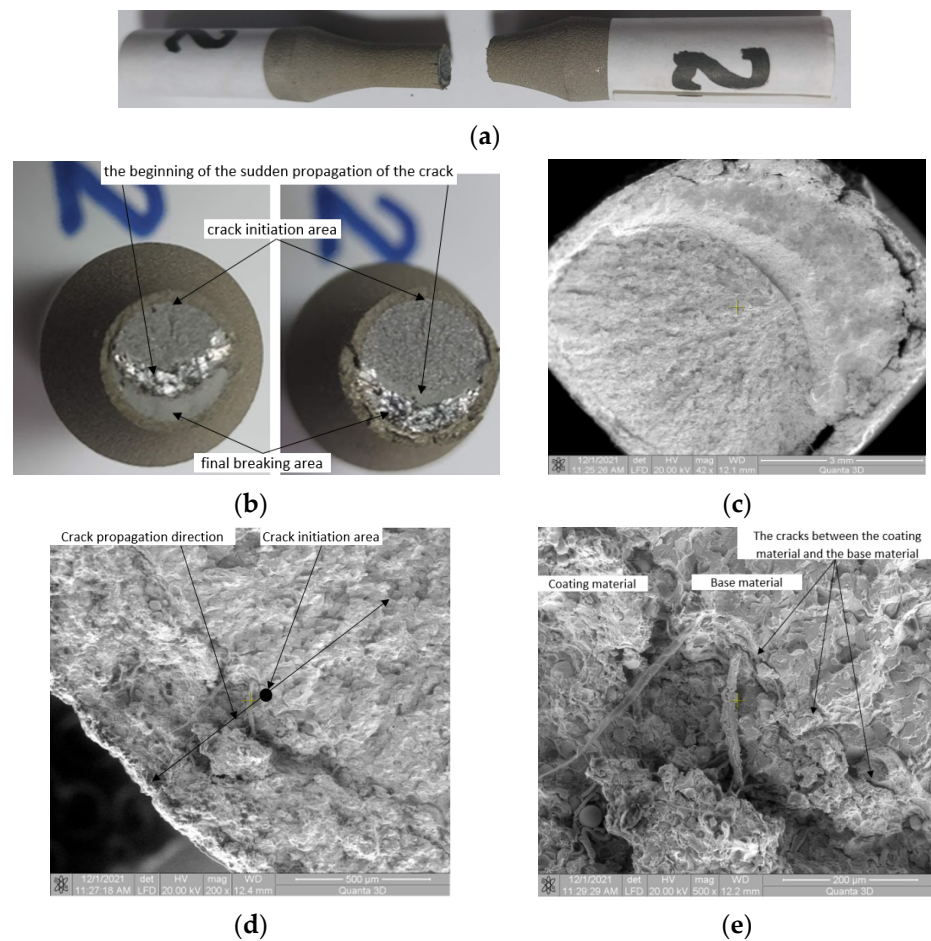
**Macroscopic observations:** Longitudinal cracks were observed in the coating material when the sample was subjected to high stresses, close to the flow limit (Figure 10a). In the area of the crack initiation, the surface of the coating material is flat, without obvious macroscopic cracks in the plane of fracture. Throughout the crack, the surface of the coating material remains flat, there being no detachment from the material (Figure 10b). At the boundary between the areas of the slowly propagating crack and suddenly propagating crack due to fatigue, significant damage to the coating material is seen (Figure 10c). Longitudinal cracks that are not seen in the other samples were found here. The longitudinal cracks appear only in the area of the suddenly propagating crack region. In the area of stable propagation of the crack front, no such cracks are found.

**Microscopic observations:** In the area of crack initiation, there is no significant damage to the coating (Figure 10d), like a macroscopic detachment from the material, cracks inside the coating material, and cracks in the particles that are in the coating material. In the zone of the crack initiation (Figure 10e), deterioration can be found in the area of the coating material with microscopic detachment from the material. In this area, no damage to the coating material is found on the outside of the sample and it can be concluded that the crack was initiated, first in the base material, after which it extended in both directions, both in the coating material, outwards and in the base material, inwards. In Figure 10e detachment of the coating material from the base material is observed. This occurred as a result of the differences between the Young modulus of the two materials, thus of the differences in specific deformation, emphasized earlier in the paper. As a result, in the area of crack initiation, the local strain of steel reached the value of 2.64%.

**Figure 10.** Macroscopic and microscopic appearance of broken surfaces for Sample 2,  $\sigma_{max} = 636$  MPa,  $N = 5300$  cycles. (a) Sample 2 broken by fatigue. (b) Fracture surfaces. (c) SEM image of the surface at  $42\times$  magnification. SEM image of crack initiation region with (d)  $200\times$  and (e)  $500\times$  magnification.

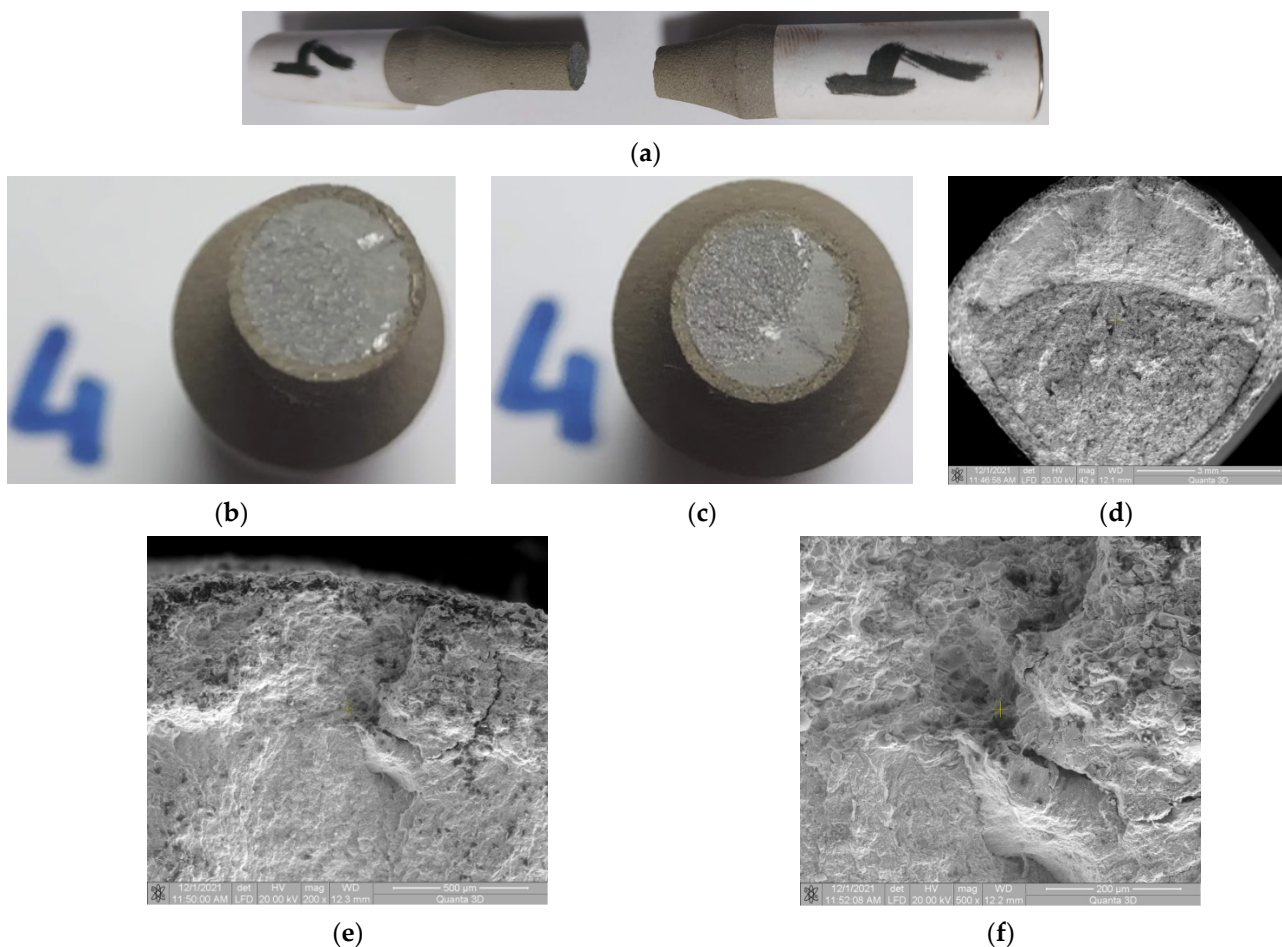
**Macroscopic observations:** For Samples 4 and 7 the conclusions are similar. The loads used for Samples 4 and 7 are increasingly low. This results in an increasingly large number of fatigue cycles before a fracture occurs. The fracture occurs by stable propagation of the crack through fatigue and no deflection of the crack is observed (Figure 12a–c). However, in these samples, the load is higher than in the following samples and the area of stable crack propagation is smaller (see the corresponding figures in the following samples). No damage is observed due to the removal/detachment of particles or by the appearance of large cracks, in the final fracture surface (Figure 12c).

**Microscopic observations:** In the area of crack initiation by fatigue, no significant damage to the coating material is found (Figure 12c). At higher magnifications, in the area of crack initiation, a detachment is revealed by showing a radial crack through the coating material (Figure 12d,e).

**Figure 12.** Macroscopic and microscopic appearance of broken surfaces for Sample 4,  $\sigma_{max} = 477$  MPa,  $N = 878,965$  cycles. (a) Sample 4 broken by fatigue. (b,c) Fracture surfaces. (d) SEM image of the fracture surface at  $42\times$  magnification. SEM image of the area where a crack initiated with (e,f)  $200\times$ , and  $500\times$  magnification.

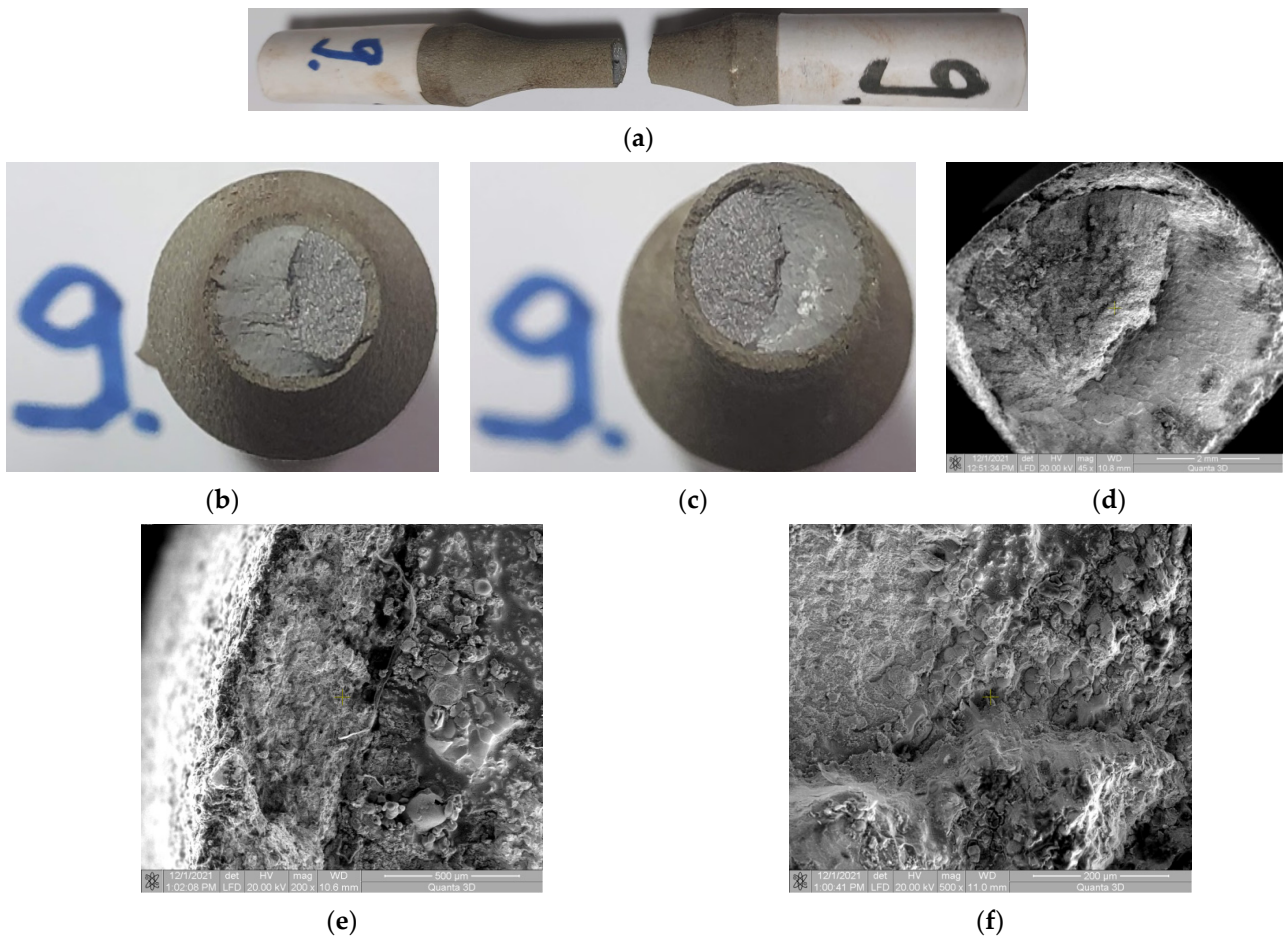
**Macroscopic observations:** For Samples 5 and 9 the conclusions are similar. These samples were tested at low loads, and more than 50% of the fracture surface is obtained by stable propagation of the crack. The coating uniformly broke throughout its circumference as shown in Figure 13a,b. A detachment of the coating material from the base material is found at the beginning of the sudden propagation of the crack front (Figure 13c).

**Microscopic observations:** In the area of crack initiation by fatigue, no significant damage to the coating material is observed (Figure 13d,e). A very fine crack between the base material and the coating material meaning a detachment between the two materials appears in the area of initiation of the fatigue crack. In this sample, inter- and intra-granular microcracks (Figure 13e), are observed more pronounced than in the previous samples, especially near the interface area between the two materials.

**Figure 13.** Macroscopic and microscopic appearance of broken surfaces for Sample 9,  $\sigma_{max} = 446$  MPa,  $N = 4,424,120$  cycles. (a) Sample 9 broken by fatigue. (b,c) Image of fractured surfaces. (d) SEM image of the fracture surface at  $42\times$  magnification. (e,f) SEM images of the area where a crack initiated with  $200\times$ , and  $500\times$  magnification.

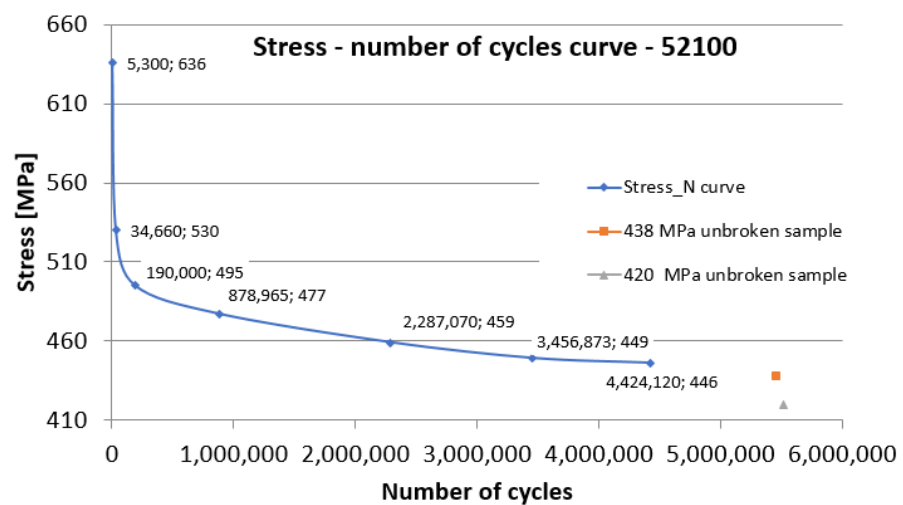
The data presented in Table 2 is plotted in a Wöhler diagram in Figure 14. Sample 8 (438 MPa) and Sample 1 (420 MPa) did not break after 5 million cycles. The appearance of the diagram is a conventional one, with a fatigue limit of around 446 MPa, given the imposed limit of 5 million cycles.

**Figure 14.** Wöhler curve for fatigue test of the 52100-steel coated with WIP-C1 powder.

The coated parts will have to work in the area of the high durability of Wöhler’s curve meaning at relatively low stress levels. If parts are subjected to high stresses, significant damage to the coating material may occur, caused by differences in deformation, in the
