Right ventricularly paced right bundle–type pattern on ECG: Does this preclude upgrading to biventricular pacing?

KEYWORDS Biventricular pacing; Cardiomyopathy; Pseudo-right bundle pattern; RBBB; Ventricular resynchronization (Heart Rhythm Case Reports 2018;4:298–300)

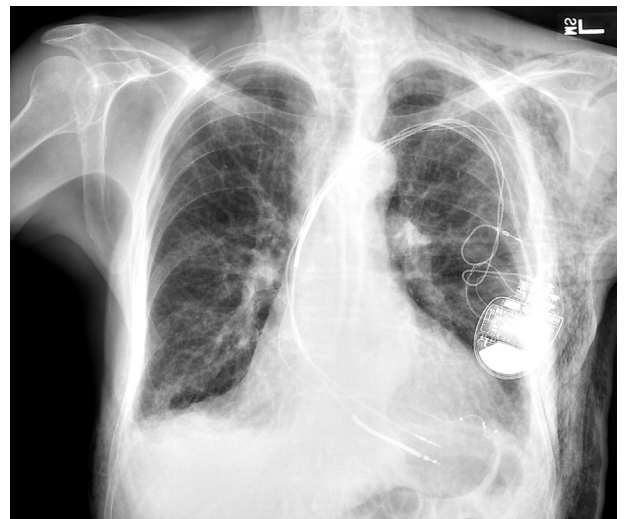
Figure 2 A posteroanterior chest radiograph from case 2 is shown with 4 pacemaker leads. One lead is in the right atrium, 1 is in the coronary sinus, and 2 are in the right ventricle (RV). One RV lead is capped. The second RV lead is the thicker electrode and is active in the defibrillation and sensing systems. It is in an appropriate apical and septal position.

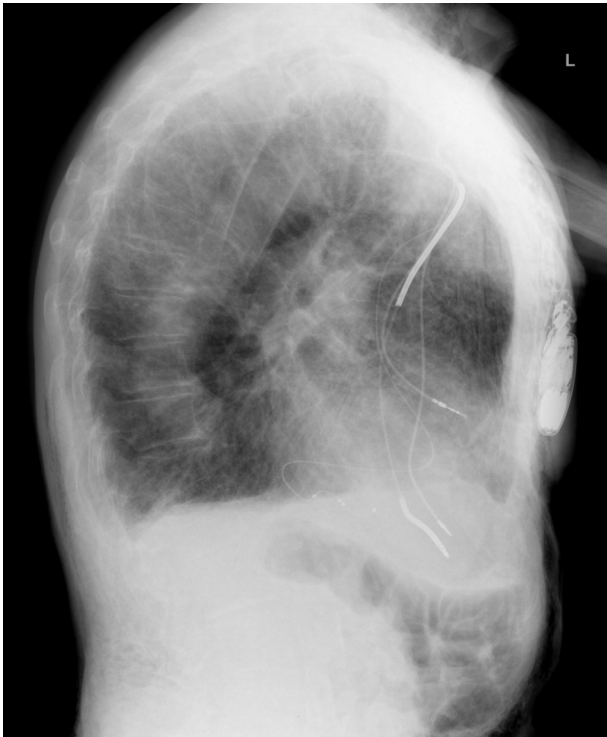
Figure 3 A lateral chest radiograph from case 2 shows the defibrillator lead in the septal position. The coronary sinus lead can be seen posteriorly.
