# Analysis of the Behavior of Fiberglass Composite Panels in Contact with Water Subjected to Repeated Impacts

**Abstract:** One of the most common applications of glass fiber composite materials (GFRP) is the manufacturing of the hulls of high-speed boats. During navigation, the hull of these boats is subjected to repetitive impacts against the free surface of the water (slamming effect), which can cause severe damage to the material. To better understand the behavior of the composite material under this effect, in the present work, an experimental test has been carried out to reproduce the slamming phenomenon in GFRP panels by means of a novel device that allows this cyclic impact to be obtained while the panels are always in contact with water. By means of non-destructive ultrasound inspection in immersion, it has been possible to establish the evolution of the damage according to the number of impacts received by each panel. Destructive tests in the affected zone, specifically shear tests (Iosipescu test), allow determination of the loss of mechanical properties experienced by the material after receiving a high number of impacts in the presence of water (up to 900,000 impact c

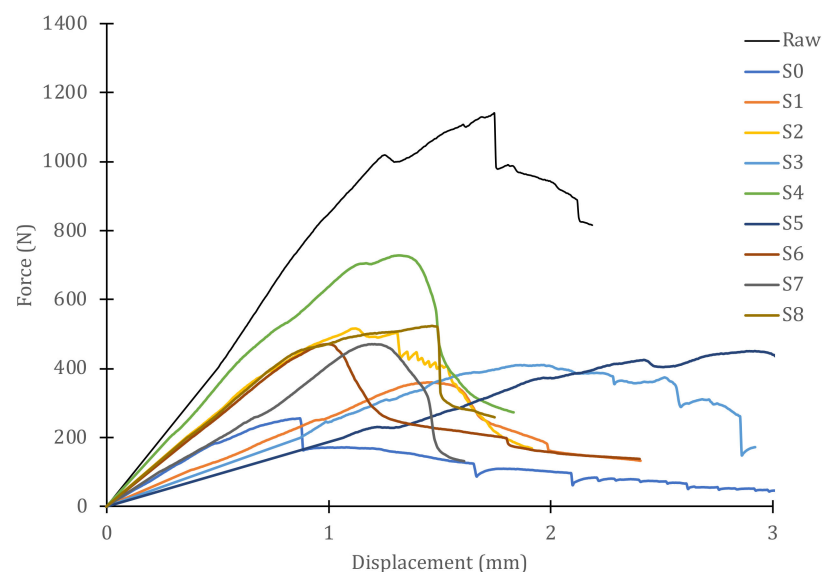
**Figure 7.** Iosipescu shear test curves for samples (dry/wet) from a GFRP panel with 900,000 cyclic impacts.

Figure 7 shows the load–displacement curves for all samples obtained from one of the panels, including the curve corresponding to the intact (raw) material. To better appreciate the behavior of the GFRP panels in dry/wet conditions, Figure 8 shows the samples extracted from the dry area of the panel. On the other hand, Figure 9 includes the plots corresponding to the samples obtained from the area of the panel that was immersed during the slamming impact cycles. For both cases, the curve of the material in its original state, not subjected to slamming impacts, and the curve obtained from the central zone, where the direct impact of the cam is received (S0), are included for reference.

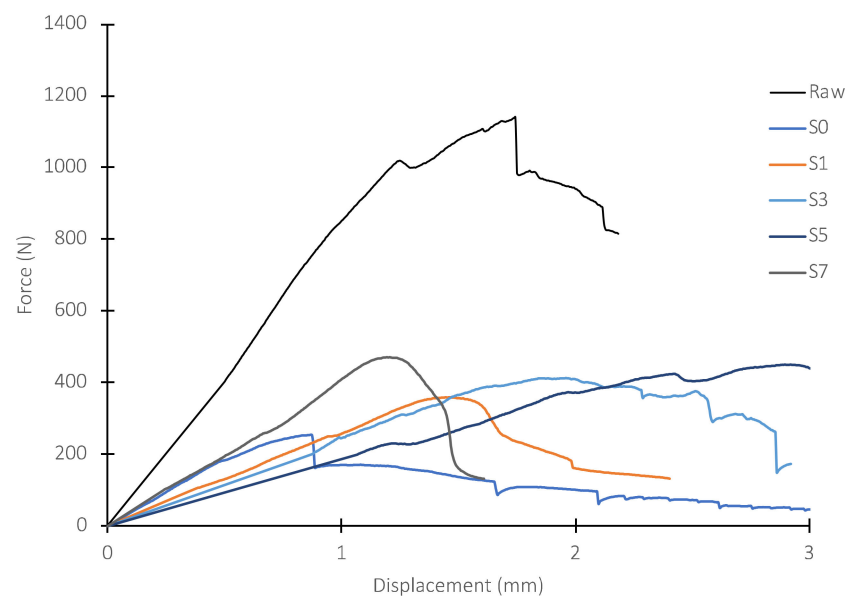
**Figure 9.** Iosipescu shear test curves for wet samples after 900,000 cyclic impacts.

In the case of specimens of dry material, the curves are half-way between those for intact material (highest peak load) and those of the direct impact zone (lowest peak load). The maximum load of each sample and the displacements at which the maximum load occurs vary for every sample. The slopes of the initial straight segments, i.e., the stiffness with which the material behaves in the linear regime, are also different for every sample. As the selected specimens move away from the impact zone, they exhibit higher peak loads, larger displacements at maximum load, with a larger linear zone, and higher stiffness. The individual values are listed in Table 1. However, for specimens obtained from immersed material, the curves are below the curve for the direct impact zone (S0), with stiffnesses equal to or less than those of S0, although the peak loads are higher than those of S0 and, particularly, the displacements at maximum load greatly exceed those of S0. The numerical values of these specimens are also shown in Table 1.

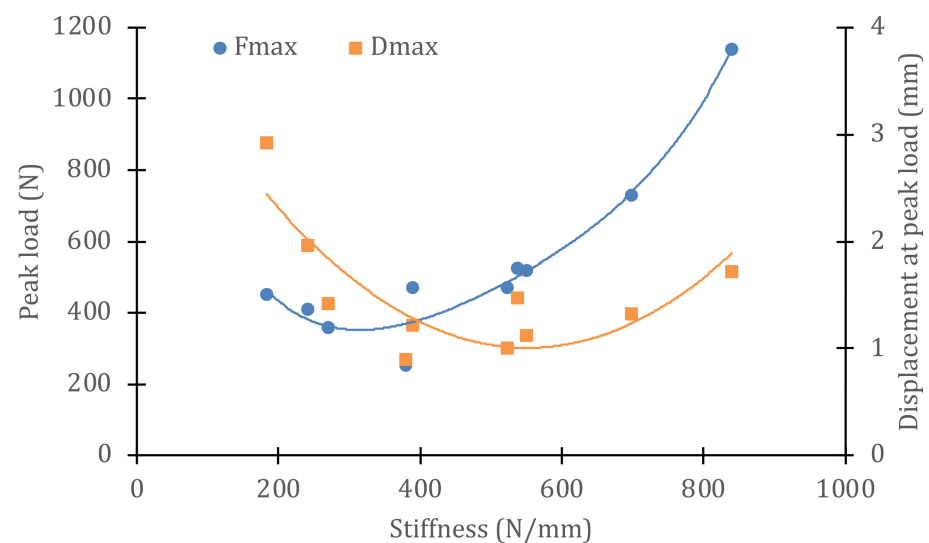
**Figure 10.** Variation in strength and displacement at maximum load as a function of specimen stiffness, after 900,000 impact cycles, under dry/wet conditions.

The behavior of the material in wet or dry conditions is very different, in view of the results of the Iosipescu shear tests shown in Figures 8–10. To better appreciate this behavior, Figure 10 shows a graph with the variations in the maximum loads and the displacements at peak load for each sample. It can be observed that the absolute minimum of both properties corresponds to sample S0—that is, in the immersed zone where the direct impacts of the cam were received. The stiffness value for this sample is 380 N/mm, as can be seen in Table 1. However, the rest of the immersed specimens (S1–S7) have stiffness values similar to or lower than those of S0. Moreover, as the stiffness of the material decreases, the maximum supported load increases and so does the displacement at peak load, always with respect to the reference value of specimen S0. For stiffnesses greater than S0, i.e., specimens taken from dry material but having received the same number of cyclic impacts, the peak load values increase with stiffness (greater distances to the center point of impact) and so do the displacement at peak load values. Obviously, the absolute maximum of these properties corresponds to the behavior of the intact, non-impacted material. The ratio between the maximum (raw) and minimum (S0) values of the stiffness is 45%. However, the residual strength after 900,000 impact cycles (ratio of maximum loads between both extreme values) is only 22% and that of the peak load displacements is 52%. These results show that the slamming process experienced by the material reduces its strength, but not its deformation capacity before failure. Thus, the stiffness is reduced, but not to the same extent as the strength. This information is valuable to be able to estimate the degradation of the vessel material throughout its service life and to decide on the basis of objective criteria when hull repairs should be carried out.

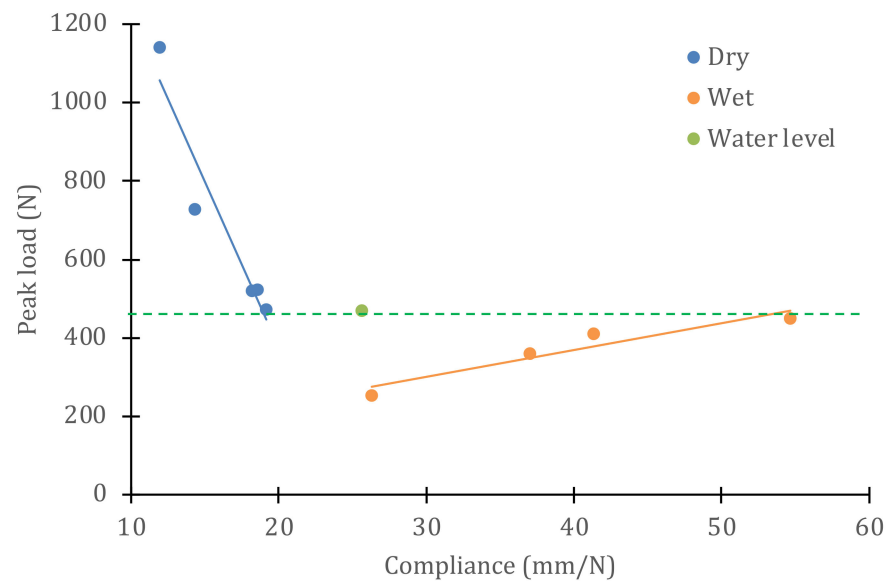
**Figure 12.** Linear correlation between strength and compliance after cyclic impact, for dry/wet conditions of the samples.

The same information can be represented as the variation in resistance as a function of compliance (inverse of stiffness), which helps to understand the effect of water on the evolution of properties as damage is generated in the material. Figure 12 presents, in the same graph, the results for both the dry/wet conditions of the material, where the horizontal line separates the samples that were submerged from those that were above the water level. For dry material, the maximum load decreases linearly with increasing compliance (slope of  $-84.3 \text{ N}^2/\text{mm}$ ), while, for wet material, the maximum load increases linearly with increasing compliance (slope of  $6.6 \text{ N}^2/\text{mm}$ ).
