Investigation of Failure Mechanisms in Ceramic Composites as Potential Railway Brake Disc Materials

Jeongguk Kim

Advanced Railroad Vehicle Division, Korea Railroad Research Institute, Uiwang 16105, Korea; jkim@krii.re.kr; Tel.: +82-31-460-5518

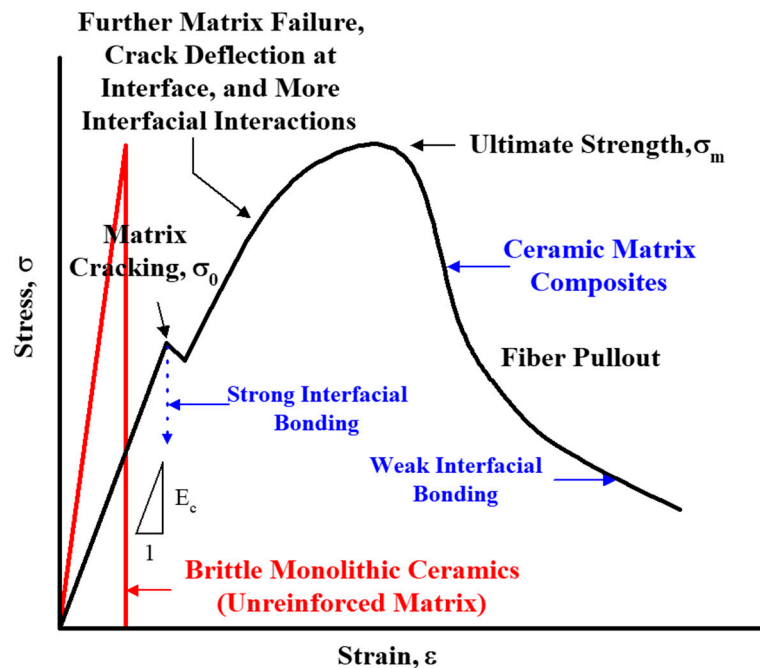
Figure 1 schematically illustrates a comparison of the fracture behavior between monolithic ceramics and ceramic composites. As shown in Figure 1, monolithic ceramics show a typical brittle fracture behavior that leads to failure immediately after undergoing elastic deformation without a plastic deformation region. On the other hand, in the case of the ceramic composite material reinforced with continuous fibers, it initially shows the elastic behavior of monolithic ceramics, and then shows the first matrix cracking as the load applied to the specimen increases. However, as the stress increases, the continuous increase in load continues due to complex interactions such as further matrix failure due to fibers present inside the matrix and crack deflection at the interface between the fibers and the matrix (Figure 1) [3,4,10–12]. After the ultimate tensile stress (UTS) is reached, the composite shows a stress-strain behavior like the shape of plastic deformation exhibited by a metallic material due to the sequential pullout of the fibers until the final failure. Due to this fracture mechanism, it is possible to improve the fracture toughness of monolithic ceramics. In other words, the fracture toughness increases by the larger area in the stress-strain curve. In addition, Figure 1 shows that interfacial bonding between fiber and matrix material is also an important factor. If there is a strong interfacial bonding between the fiber and the matrix, the fiber reinforcement effect will not be seen, and if there is proper interfacial bonding between the fiber and matrix, a ceramic composite material with reinforced toughness as shown in Figure 1 can be expected.

Figure 1. A schematic comparison of fracture behavior between monolithic ceramics and ceramic composites [3].

Figure 7 shows the tensile test results of the Nicalon/SiC ceramic composite material. In common for both specimens, the proportional limit value was obtained around 100 MPa, showing the elastic region up to this point (Figure 1). After that, as the load on the specimen increases, the load curve becomes increasingly nonlinear. Both composite material specimens were finally fractured near the ultimate tensile stress (UTS), and the maximum tensile stresses were about 225 and 300 MPa for plain-weave and cross-ply composites, respectively. The tensile load of the cross-ply composite specimen was found to be higher, which is due to the microstructural influence, and it is believed that the plain-weave composite material is structurally more vulnerable to loads than the cross-ply structure [1,4]. As shown in Figure 1, it can be seen that the failure pattern due to plastic deformation of the metallic material according to fiber pullout after UTS was not shown. This is because, even if the two specimens are finally destroyed by fiber pullout, the energy absorption mechanism varies depending on the stiffness of the fiber or the coating conditions of the fiber. In addition, it is possible to infer that the fiber bundles were destroyed at the same time at the final fracture.

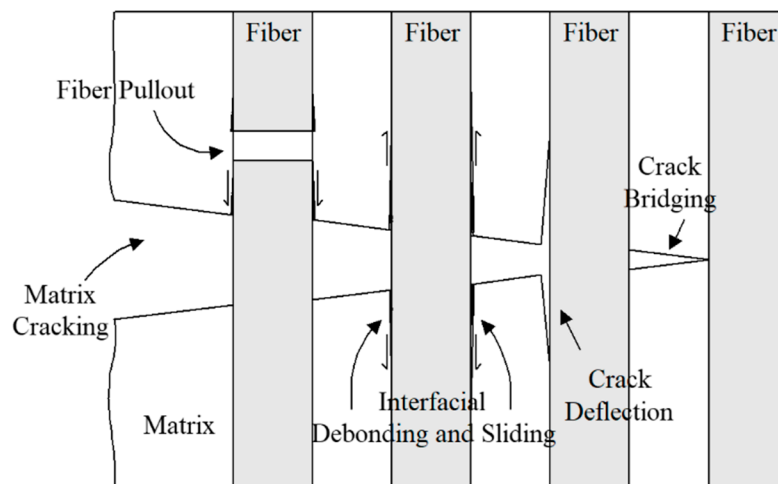
Figure 2 schematically shows the typical failure patterns found in ceramic composites [3,4,10]. As the load increases after the initial matrix cracking, phenomena such as interfacial debonding and sliding, crack deflection, and crack bridging between the fiber and the matrix material go through. After that, the fiber is finally broken, and the final failure mechanism is completed through extensive fiber pullout. The fracture toughness of the ceramic composite material is improved by delaying the final fracture through those energy absorption mechanisms [10]. Marshal et al. investigated the failure mechanisms in ceramic matrix composites [10].

Figure 2. A schematic representation of typical failure patterns of ceramic composites.

Figure 3 shows an example of the schematic representation shown in Figure 2. It is obtained from the fracture surface of the actual ceramic composite material, and it shows in detail the process of absorbing fracture energy such as matrix cracking and propagation of crack, interfacial sliding and debonding between fiber and matrix, fiber bridging, and fiber pullout [10,13,14].

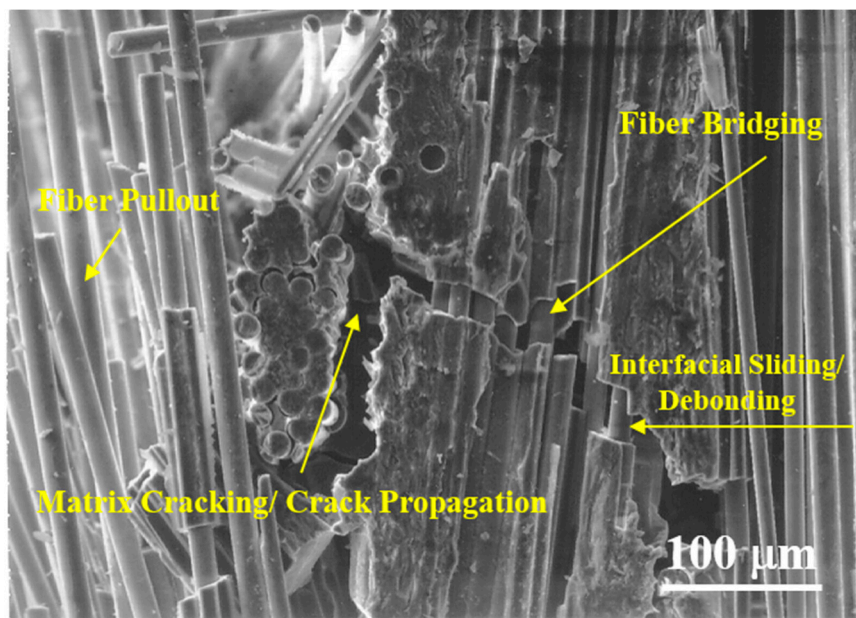
Figure 3. Typical examples of failure mechanisms in ceramic matrix composites as failure energy absorption mechanism.

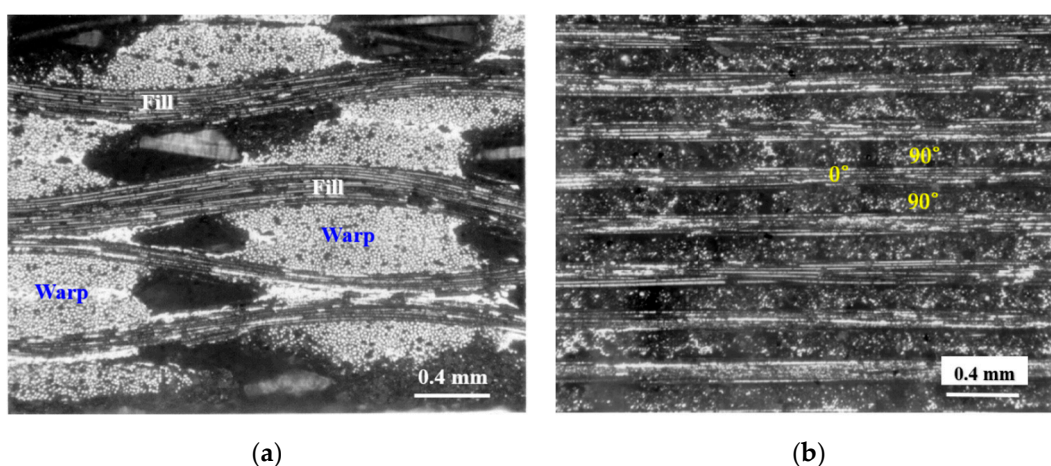
Figure 4 provides a cross-sectional views of the two composite materials. Figure 5 shows the size and geometry of the specimen, and the thickness of the specimen is about 3 mm. Monotonic tensile test was carried out at room temperature using MTS testing equipment (MTS 810, MTS, Eden Prairie, MN, USA). The tensile test was performed under displacement control with a cross-head speed of 0.3 mm/min. The strain was measured by attaching an axial extensometer (MTS, Eden Prairie, MN, USA) to the grip part of the specimen (Figure 6), and the tensile test was performed according to the ASTM guidelines [19]. Since the specimen used in this study is a ceramic-based specimen, an aluminum tab was attached to the grip portion to prevent the grip portion from being distorted when the specimen was mounted on the tensile tester as shown in Figure 6. For the tensile tests, three samples were prepared and tested for each composite material. After the tensile test, microstructural analysis was performed using SEM (S-360, Cambridge Instruments, Cambridge, UK). After that, in order to provide information to readers in an easy way, the result of this analysis was visualized as a two-dimensional figure to express the final failure process.

Figure 4. The microstructures of (a) plain-weave and (b) cross-ply Nicalon/SiC composites.

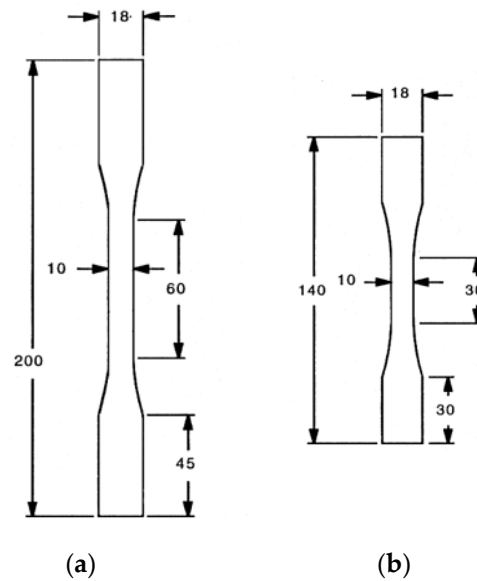
Figure 5. The geometries of tensile test specimens. All dimensions in mm. The Radius of curvature in the shoulder section: 100 mm. (a) plain-weave specimen. (b) cross-ply specimen.

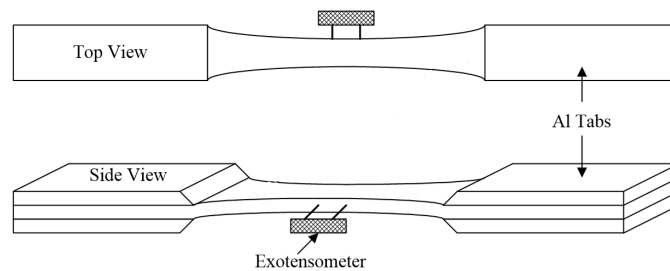
Figure 6. A schematic illustration of mechanical testing setup with specimen.

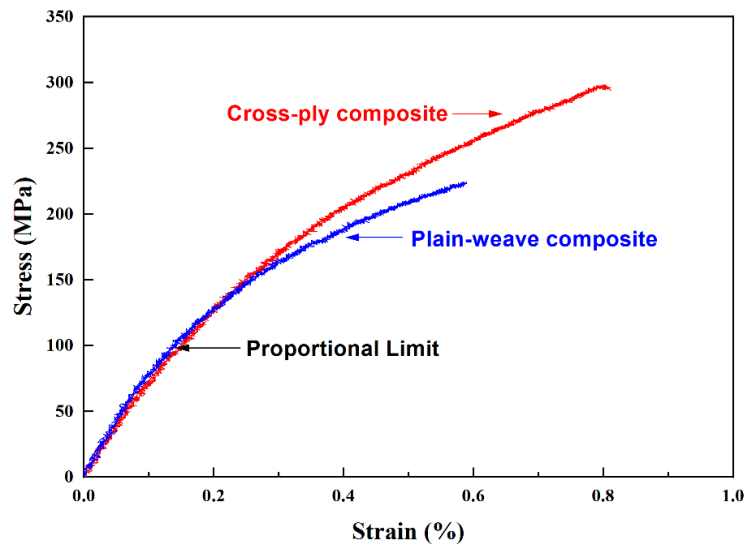
Figure 7. The result of tensile test for Nicalon/SiC ceramic composite.

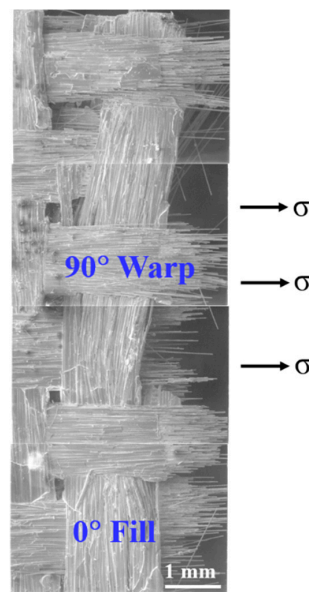
Figure 8 shows the fracture surface in a plain-weave composite. Figure 9 shows a cross-sectional view of the fracture surface of a plain-weave Nicalon/SiC composite. As shown in Figure 8, the 90° warps are oriented in the direction of stress application, so it can be understood that the specimen was finally ruptured through the final fiber fracture. On the other hand, in the case of 0° fills, since they are woven horizontally with 90° warps, the crack propagates at 90° warps after the first crack, and plays a role in giving time so that the final failure can occur at 90° warps. This can be inferred through the cross-sectional view in Figure 9. As shown in Figures 8 and 9, the final failure occurred at 90° warp in

the same orientation as the stress applied direction, and it can be seen that the 0° fill plays a role in supporting the final load for failure (Figure 8). Figure 9 also shows a fracture surface similar to that shown in Figure 8. However, when viewed through the cross-sectional view, the role of the 0° fill and 90° warp in the fracture process can be clearly understood [1,2,4].

Figure 8. Planar view of fracture surface of plain-weave composite.

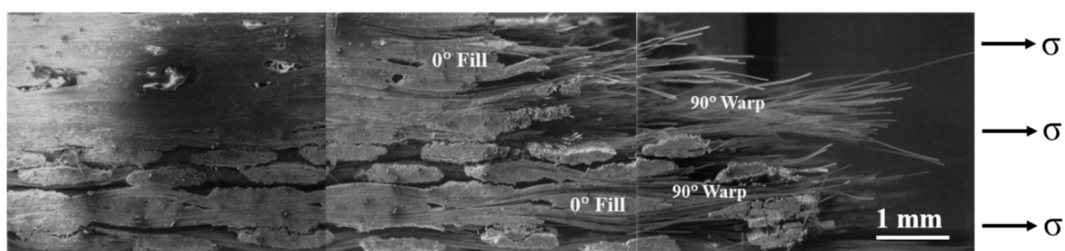
Figure 9. Cross-sectional view of fracture surface of plain-weave composite.

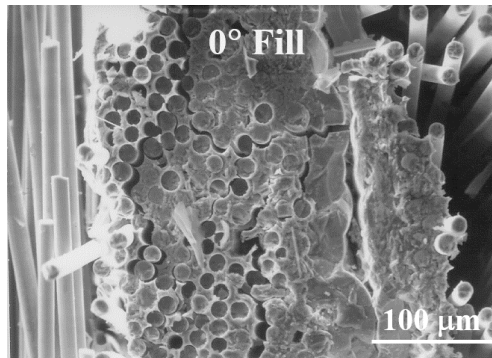
Figures 10 and 11 show more detailed fracture surfaces. In Figure 10, the 0° fill shows the crack in the SiC matrix. The matrix crack can be seen, which is the starting point of failure caused by the initial load (Figure 10). After that, the crack continues to propagate at the 0° fill (Figure 10). Subsequently, debonding occurs between the fiber and the matrix, and according to the continuously applied load, it reaches 90° warp. Through this fracture process, it can be seen that the fiber pullout at 90° warp and finally fiber breakage lead to final rupture. This process is illustrated schematically, which is described in detail in Figure 12 [4]. Through this process, it is possible to explain the fracture process of the plain-weave Nicalon/SiC composite material.

Figure 10. Multiple matrix cracking of 0° fill in plain-weave composite.

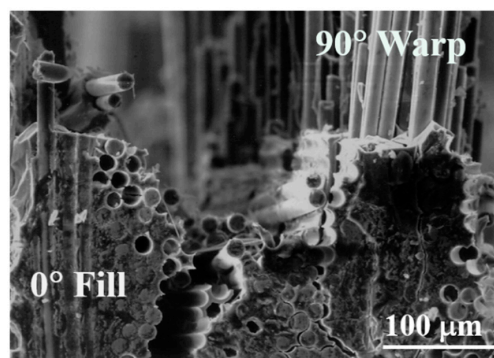
Figure 11. Fiber pullout of the 90° warp followed by severe matrix cracking of the 0° fill in plain-weave composite.

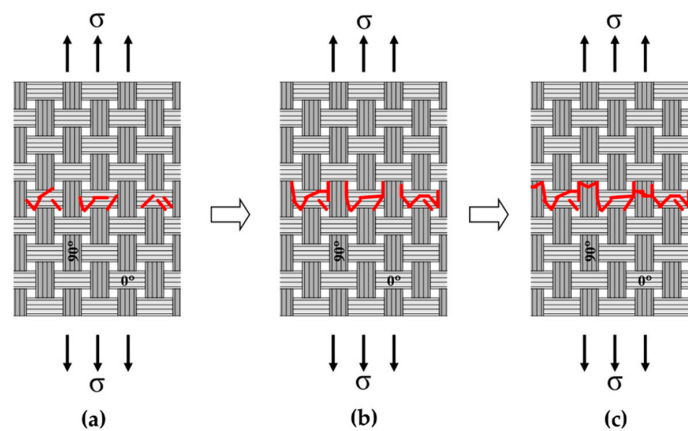
Figure 12. Failure mechanisms in plain-weave Nicalon/SiC composite; (a) matrix cracking in 0° fills and crack propagation within 0° fills, and debonding between fiber and matrix in 0° fills, (b) delamination in 0° fills and 90° warps and further crack propagation, and debonding between fiber and matrix in 90° warps, (c) fiber fracture and extensive fiber pullout in 90° warps.

In the case of plain-weave composite material, it was found that the crack of the silicon carbide matrix started at 0° fill. After that, the crack continued to propagate at 0° fill, and then debonding between the fiber and the matrix occurred, and the crack reached 90° warp according to the continuously applied load. Through this fracture process, it was found that the fiber pullout at 90° warp and finally fiber breakage lead to final rupture.

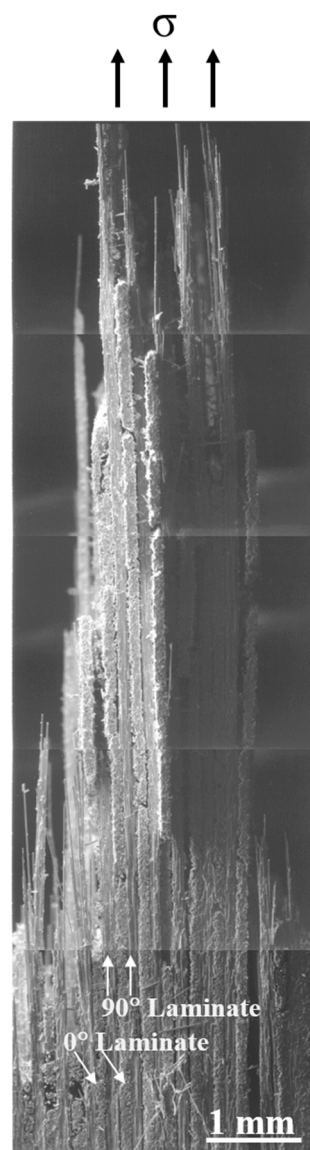
Figure 13 shows the fracture surface of a cross-ply Nicalon/SiC composite. It can be seen that the 0° and 90° laminates are intersected and the final failure occurred through the 90° laminates arranged parallel to the stress applied direction (Figure 13). Figures 14 and 15 show more detailed fracture surfaces. As shown in Figure 14, as a load is applied, the matrix cracking occurs preferentially in the 0° laminate (Figure 14), and then debonding between the matrix and fibers occurs, and crack propagation occurs in the 90° laminate direction. It can be inferred that the final breakdown consists of massive fiber pullout and a final fiber breakage in the 90° laminate (Figure 15). Similar to the description of the failure process of plain-weave composites, the failure of cross-ply composites is schematically described in Figure 16. In other words, first matrix cracking starts in the 0° laminate, followed by debonding between the fiber and the matrix in the 0° laminate. After that, crack propagation continues in the 0° laminate. Thus, as the load increases, delamination occurs between the 0° and 90° laminates. Subsequently, fiber debonding and pullout are performed on a 90° laminate. The final fracture is completed with massive fiber pullout and fiber breakage in a 90° laminate [1,3].

Figure 13. Cross-sectional view of fracture surface of cross-ply composite.

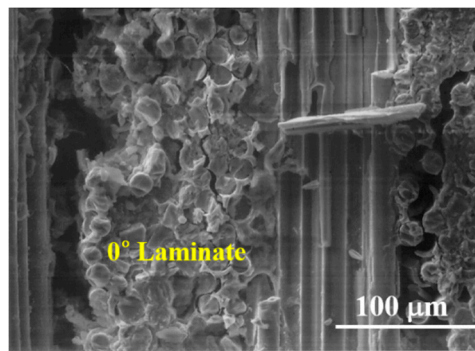
Figure 14. Delamination between fiber and matrix in 0° laminate.

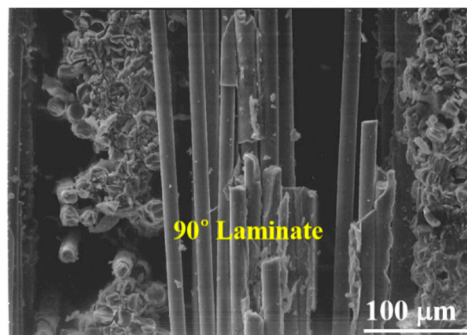
Figure 15. Final failure of the 90° laminate with fiber pullout.

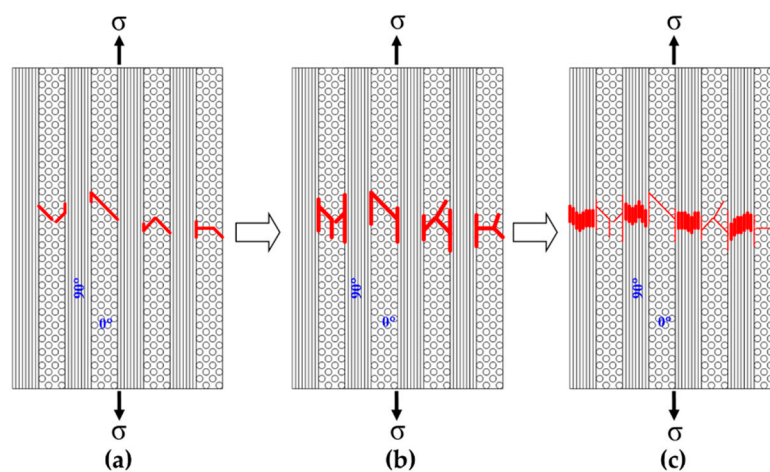
Figure 16. Failure mechanisms in cross-ply Nicalon/SiC composite; (a) matrix cracking in 0° laminate and debonding between fiber and matrix at the 0° laminate, (b) further crack propagation in 0° laminate and delamination between 0° and 90° laminates, (c) fiber debonding and pullout in 90° laminate and final rupture with extensive fiber pullout.

In the case of cross-ply composites, first matrix cracking begins in the 0° laminate, followed by debonding between the fiber and the matrix in the 0° laminate. After that, crack propagation occurs continuously in the 0° laminate. Thus, as the load increases, delamination occurs between the 0° and 90° laminates. Subsequently, fiber debonding and pullout are performed on a 90° laminate. It can be seen that the final rupture completes the failure process by massive fiber pullout and fiber breakage.
