Novel Repair Procedure for CFRP Components Instead of EOL

Abstract: Today, numerous carbon fiber (CF) reinforced plastic (CFRP) components are in continuous usage under harsh environmental conditions. New components often replace damaged structural parts in safety-critical applications. In addition to this, there is also no effective repair method to initially restore the mechanics of these structures using dry fiber material. The high costs of CFRP components are not in proportion to their lifetime. The research project IGF-19946 BR “CFRP-Repair” addresses this specific challenge. By using an oxide semiconductor that is activated by ultraviolet (UV) irradiation, the thermoset matrix can be depolymerized and thus locally removed from the damaged CFRP component. Afterward, the harmed fibers can be physically removed from the laminate in this certain area. A load-adjusted tailored fiber reinforcement patch is subsequently applied and consolidated by local thermoset re-infiltrating. Using this procedure, the structure can be locally repaired with new CF. As a result, repaired CFRP structures can be obtained with reduced mechanics and an approximately original surface. This article gi

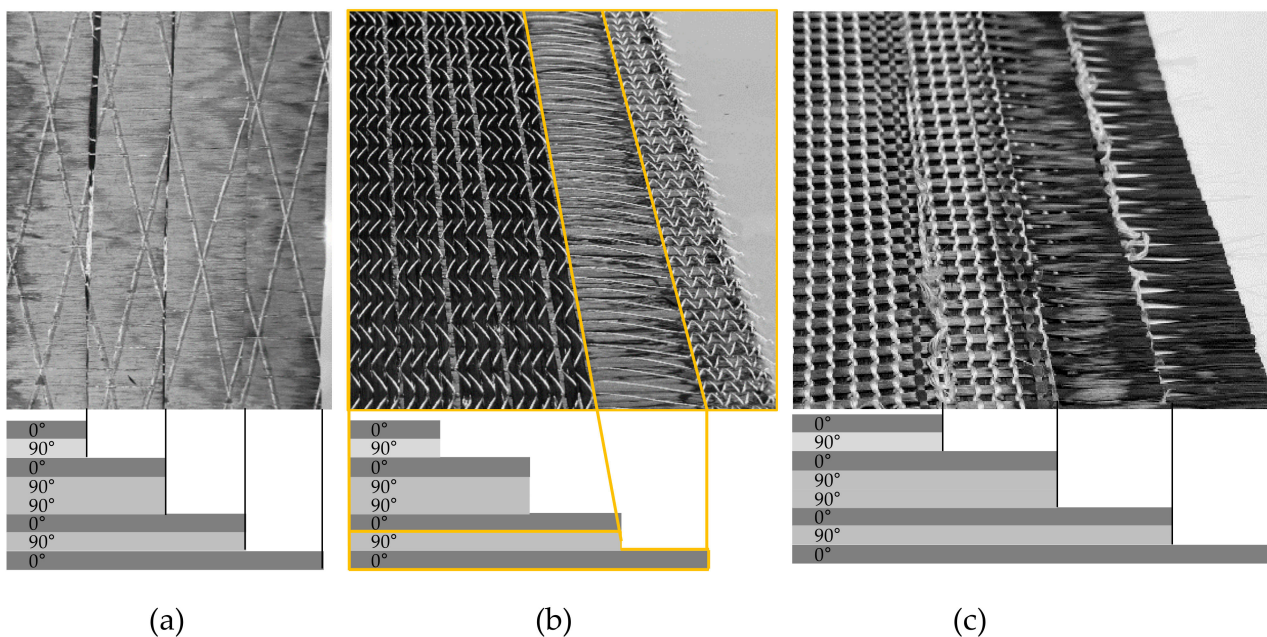
Figure 1. Manufactured repair patches, right half shown, with stacking sequence below: (a) full stacked UD patch, (b) one part of the full biaxial reinforced two-layered TFP-patch (yellow marked layers of the full patch) and (c) stacked, biaxial, reinforced MLG-patch that consist of four double layered patch plies.

- CNC-cutting and stacking of the UD material (UD): The UD patches were CNC-cut-outs from a roll of UD material with 151 g/m^2 areal weight. The CF is fixed by an adhesive thread grid on the back side. After CNC-cutting eight single plies, they were stacked and thermo-bonded with each other (Figure 1a).

- Tailored fiber placement (TFP): The CF was embroidered onto a thermostable film using Grilon KE85, 166 dtex fusible adhesive thread and thus fixed. Four patch-structures with two layers ($0/90^\circ$) were produced (Figure 1b). In a downstream process, the patch was fixed by heating above $85 \text{ }^\circ\text{C}$ through the melting of the fusible adhesive yarn so that the embroidery base could be easily removed.

- Multilayer weft knitting (MLG): The four biaxial reinforced repair-patches were knitted in one piece and subsequently divided into four structures. The stacked patch-structure can be seen in Figure 1c. In the edge areas, the stitch thread was thermo-bonded to prevent the mesh thread from unraveling.

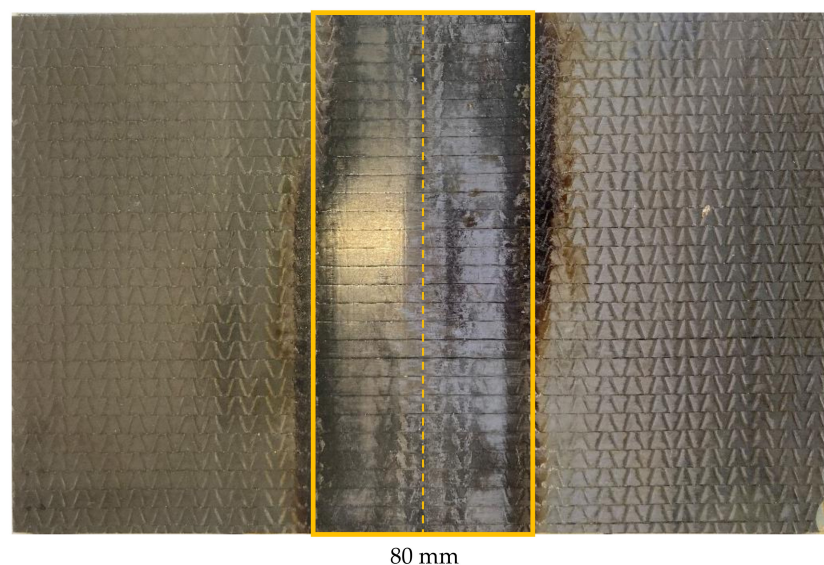
Figure 2. Example for a ‘matrix-repair’ CFRP plate (250 mm \times 150 mm) after repair.

Within this study, the matrix of CFRP plates with the dimensions 250 mm \times 150 mm \times 1.5 mm has been removed, followed by cleaning and resizing two sides from the middle of the specimen (marked with a yellow dashed line) within a length of 80 mm (yellow marked area: 150 mm \times 80 mm). Each test series consists of ten specimens (25 mm \times 250 mm) cut from two CFRP plates (Figure 2).

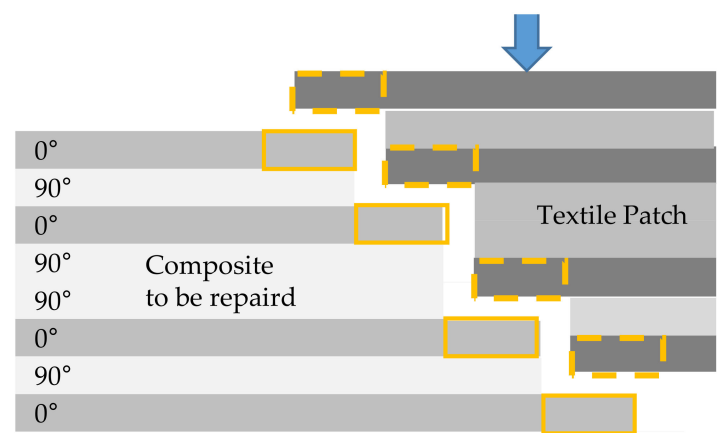
Figure 3. Repair area with the prepared staggered composite with textile fiber ends (yellow), and the textile patch with overlapping fiber ends (yellow dashed line).

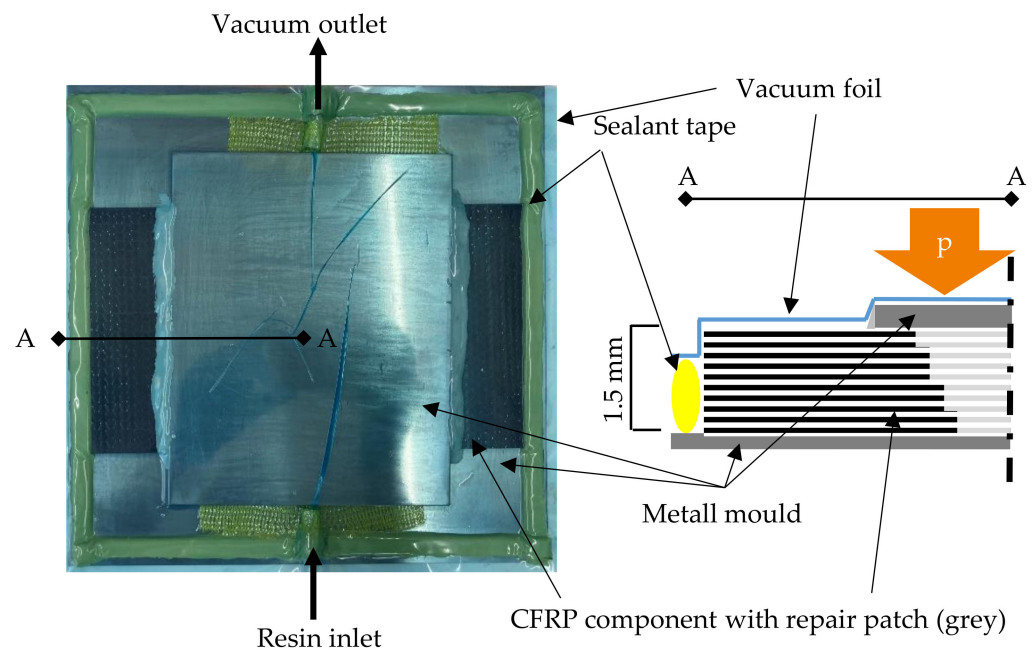
Figure 4. VARI re-infiltration setup for CFRP repair with textile patches.

After removing matrix and the harmed fibers in a staggered scheme, the repair area is surface-activated and resized comparable to the 'matrix-repair'. The prepared repair area is filled up to the removed fiber mass using a customized repair patch. These textile patches are prepared by three different textile fabric formation procedures (Section 2.1) with an overlap of 20 mm per 0°-layer. The upper layer of the patch has a total size of 160 mm × 150 mm, with the smallest layer on the opposite side 40 mm × 150 mm. Belonging to the patch structure, the fibers are placed in one-piece (UD) or layer-by-layer (TFP, MLG). A metal pressure piece like a counterpart to the metal tool is placed on top of the repair area (Figure 4). After the placement of the patch and the metal counterpart, the whole area is sealed by a vacuum film and tacky tape. The vacuum is applied, the CFRP plates on the metal tool are preheated to 50 °C, and the chosen repair resin system (Section 2.1) is infused using a vacuum-assisted resin infusion (VARI) technique. After the re-infiltration is finished, the plates are put in a hydraulic press to get back the former surface quality. After curing the resin system (40 min), the sample is cooled down and unpacked from the vacuum bagging.

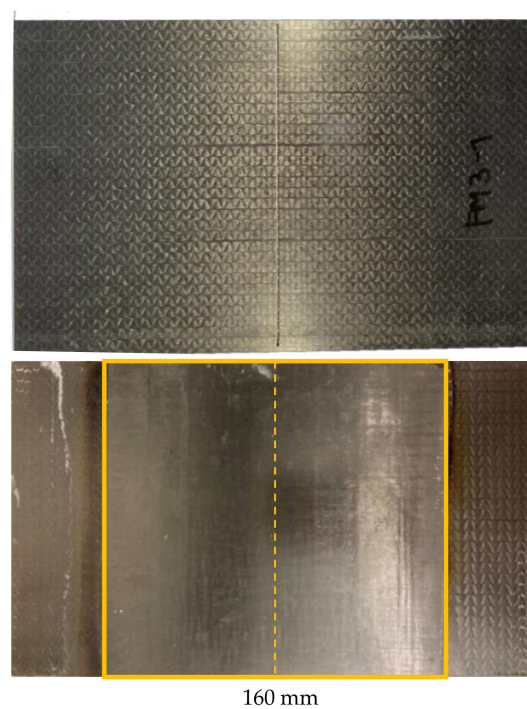
Figure 5. Exemplary damaged CFRP plate (top) using CNC milling and a ‘patch-repair’ CFRP plate ($250\text{ mm} \times 150\text{ mm}$) with a UD patch after re-infiltrating (bottom).

Within the study, CFRP plates ($250\text{ mm} \times 150\text{ mm}$) have been used to develop and show the repair procedure. Therefore, in the middle of the plate (Figure 5, yellow dashed line), damage is realized by CNC milling of a 1.0 mm gap through the complete laminate thickness. In this way, the damaged samples do not have any residual load bearing capacity, and a good comparison to the undamaged ‘reference’ is possible. The CFRP plates prepared in this way are repaired by the ‘patch-repair’. The series that was prepared and tested on ten specimens ($25\text{ mm} \times 250\text{ mm}$) from two CFRP plates can be seen in Figure 5. The patch length on the front (patch)-side of the sample is 160 mm .

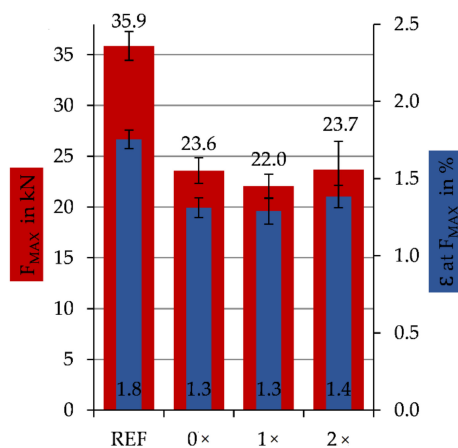
Figure 6. Specific tensile values (DIN EN ISO 527-4) for ‘matrix-repaired’ samples with different cleaning and sizing procedures (0×, 1×, 2×) in comparison to the reference without any defect.

The results of the tensile test (DIN EN ISO 527-4) for the ‘matrix-repaired’ specimens can be seen in Figure 6. The diagram depicts maximum force F_{MAX} and the elongations ϵ at F_{MAX} depending on the chosen repair method. As already mentioned in Section 2.2.1, three different series (0×, 1×, 2×) have been characterized, and the results are compared to the ‘reference’. Samples repaired with the ‘matrix-repair’ method show a lowered maximum force F_{MAX} . About 66.7% of the maximum force of the ‘reference’ CFRP can be reached. This corresponds to a loss of 33.3% of the maximum force by the UV-irradiation, cleaning, surface activation and resizing and re-infiltrating. With regard to the elongation ϵ at maximum force, the same results can be seen, with about 70% maximum elongation remaining from ‘reference’. The standard deviation of the ‘matrix-repair’ series values rises in comparison to the ‘reference’. The difference between the series with different preparation (intensity by repetition) is only marginal. The repeated surface activation with an increasing number of repetitions and thus the amount of sizing do not change the maximum achievable force or maximum elongation.

It was shown in Figure 6 that the ‘matrix-repaired’ samples lost about one-third of the mechanical properties compared to the ‘reference’ representing the original CFRP-component without any damage. The breaking behavior of the three different prepared series (0×, 1×, 2×) is comparable. In comparison to the clean breakage of the ‘reference’ samples, the ‘matrix-repaired’ samples exhibited a rather brittle fracture behavior. The structural failure of all specimens occurred in the treated center area. The reduction of the maximum force F_{Max} (−33%) and the maximum elongation ϵ (−23%) is probably due to the matrix residues remaining in the cross-section during the matrix’s UV-irradiation based decomposition. These residues obviously cannot be completely removed even by plasma-based cleaning and surface activation. They act as disturbing foreign bodies during re-infiltration that impair resin bonding. These residues thus prevent complete re-infiltration at the filament level (intralaminar). The incomplete re-infiltration results in higher porosity and insufficient fiber-matrix adhesion due to the local disruption of the load transfer. The brittle fracture behavior of the specimens underlines this assumption of the resulting composite mechanics.

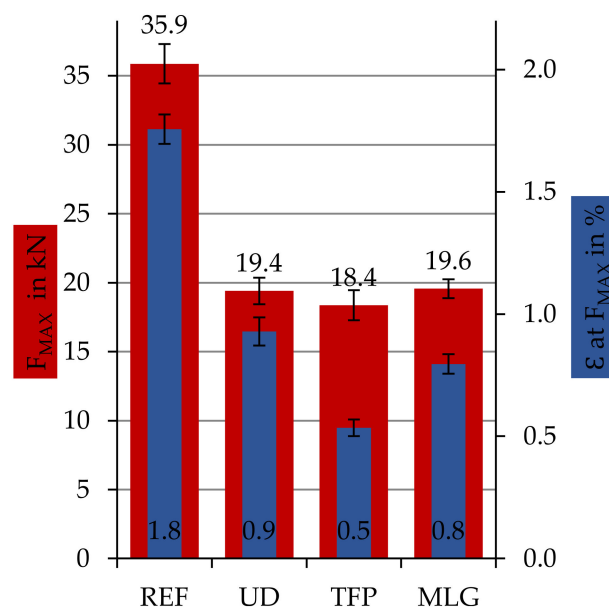
Figure 7. Specific values of damaged samples, repaired with different patch materials—cut UD material (UD), patches manufactured by tailored fiber placement (TFP), patches manufactured by multilayer weft knitting (MLG) compared to the reference samples without any defect.

Figure 7 depicts the results of the tensile test (DIN EN ISO 527-4) performed with ‘patch-repair’ samples. Three different series of damaged samples have been repaired with different patch materials: UD, TFP, MLG (Sections 1 and 2.1) and the results are compared to the ‘reference’. All patch-materials show almost similar maximum forces F_{MAX} . Concerning the maximum elongation, the samples repaired with UD and MLG are almost similar, and the samples repaired with TFP were already breaking at 0.5% strain. The ‘patch-repair’ samples show about 51–55% of F_{MAX} and elongation ϵ at F_{MAX} compared to the reference samples. The standard deviations of the readings (F_{MAX} , ϵ) are in the same range as the reference.

In Figures 7 and 10, the results of the tensile test of the sample series ‘patch-repair’ are shown. All samples broke early at 51–55% of the breaking force of the ‘reference’, independent of the applied patch material or infused repair resin system. The specimens of all ‘patch-repair’ series showed a comparable fracture behavior. The specimens fractured along the edge region between the patch and the stock bond. The areas marked in yellow in the schematic diagram (Figure 3) should lead to an increase in the fiber–fiber adhesion due to the overlap of the exposed fiber ends with the fibers of the patch and thus cause high breaking forces. However, the assumption could not be confirmed in this test series. The specimens fractured due to interlaminar shear failure of the matrix in the repair areas. An increase of the breaking force by generating a force flow through the overlapped fibers

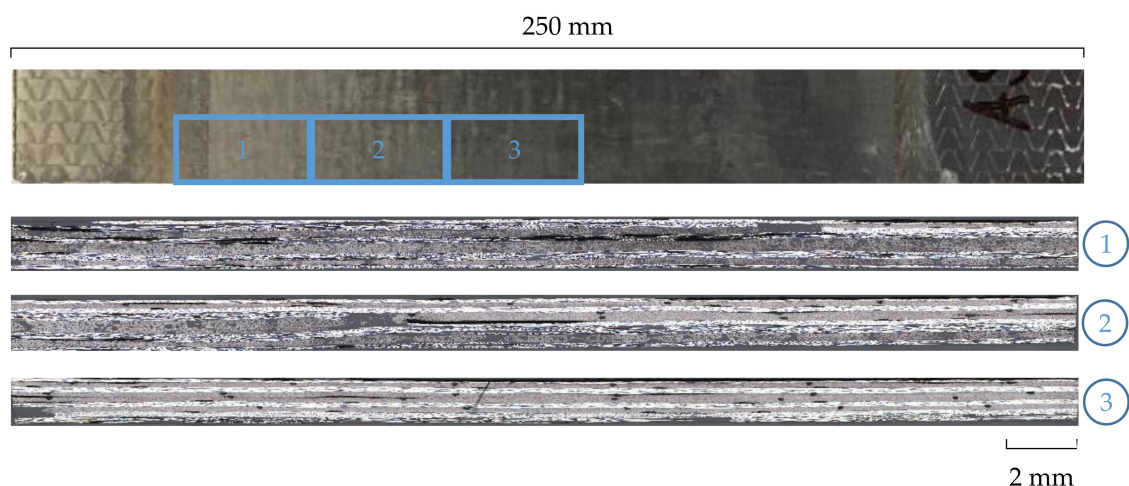
Figure 8. Microscopic cross-sectional views (50 \times) of different regions of a specimen repaired with a UD patch.

Figure 8 shows three microscopic images of a repaired CFRP area—from the edge to the center of the sample (1–3). It can be seen that the composite area completely replaced with the UD-patch (3) was well impregnated and only a small number of pores are visible. The first and second images depict a higher number of dark areas due to residuals from the UV-induced matrix removal process or pores resulting from these residuals, respectively.

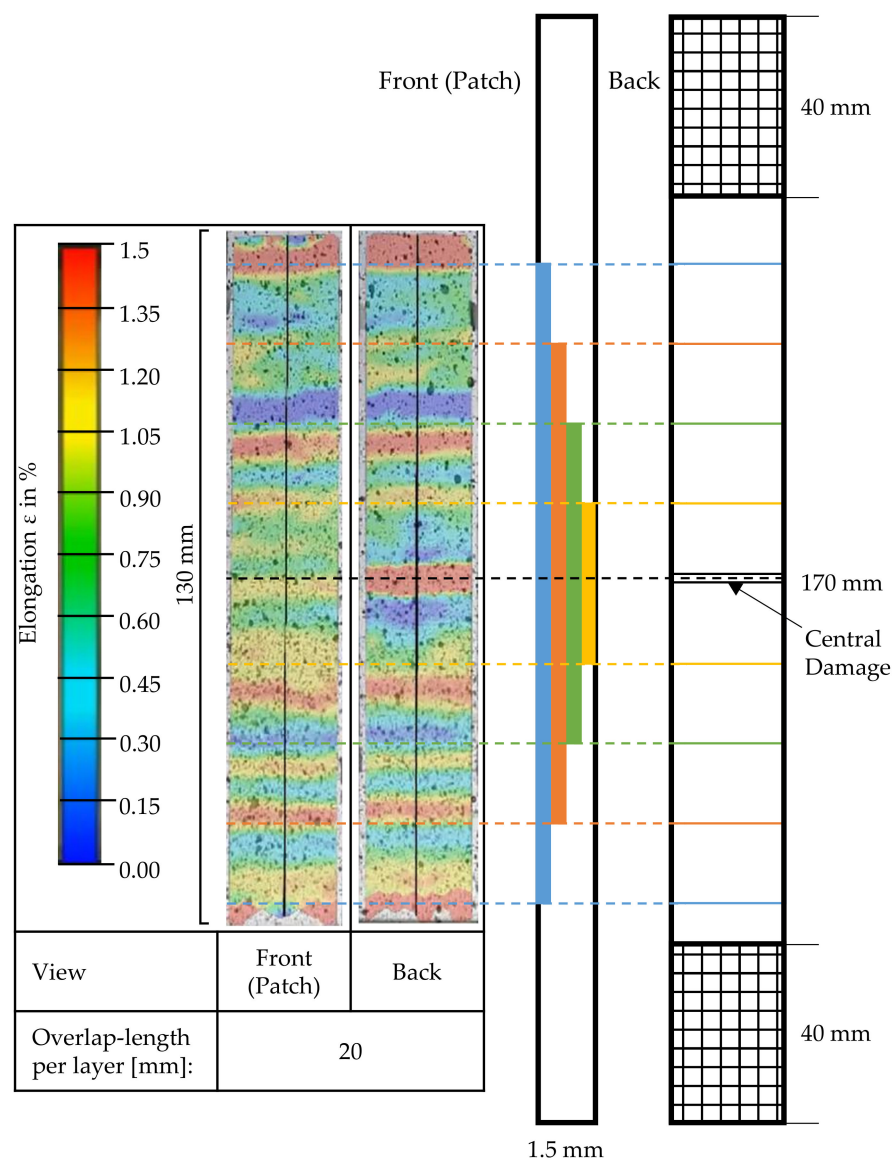
Figure 9. Results of the DIC during tensile testing just before the breakage of damaged samples ‘patch-repair’ with UD patch.

Samples repaired with UD material were examined closer with DIC during the tensile test. Figure 9 shows the calculated strain using GOM Correlate software on one sample. The local stress concentrations just before CFRP breakage from the front and the back side of the sample can be observed. The front side shows the area with the applied patch, and the back side shows the remaining composite of the repaired CFRP plate. The picture shows different inhomogeneous strain fields with strains ϵ between 0% and 1.5% along the measuring length of 130 mm. On the front side (patch), the elongation ϵ alternates in total 0.9% (Figure 7, UD) in equidistant steps over the length of the sample. The steps show the prepared stepped sample and the inserted patch. The backside looks similar, but there is a high elongated area in the middle can be seen, which represents the inserted damage of the CFRP by CNC milling (Section 2.2.2).

With the help of the DIC, the local elongations of the patch area could be determined. In all specimens (Figure 9 representing one result of a 'patch-repair' sample with a UD patch reinfused with the reference matrix-system HS1), it can be seen that areas of locally varying strain occur along the length of the specimen. Areas of greater strain occurring on both sides of the specimen are marked. These steps show the staggered scheme of the prepared CFRP specimen and those of the patch, respectively, which are interlocked. In the center of the image of the rear side of the specimen, the inserted damage area can be seen centrally. It seems clear that a higher strain occurs in this area than in undamaged areas. For all repaired CFRP specimens, it can be recognized that the monitored area of the as-built bond (non-patch area) exhibits a significantly higher strain (red) than the bond in the patch area (blue-yellow) up to the complete fracture of the specimen. This suggests that there is no uniform stress distribution across the repaired area. A load transfer into the patch is obviously not fully possible. The failure behavior along the shank can be foreseen by analyzing the images even before the fracture. From the area of greatest strain in the center of the specimen's back (damage), fractures occurred along the shank to the as-built bond by interlaminar shear failure.

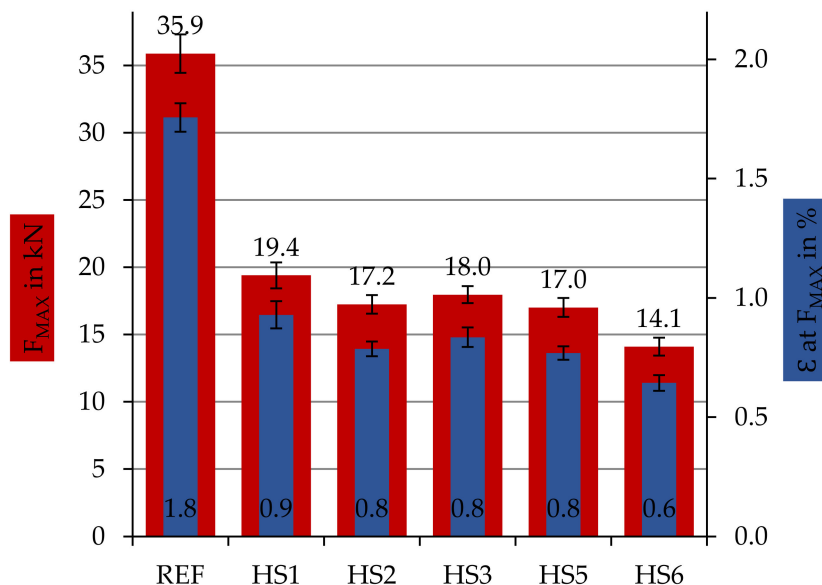
Figure 10. Specific tensile values of damaged samples repaired with UD patch material and different repair resin systems HA1-HS6 in comparison to the reference samples without any defect.

Figure 10 shows the results of the tensile test (DIN EN ISO 527-4) for the ‘patch-repair’ specimen series repaired with a UD patch but with different resin systems (cf. Table 1). HS1 is equal to the UD series in Figure 7 due to the same standard resin system. The other series

have been repaired by different resin systems to determine the influence of the achievable (chemical) bonding. The standard resin system HS1 exhibits the highest force results, but HS3, HS2 and HS5 are quite close.

As a further remarkable factor in the repair of components, various thermoset resin systems were used for the repair. Figure 10 shows the obtained results. By varying the thermoset resin systems HS2–HS6, no further improvement of the breaking force could be achieved compared to the standard resin system (HS1). The achievable specific values using the resin systems HS2, HS 3 and HS 5 are approximately 10% lower than the standard resin system HS1. This means that a later repair with an alternative resin system performed in a repair shop without the knowledge of the origin resin system is possible.
