COVID-19 Outbreak Associated with Air Conditioning in Restaurant, Guangzhou, China, 2020

To the Editor: In the research letter by J. Lu et al. (1), the authors claim that “The air outlet and the return air inlet for the central air conditioner were located above table C (Figure, panel B).” This sentence does not describe the actual layout depicted in the Figure, in which the air conditioner is located by table C and the exhaust fan is between tables B and D.

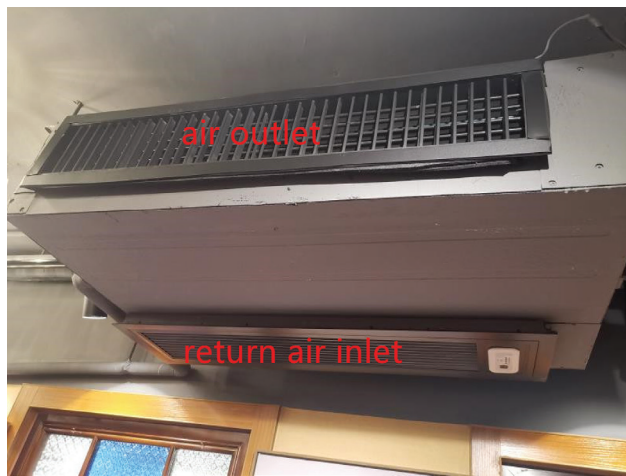
Figure 1. Inlet and outlet of air conditioner described in study of COVID-19 outbreak associated with air conditioning in restaurant, Guangzhou, China, 2020 (2).

We wish to explain that although she stated that, “The air outlet and the return air inlet for the central air conditioner were located above table C (Figure, panel B)” does not describe the actual layout depicted in the Figure, in which the air conditioner is located by table C and the exhaust fan is between tables B and D” (1). In fact, the air outlet and the return air inlet for the central air conditioner were located above table C (Figure 1). The central air conditioner is constructed in 2 parts: air outlet and air inlet, indicating no discrepancy between the text and the figure.
