## Dual-taper modular hip implant: Investigation of 3-dimensional surface scans for component contact, shape, and fit

**Background:** The etiology of wear particle generation and subsequent corrosion in modular total hip arthroplasty implants likely begins with mechanical fretting. The purpose of this study was to determine geometric features of the male and female taper surfaces that drive stability within the neck-stem junction.

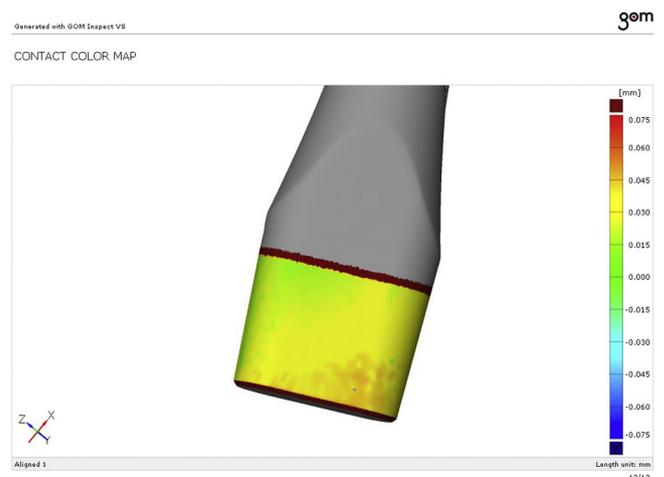
**Figure 1.** Representative contact color map depicting the distance between the neck and stem surfaces, which is shown on the surface of the neck.

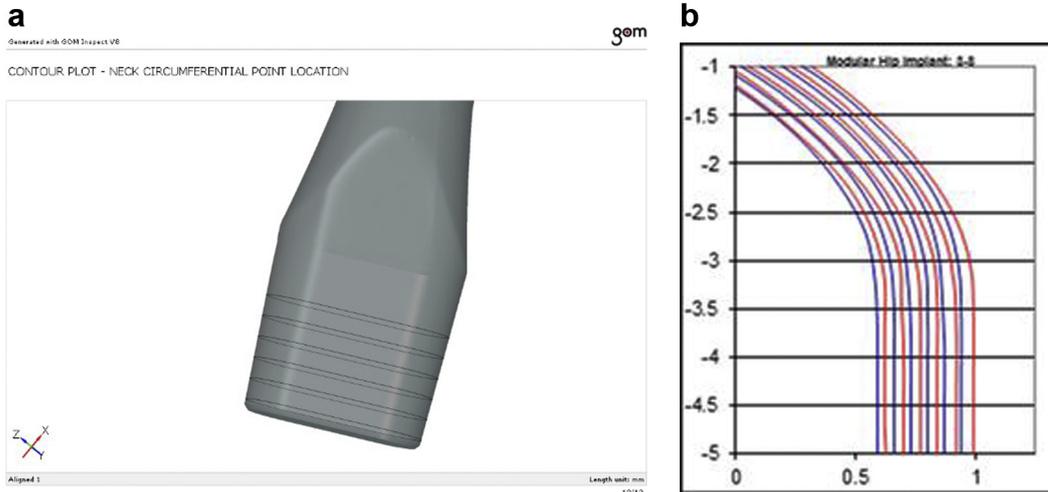
**Figure 2.** Circumferential lines (a) represent the location of points on the neck surface used to generate the surface contour plots (b), which were projected onto a plane at the base of the neck. The contour lines were projected onto this plane from an axial height of 1.0, 3.5, 6.0, 8.5, 11.0, and 13.5 mm. Corresponding circumferential lines on the stem slot were also projected onto this plane. Blue lines represent the neck contour, and red lines represent the stem slot contour (b).

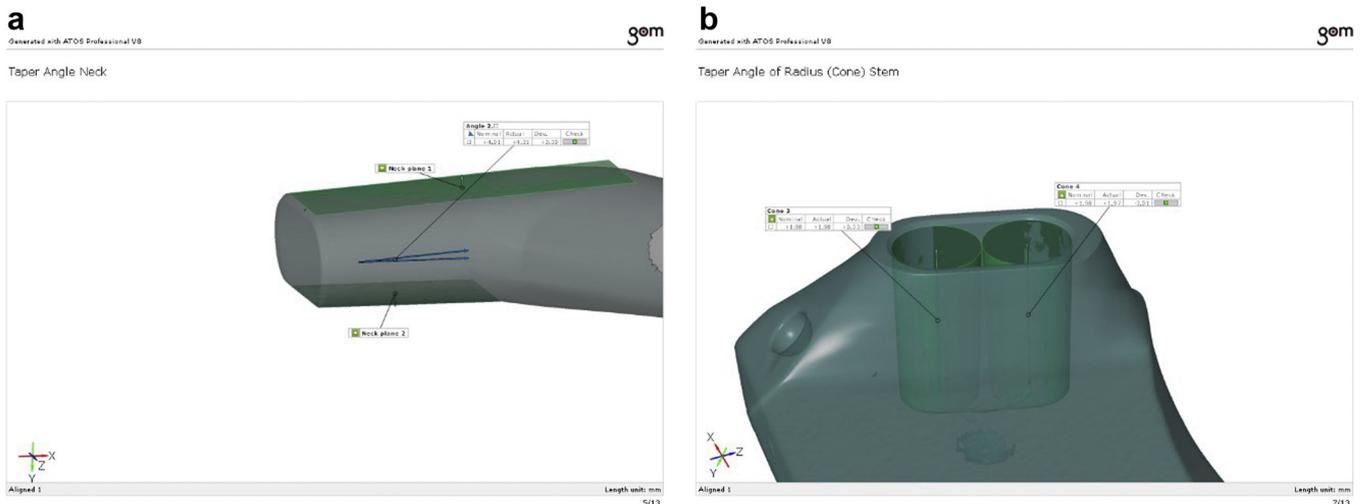
**Figure 3.** Taper angles from the neck and stem in the straight (a) and radius (b) sections were determined from the angle between fitted planes and cones, respectively. Not shown is the neck radius and stem straight section angles.

Three-dimensional scans were performed using an ATOS III Triple Scan blue light optical scanner (GOM mbH, Braunschweig, Germany) and analyzed using the GOM Inspect software application (GOM mbH, Braunschweig, Germany). The scanning system consisted of two, 8,000,000 pixel cameras. The implant image volume was resolved to a point spacing of 0.5 mm. Digitized component surface data were imported into the GOM Inspect software application, and a surface mesh of each component was created. Surface marker positions were digitally identified and used to align the individual components in the assembled positions. Surface measurement and analysis were conducted using the GOM Inspect software. Measurements were made to determine the normal distance between the surfaces of the neck taper as seated in the stem slot. These measurements were used to produce a color map of the contact proximity between the neck and stem surfaces (Fig. 1). Circumferential surface points from the neck and stem slot at corresponding taper axis heights (1.0, 3.5, 6.0, 8.5, 11.0, and 13.5 mm relative to a plane at the base of the neck) were used to create surface contour plots to identify surface shape variation and contact (Fig. 2). Taper angles for the neck and stem were determined in the straight and radius sections to compare taper shape (Fig. 3) (Table 1). Finally, the neck seated depth in the stem slot was measured.

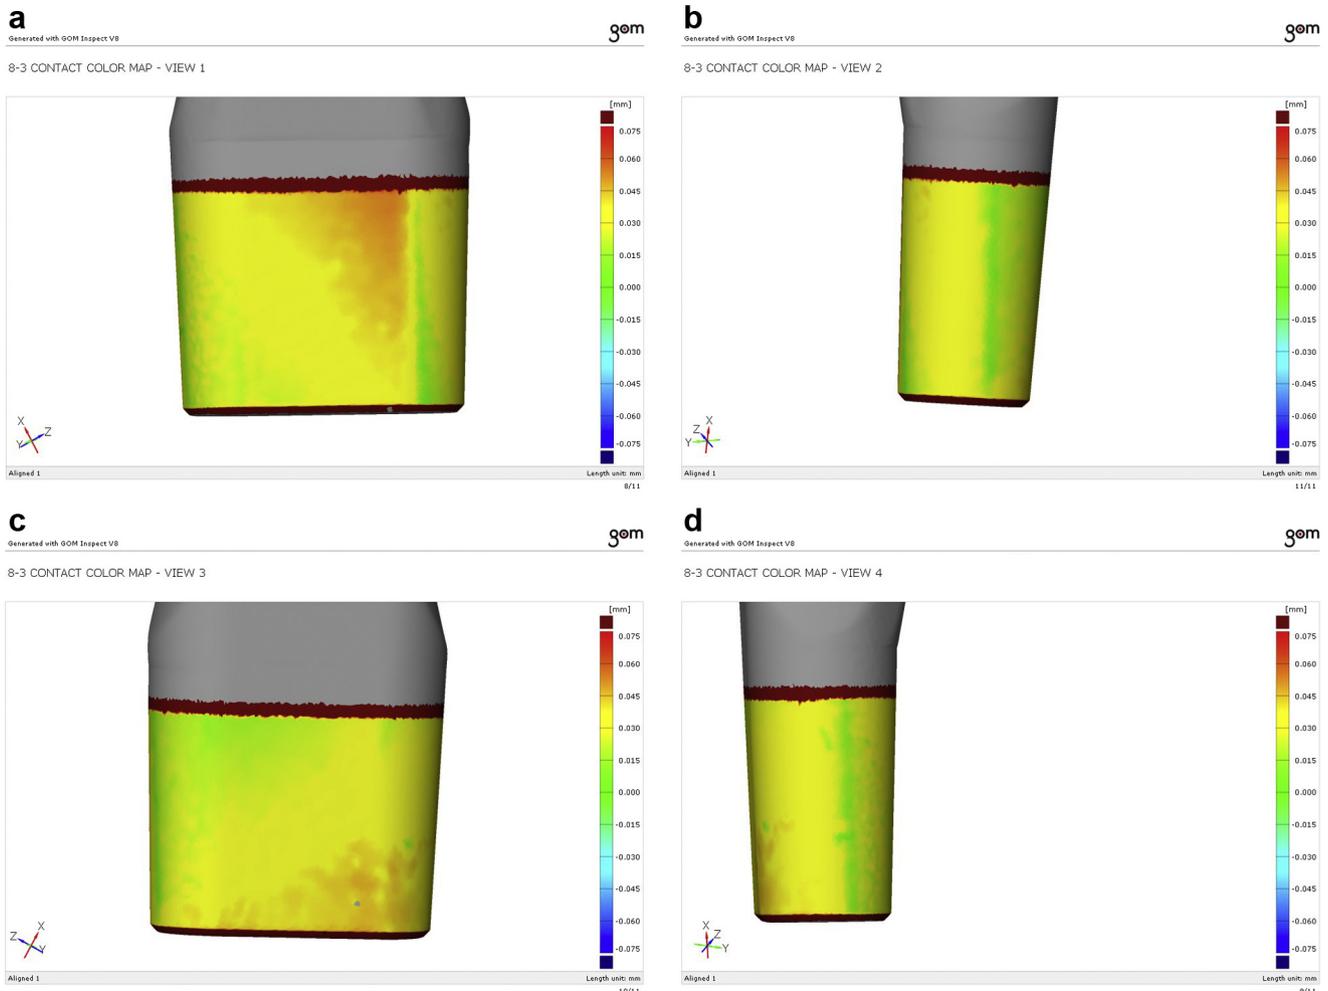
**Figure 4.** Contact color maps of the same implant. Image sequence (a-d) provides a 360° view of the implant and illustrates the 4 typical features.

Surface data were used to produce contact color maps. The color map was projected onto the neck component and shows the normal distance from the neck surface to the stem surface (Fig. 4).

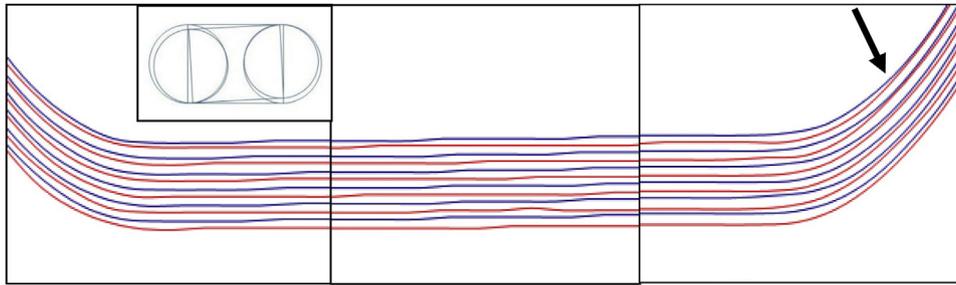
**Figure 5.** Contour plots of the neck and stem depicted in Figure 4a (upper left image) of the implant shown in the contact color maps, above (blue is the neck surface; red is the stem surface). The height of the rings (contour lines) increases from the inner rings to the outer rings (innermost = 1.0 mm and outermost = 13.5 mm). Note the surface variations and the departure of the neck and stem contour lines from left to right, which corresponds to the left to right change of color, from green to yellow, in the 3D contact color map. Inset depicts a neck with axial rotation relative to the stem, an ideal contact pattern that may explain the neck-stem departure along the flat surface, but does not explain the contact in the radius (arrow).

Circumferential points from the neck and stem at corresponding taper axis heights were projected onto a plane to produce surface contour plots. These plots were made to identify surface variations that explain the corresponding contact color map. The contour plot in Figure 5 shows the neck and stem surface proximity corresponding to the upper left image of the flat surface region (Fig. 4a), above. Observed is the departure of the neck and stem contour lines from left to right. This corresponds with the left to right change in color from green to yellow, illustrating a malformed neck flat section that is not truly flat. If purely dependent on position, such as an axial rotation of the neck with respect to the stem (Fig. 5, inset), the subsequent contact in the curved section would not occur at the location shown by the arrow. The contour plot shows instead a flattened variation of the neck radius, rather than a circular arc, and corresponds with the contact color map.

Projected contour plots of circumferential lines at different taper axis heights provide insight into the shape of the mating taper surfaces. Three key shape features were found to correspond to the contacts in the color maps. The first feature was a general closer proximity of the neck to the stem at the transition from the curved section to the flat portion of the taper followed by a gap at the taper as one moves circumferentially toward the other curved section. This pattern then repeats itself as one circumferentially returns to the starting point on the color map. Such a feature suggests that the neck is sitting in a toggled position in the stem, and these findings correlate to the colored vertical striations which are appreciated on the 3D color maps. The second feature appreciated was a closer proximity of the color plots to one another when moving from a proximal to distal direction in the axis height measured. Stated differently, there tended to be a departure of the neck from the stem as one moves more proximally in the taper contact area. Finally, there was an apparent flattening of the radius section roundness in the stem. In the contour plots, the stem surface tended to flare away from the neck surface and have a tighter curvature before flattening out and then repeating, which caused an increased gap and then contact at the transition from the flat region to the radius region, followed by the second contact after the radius centerline. Departure of the neck surface from the stem indicates a possible out-of-parallel manufacturing artifact or a tilted fit of the taper. The “toggled” fit and stem radius curvature observations may also be a manufacturing artifact. Machining marks were observed

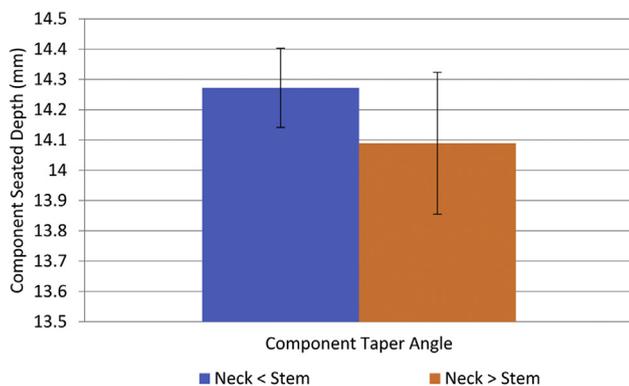
**Figure 6.** Neck seated depth comparison. The depth at which the neck component fit into the stem was influenced by the angle of the taper. When the neck taper angle was less than the stem taper angle the neck sat deeper in the stem than when the neck taper angle was greater than the stem taper angle.

To determine if the difference in taper angles ( $S < N$  or  $S > N$ ) influenced the seated depth of the neck, we performed a regression analysis, which showed that the seated depth of the neck was dependent on the taper angles in the flat section of the neck ( $R^2 = 0.5000$ ,  $P = .0332$ ). Seated depth indeed decreased as the neck taper angle increased above that of the stem taper angle.
