# Experimental Study on the Fire Performance of Tubular Steel Columns with Membrane Protections for Prefabricated and Modular Steel Construction

**Abstract:** Experimental research was conducted to study the fire resistance of steel tubular columns used in prefabricated and modular construction. In order to achieve high-efficient prefabrication and fast on-site installation, membrane protections using board products and thermal insulation blankets are adopted as the favorable protection method. Three protected tubular columns were tested in a full-scale column furnace with axial load applied. The study variables were different membranes, including fiber reinforced calcium silicate (FRCS) boards, rock wool and aluminum silica (Fiberfrax) insulations. The results suggest that one layer of 12 mm FRCS board with rock wool insulation has insufficient fire protection. However, steel columns protected with two layers of 12 mm FRCS boards with insulation appeared to have good fire resistances and could achieve a fire resistance rating as high as 2.5~3.0 h.

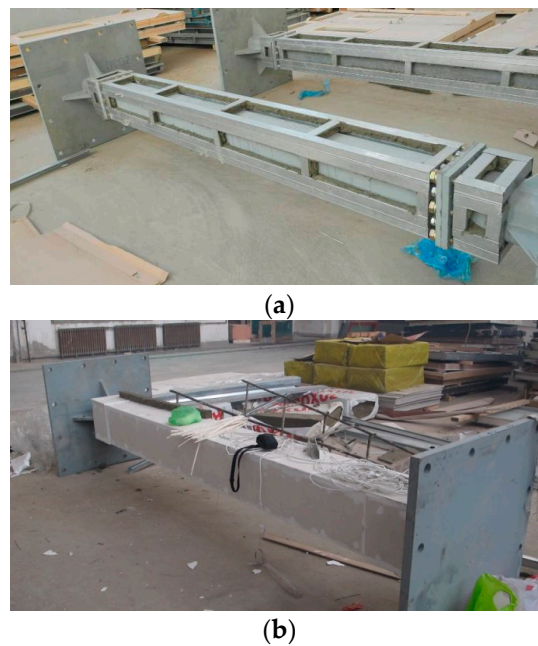
Figure 2. Fabrication of the column protection: (a) unprotected; (b) protected.

Figure 2 shows fabrication of the column protection. The column protection details are shown in Figure 3 in a cross-section view.

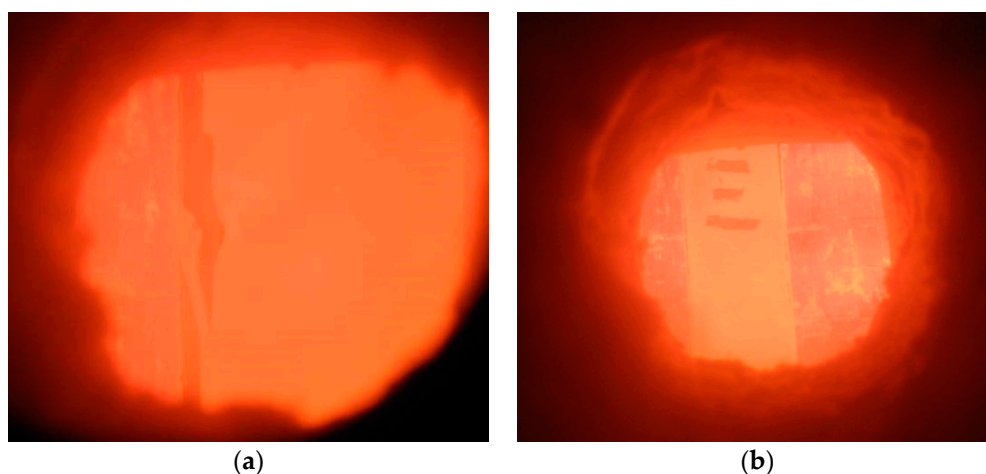
**Figure 4.** View of test specimens through the observation window: (a) HSS-C1; (b) HSS-C3.

For HSS-C1, after about 10 min, the board joints started to open up slightly. At about 20 min, the board joints opened up significantly, shown in Figure 4a. The steel studs and rock wool were then exposed to fire exposure at the opened joints. At 74 min, the column lost its strength and failed.

For HSS-C3, after about 10 min, the board joints started to open up slightly. No cracks appeared on the boards during the 3.0 h tests, shown in Figure 4b. The fire resistance test was terminated at 180 min with safety concerns, because the furnace was designed to run fire tests within 3.0 h. The column did not show any sign of failure at the end of the test. Therefore, the ultimate fire resistance of the column of HSS-C3 would be larger than 3.0 h.

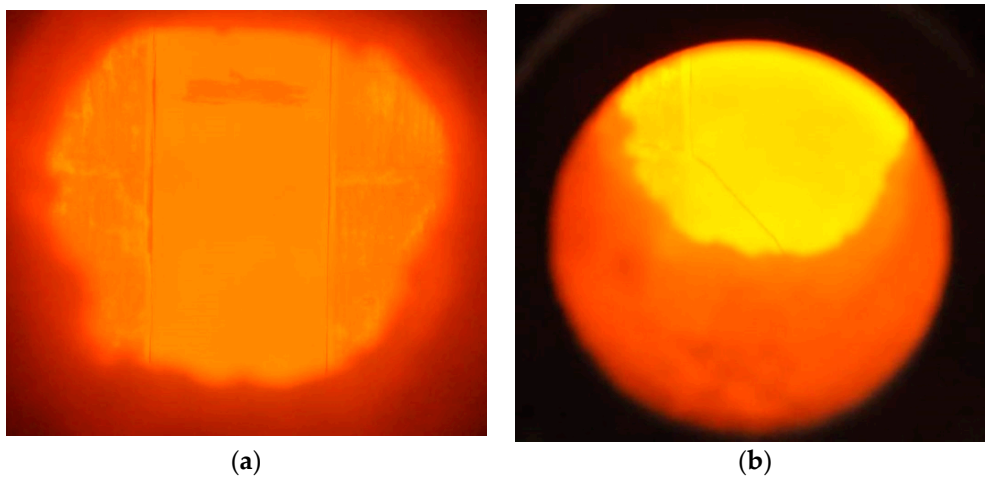
Figure 5. View of test specimen HSS-C2 through the observation window: (a) at about 10 min; (b) at about 25 min.

For HSS-C2, after about 10 min, the board joints opened up slightly, shown in Figure 5a. The sealing mortar started to fail off. At about 25 min, a crack appeared at the bottom left on the front side of the FRCS board but did not fall off during the rest of the test, shown in Figure 5b. At 180 min, the column failed.

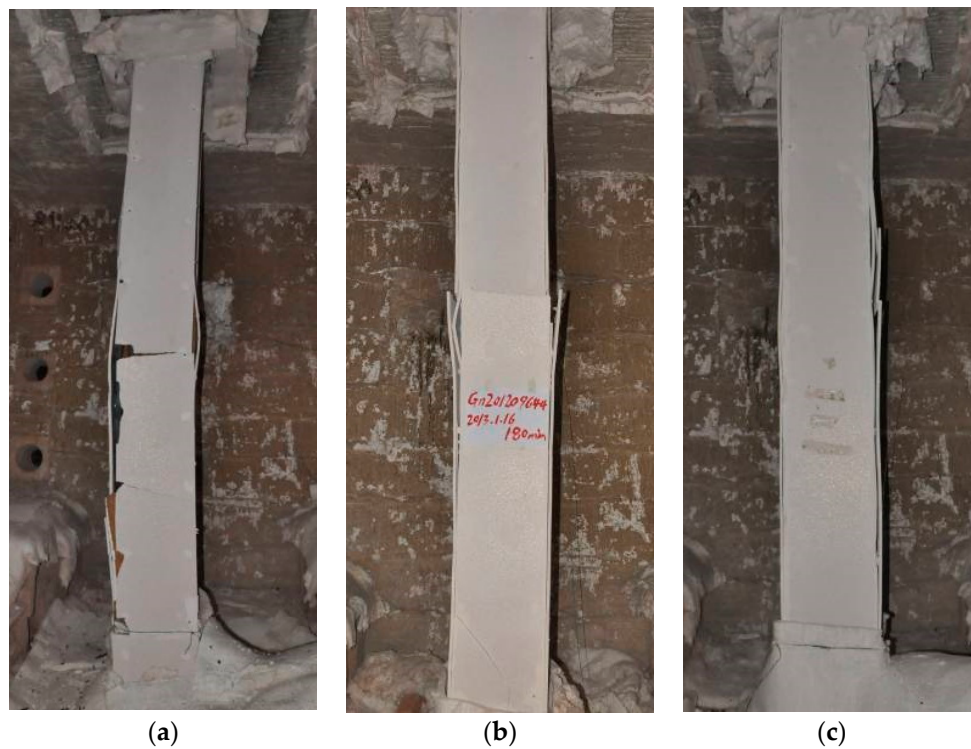
Figure 6. Columns after tests (still in the furnace): (a) HSS-C1; (b) HSS-C2; (c) HSS-C3.

The results of the three full-scale fire resistance tests are summarized in Table 2. The three columns after fire tests are shown in Figure 6. Note that the FRCS boards for specimen HSS-C3 did not break during the test. However, the breaks occurred during the cooling time.

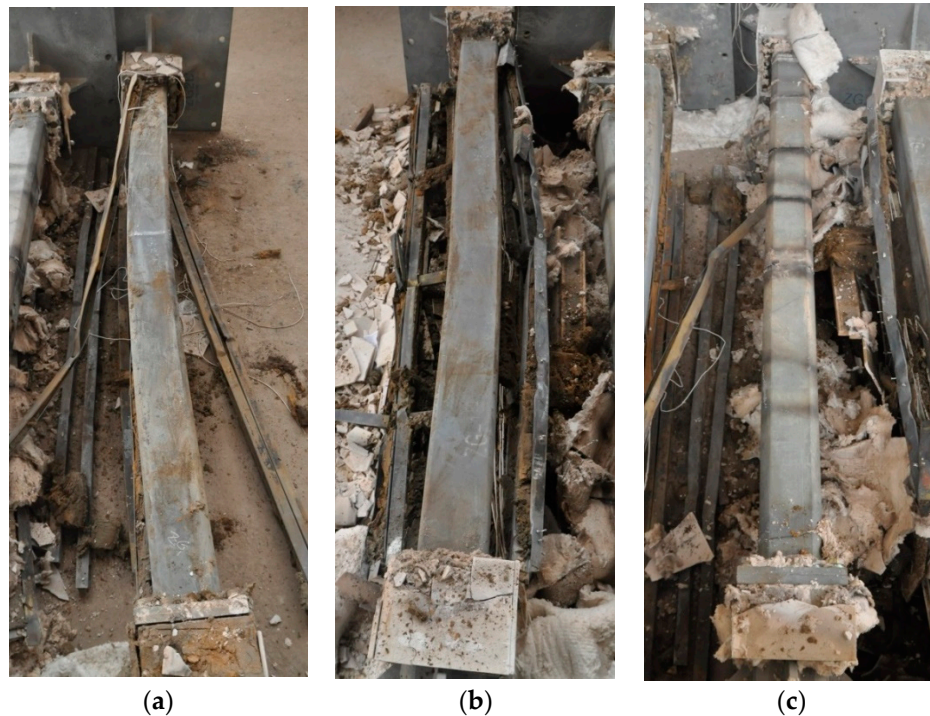
Figure 7 shows the three columns with protection removed. Both specimen HSS-C1 and HSS-C2 show considerable deformation of buckling at about the middle height of the columns, while the specimen HSS-C3 shows no apparent deformation.

**Figure 7.** Columns after tests (protections removed): (a) HSS-C1; (b) HSS-C2; (c) HSS-C3.

For specimen HSS-C1 protected with one layer of FRSC board, the temperatures behind the boards (A3 and B3) started to increase rapidly after about 7–8 min exposure (Figures 9 and 10). At about 45 min, the A3 and B3 temperatures reached the same as the furnace temperature (Figure 9). This indicated that the thermocouples were exposed to direct fire exposure. At 74 min when the column failed, the steel temperature at the middle plan (B1\_M) reached 500 °C. Figure 7 shows that the column experienced considerable deformation in the test.

For specimen HSS-C2, the column steel temperatures (A1 and B1) increased slowly before 60 min, as shown in Figures 11 and 12. After about 60~70 min, the column temperatures started to increase almost linearly. At 180 min, the temperatures at the middle height of the column (A1\_M and B1\_M) reached about 600 °C. Accordingly, it can be observed in Figure 7 that the column experienced considerable deformation at these high temperatures.

For HSS-C3, the steel column was wrapped up with Fiberfrax blanket. This insulation cut out the heat transfer from the steel studs to the column and provided excellent insulation for the steel column. As shown in Figures 13 and 14, at the end of the test, the column temperatures were about 200~250 °C, which is much less than the critical temperature of 550 °C for structural steel. The column did not fail at 3.0 h but the test had to be terminated due to the design safety of the furnace. It can be confirmed that the column experienced no visible deformation in Figure 7.

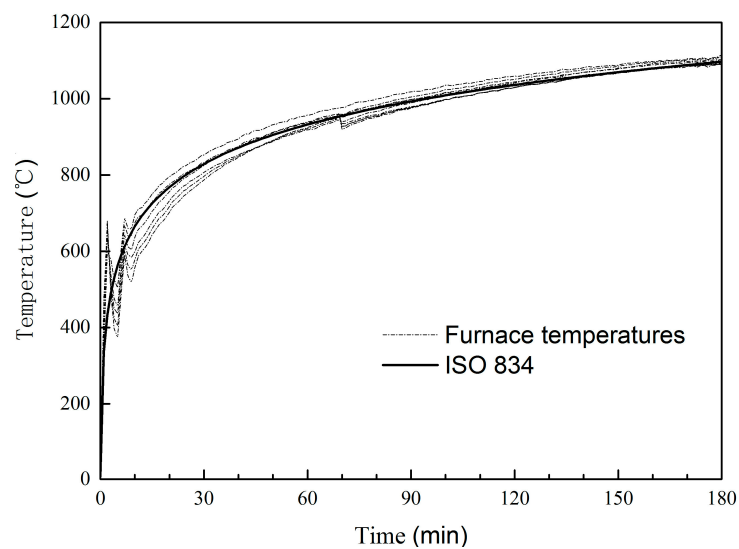
**Figure 8.** Furnace temperatures for HSS-C2.

The measured furnace temperatures for specimen HSS-C2 are plotted in Figure 8 as an example. During the first 10 min, the temperatures had some oscillation. After 10 min, the average furnace temperature followed the standard temperature curve very well.

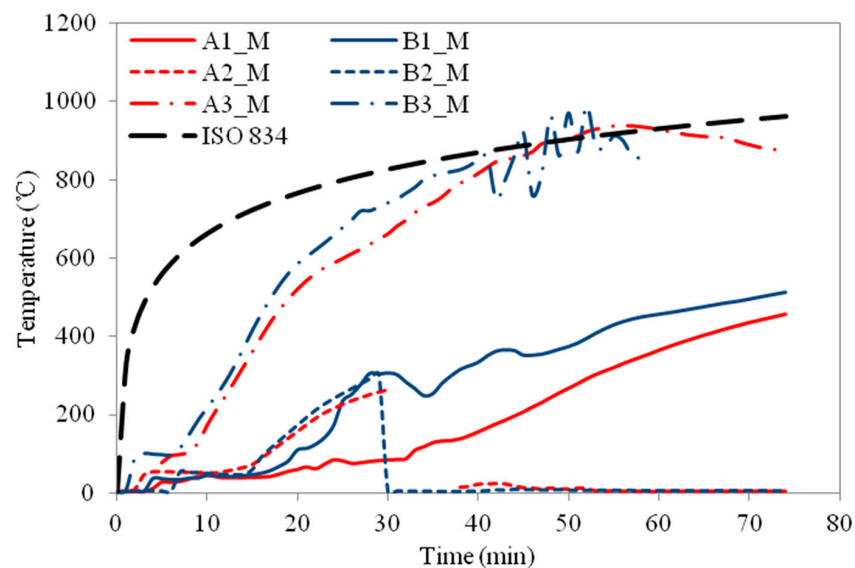
Figure 9. Temperature profiles at the medium section for HSS-C1.

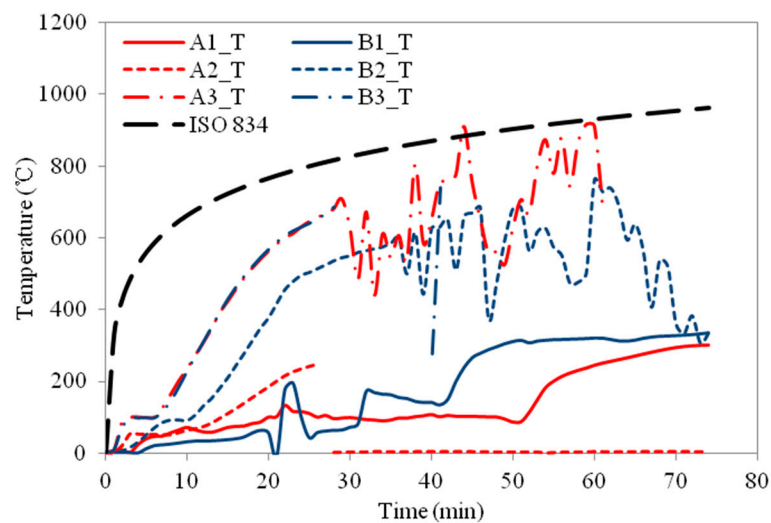
Figure 10. Temperature profiles at the top section for HSS-C1.

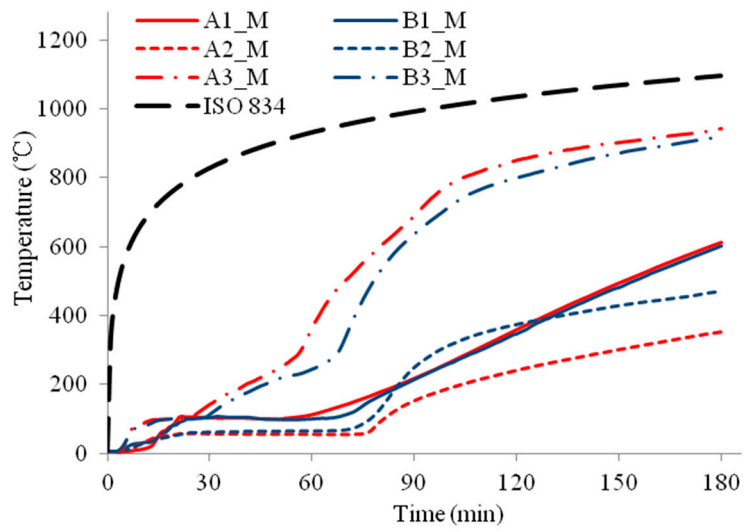
Figure 11. Temperature profiles at the medium section for HSS-C2.

For specimens HSS-C2 and HSS-C3 protected with a double-layer of FRSC boards, temperatures between the boards and insulation (A3 and B3) had similar increase trends, as shown in Figures 11 and 13. At 180 min, the furnace temperature was about 1100 °C and the A3 and B3 temperatures reached about 900–1000 °C (Figures 11–13), which were less than the furnace temperature. This indicated that the boards did not break before 180 min and the rock wool did not experience direct exposure to the fire during the tests.

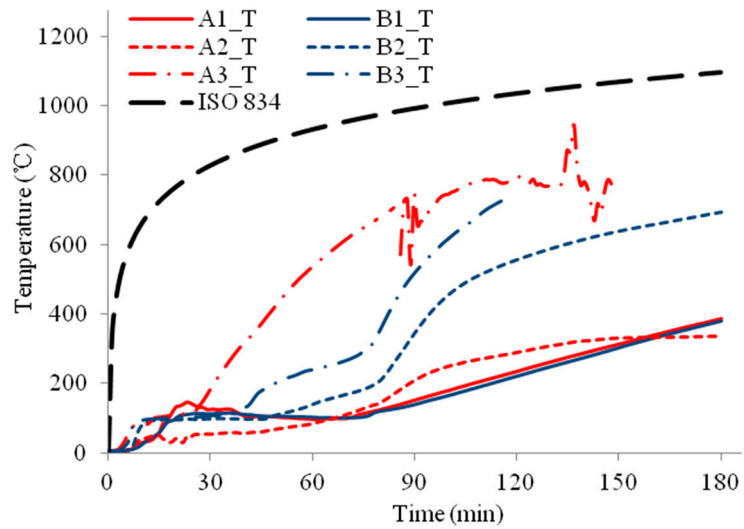
Figure 12. Temperature profiles at the top section for HSS-C2.

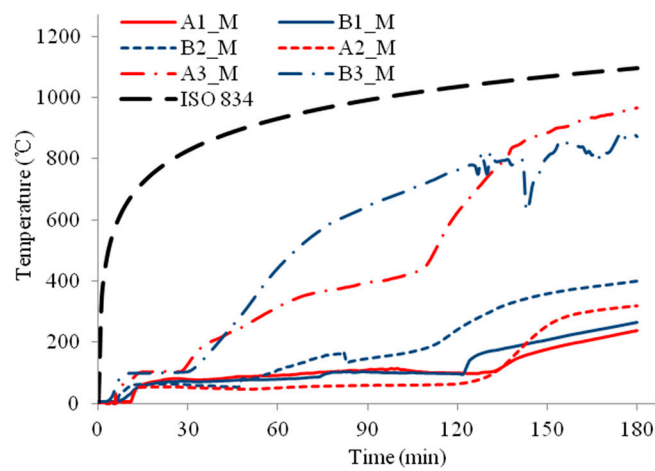
Figure 13. Temperature profiles at the medium section for HSS-C3.

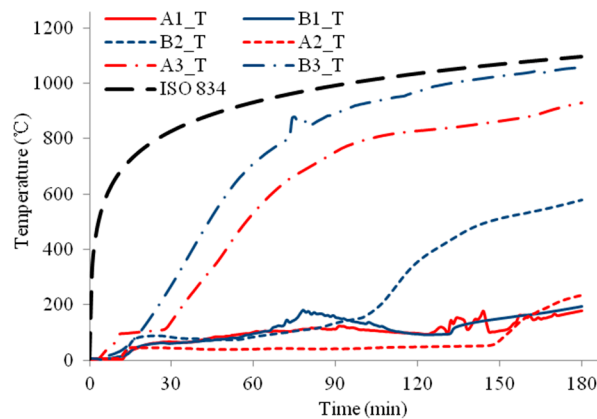
Figure 14. Temperature profiles at the top section for HSS-C3.

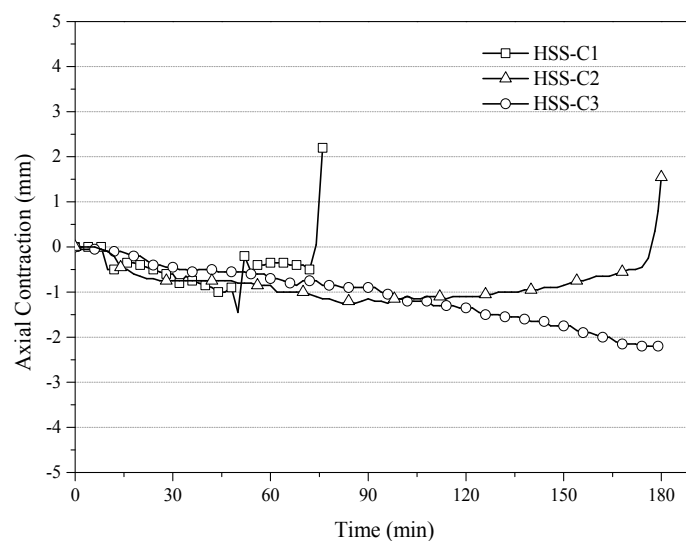
Figure 15. Axial contractions of the three columns.

The measured axial contractions are shown in Figure 15. The negative values represent that the columns were experiencing thermal expansion. For HSS-C3, the specimen underwent thermal expanding continuously throughout the test. However, HSS-C1 and HSS-C2 experienced a fast increase

in the axial displacement near the end of the tests. The columns failed due to the criterion of the rate of axial contraction.
