RESEARCH ARTICLE

The deterioration of the Pueblo Bonito Great House in the Chaco Culture National Historical Park, New Mexico, USA

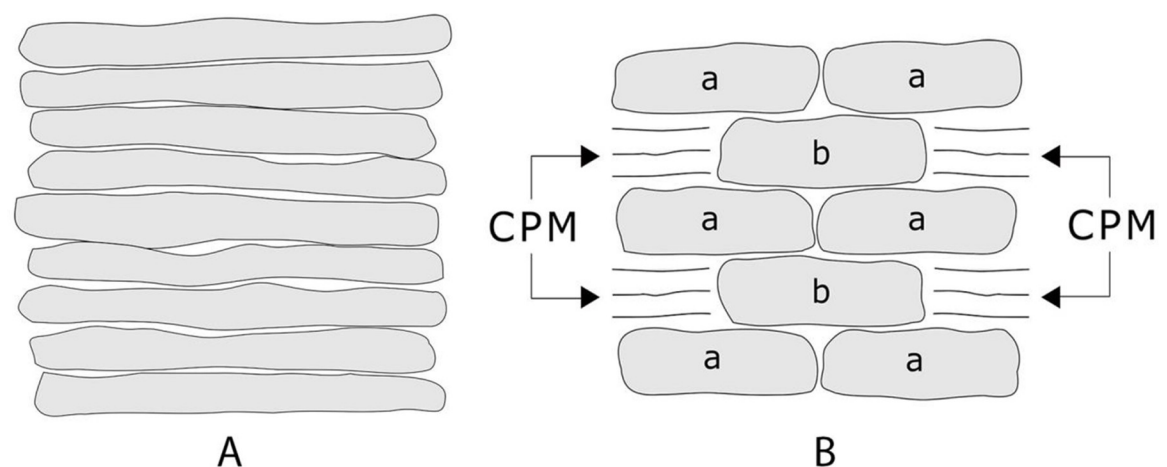
Fig 1. Examples are stacked plate masonry (A) and stacked core masonry (B). Stones marked (a) in example (B) would correspond to "headers" in contemporary brick masonry. Stones marked (b) in example (B) would correspond to "stretchers" in modern brick masonry and core stones in Ancestral Puebloan masonry. CPM (core protection masonry) in Ancestral Puebloan masonry consists of slabs wedged between courses of stones (a) to provide levelness and to protect the mud mortar.

Above-ground surface walls, exposed to the elements, used mud to bed the stones, with stones overlaying other stones, becoming the important wall volume. The challenge in these above-ground surface walls was protecting the mud mortar from moisture. Early stacked plate masonry surface walls (Fig 1A, is a representation of stacked plate masonry) were one stone wide (PB-19), and photographs (PB- 20; PB- 21) show layers of different sized rocks dipping in disorderly courses, providing uneven between-rock contact and diffused load paths. Some stacked wall plate segments standing in 1887 had fallen by the time of the Hyde expedition of 1896–9, indicating the continual process of wall deterioration. Presumably, the individual stones had been embedded in mud mortar, but the mud substrate had weathered away over time. Thus the problem: the mud-binding unit was unable to maintain wall integrity because the mud was susceptible to dispersion by rain, flooding and wind.

the touching plate ends so the plates could not shift, and thus would be confined, would provide strength. The product was stacked core masonry. Examples are (PB- 27; PB- 28) as well as representation B in Fig 1. The photographs identified as examples of stacked core masonry, cited below, are imperfect because such illustrations require wall cross-sections and such cross-sections exist only because of wall trauma. Stacked core masonry construction usually used larger stones with many smaller stones wedged in to provide stability and levelness (PB- 25). An additional technique was utilized in the construction of the great north wall which was a meter wide at its base. The core contained rows of both flat plates, large core stones, abundant mud, and rock debris (PB- 29; PB- 30; PB- 31).

Protecting the core. There are similarities between the modern brick wall and the stacked core masonries of Pueblo Bonito. Bricks comprising a course called "headers" are analogous to stones identified as (a) in Fig 1B, and bricks called "stretchers" are analogous to stones identified as (b) in Fig 1B. The 21st century mason fills the height gap between courses of "headers" with partial bricks and lime-based mortar. The Ancestral Puebloan mason, dealt with asymmetrical "headers" and "stretchers", a mud mortar, and resorted to filling the height gap between courses with mud and rock fragments (the CPM in Fig 1B) to provide levelness before the next course of stones (a) was added. That CPM filling is called core protection masonry herein. If the wall grew wide by adding additional "headers" and "stretchers" internally, then there were internal spaces to also be filled with a jumble of rocks, rock fragments, mud, and debris (PB- 24; PB- 26). Such rubble filling seems common in some Pueblo Bonito walls. A core consisting of rocks with mud would be vulnerable if wetted, with the loss of the binding-mud resulting in the shifting of rocks with uneven surfaces, reducing the contact between rock surfaces and causing a dispersed load path. A good strategy to avoid this problem was to protect the core with CPM to produce a stable load path.
