Research article

Image analyses of artificially damaged carbon/glass/ epoxy composites before and after impact load

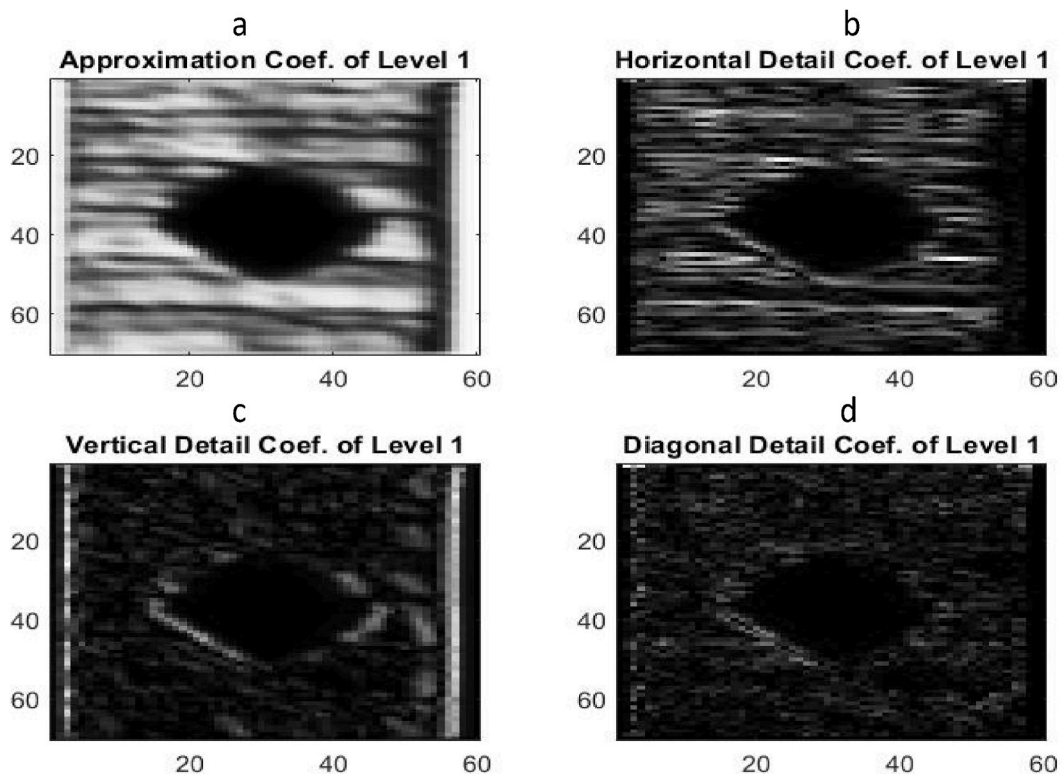
Fig. 6. C/UD sample image processing by DWT method, approximation images (a), horizontal detail (b), vertical detail (c), diagonal detail (d).

Discrete Wavelet Transform (DWT) was used to decompose the image into four sub-images; approximation images (Fig. 6a) and

detail images horizontal (Fig. 6b), vertical (Fig. 6c), and diagonal details (Fig. 6d) at one resolution level by using a 'db5' type wavelet. MATLAB program includes several families of wavelet that have proved to be useful for different types of applications. Since tailoring the choice of best wavelet depends on the image size and desired quality reconstructed image [34–36], in this study some pre-determined mother wavelets such as Haar, Daubechies, Symlets, Coiflets, and biorthogonal were applied to image frames and compared in terms of their defect segmentation. According to the visual comparison, it was revealed that the highest segmentation result was obtained with 'Daubechies'. In the MATLAB program, the names of the Daubechies family wavelets are written dbN, where N is the order, and db is the "surname" of the wavelet. There are nine members of Daubechies from "db2" to "db10". The best choice of the mother wavelet was determined as "db5" among nine alternatives by trial and error.

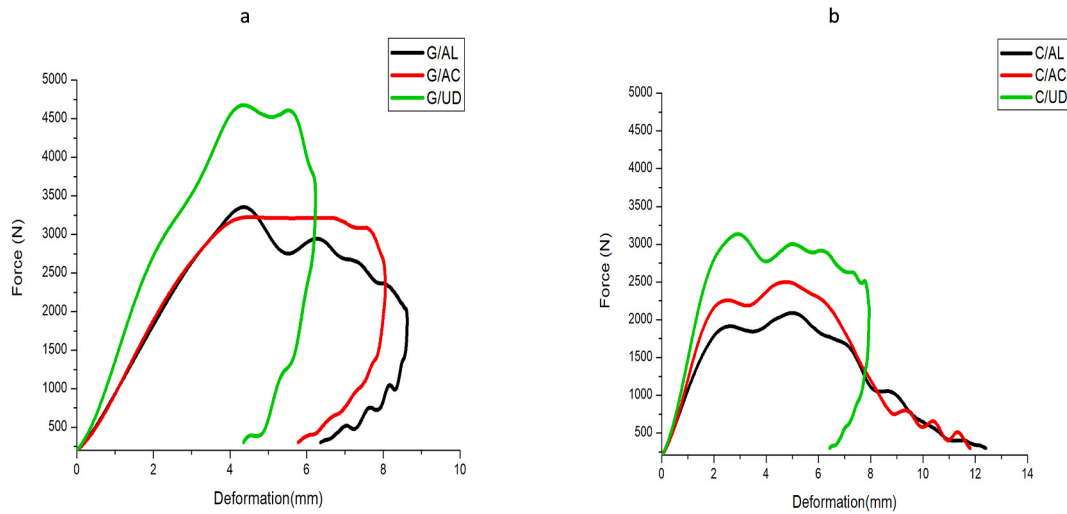
Fig. 7. Force-deformation graphics of GFRP (a) and CFRP (b).

Peak force values of GFRP composites in all three forms (G/UD, G/AC, G/AL) were higher than samples (C/UD, C/AC, C/AL) (Fig. 7a and b). The maximum strength value that the artificially damaged specimens could bear decreased between 20.25% and 33.29%, as expected, compared to the undamaged specimens. As shown in Fig. 6, the maximum deformation (mm) value increased in artificially damaged composite structures in both GFRP and CFRP composites compared to undamaged GFRP and CFRP composites. The highest deformation value was measured as 8.624 mm in the GFRP composites G/AL, while 12.412 mm in the CFRP composites C/AL inserted. For GFRP, displacement values increased up to 38% in G/AL, while this value was 29% in G/AC. Since the striking head at the drop-weight test could not fully penetrate some samples, some of the impact energy was stored as elastic energy, causing the striking head to bounce back. The highest elastic recovery was calculated as 32% for G/UD, followed by 28% for G/AC and 26% for G/AL. On the other hand, only C/UD showed 19% elastic recovery, and the other CFRP with the artificially damaged punctured under an impact force.
