RESEARCH ARTICLE

Quantification of the Contact Area at the Head-Stem Taper Interface of Modular Hip Prostheses

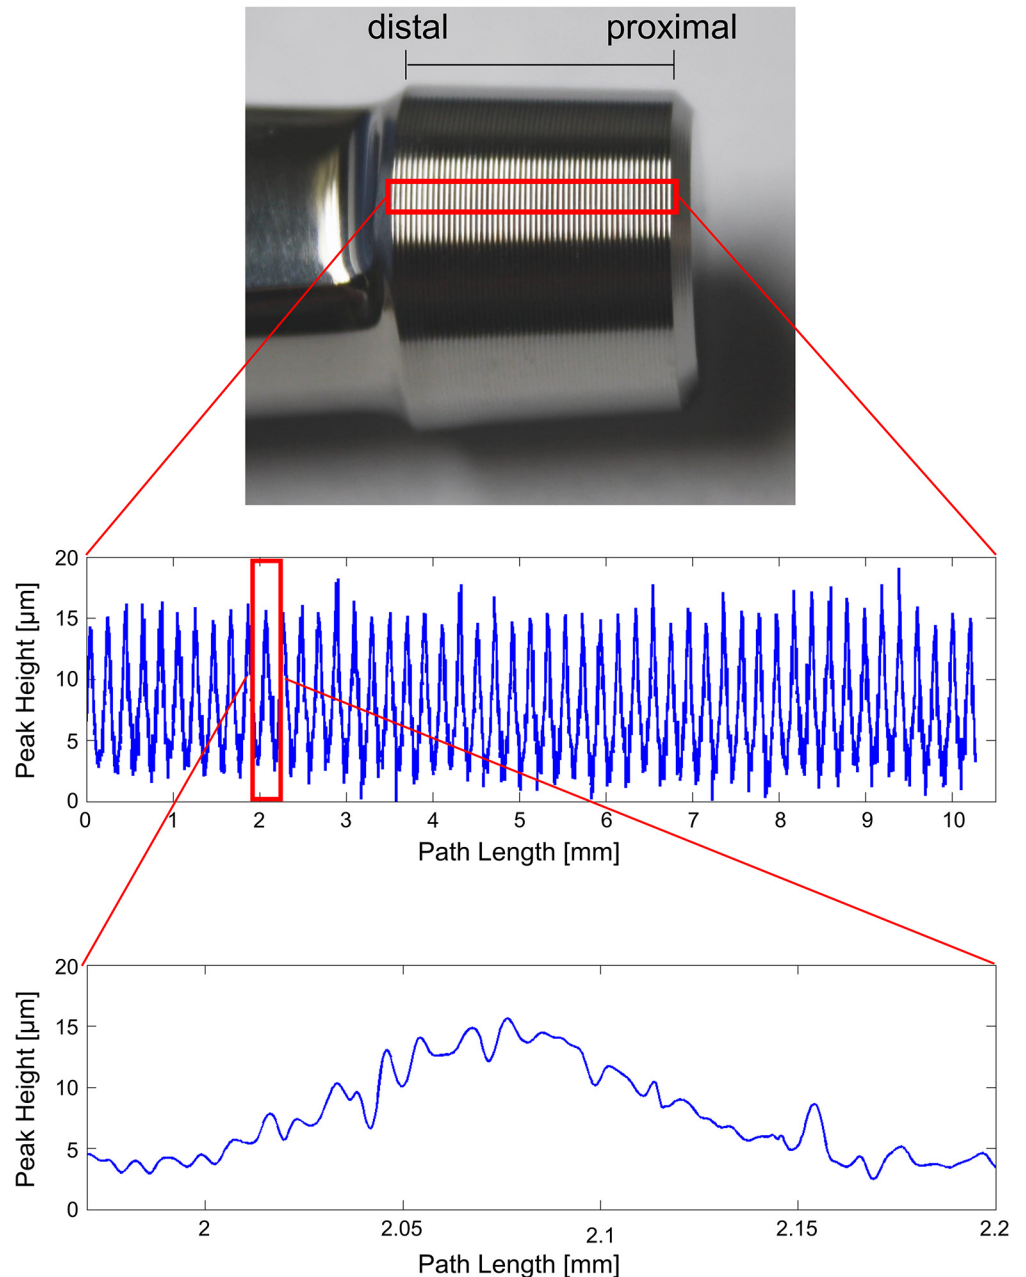
Fig 2. Stem Taper profile. Multiple measurements of the same stem region (red rectangle, top) were performed. A 100 μm wide path from distal to proximal was chosen to obtain a mean profile (middle). It is noted that each profile ridge demonstrates a surface roughness of about an order of magnitude smaller amplitude and period (bottom).

A regular wave profile was observed on the surface of the stem taper, with a wavelength of $\sim 200 \mu\text{m}$ and an amplitude of $\sim 10 \mu\text{m}$ (Fig 2). This profile is a right-handed thread spiral, with 51 ridges along the length of the taper. This manufactured surface profile was superimposed by a surface wave of shorter wavelength and lower amplitude (by roughly an order of magnitude).

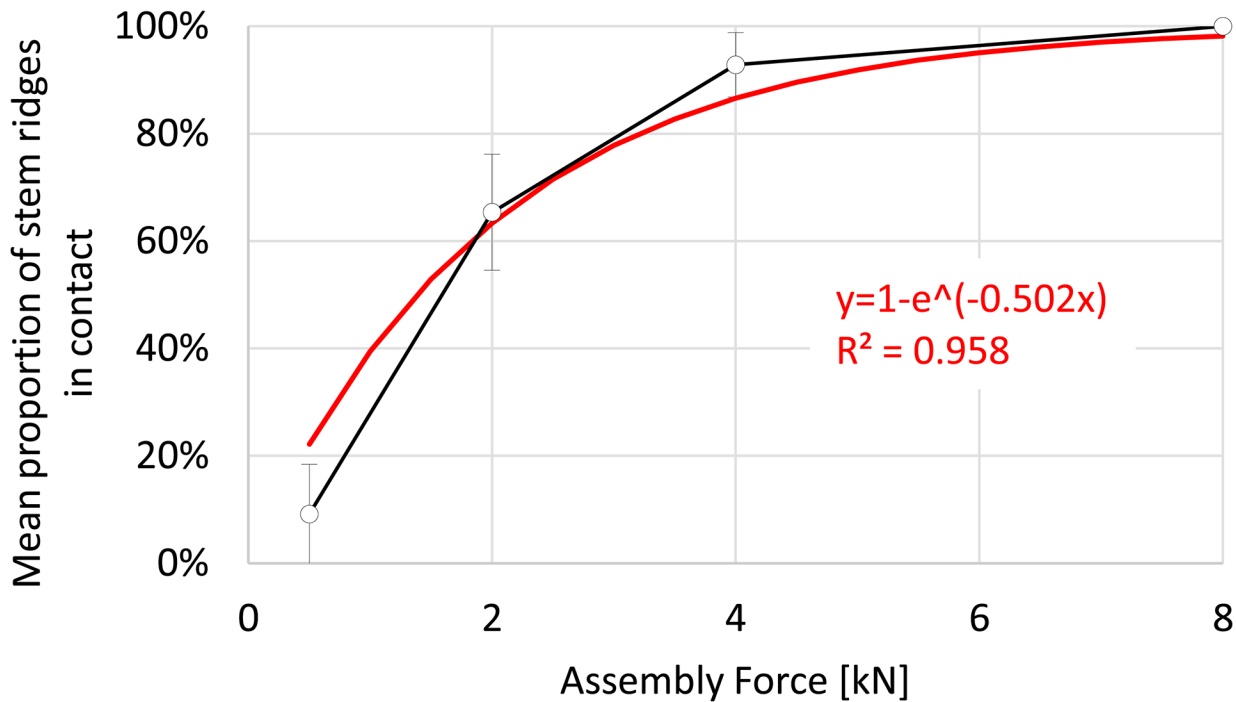
Fig 5. Stem taper ridges in contact. With increasing assembly force an increasing number of stem taper surface ridges came into contact with the head taper surface. For an assembly force of 8000 N all stem taper surface ridges were in contact.

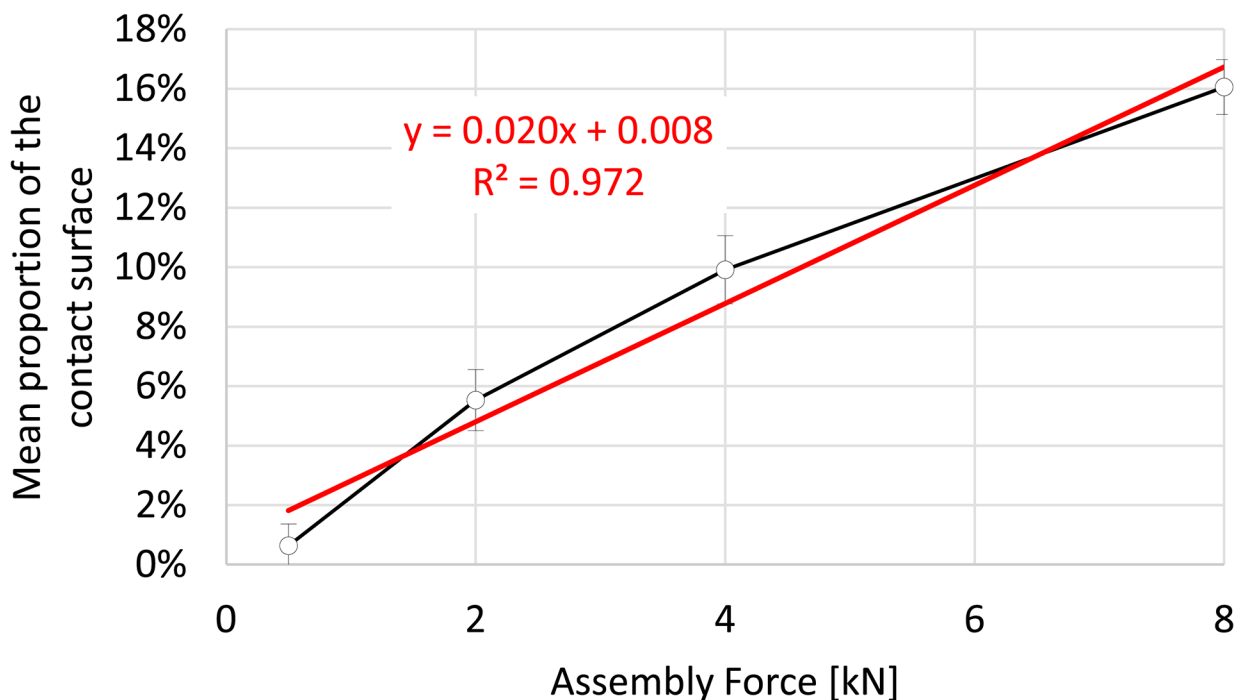
Fig 6. Stem contact area. With increasing assembly force a linear increase of the proportion of the surface in contact was observed.

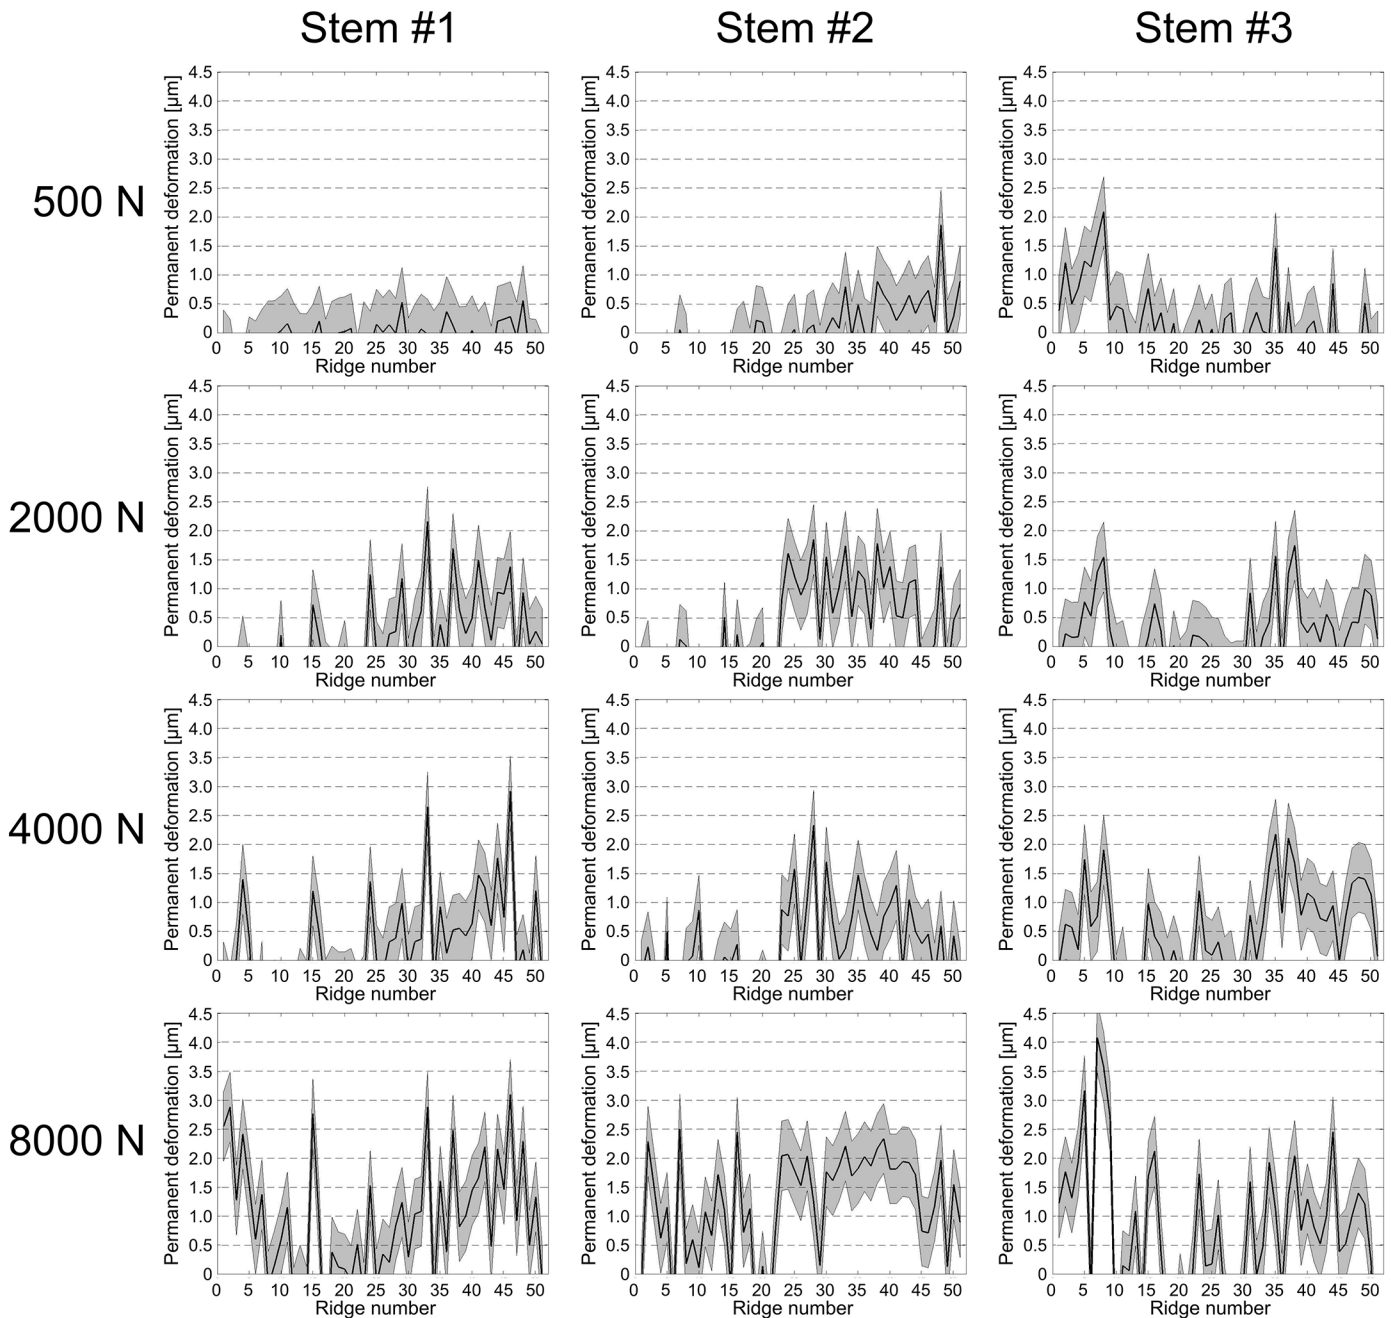
Fig 7. Permanent radial deformation of the stem taper surface profile. The height difference of the stem taper profile between assembled and original condition for each ridge is plotted as a black line, with the measurement accuracy (0.6 µm) in grey.

The distribution of permanent deformation of the ridges was irregular along the length of the taper surface and varied between the three specimens according to the respective contact patterns (Fig 7). Not all of the ridges demonstrated permanent deformation, even for the highest assembly force of 8000 N (for which contact with every ridge was demonstrated). The maximum permanent deformation measured was $3.5 \mu\text{m}$ at 8000 N. Permanent deformation of the wave profile was characterised by flattening of the ridges, which resulted in a material expansion at the sides (Fig 8). Similarly to the increasing number of ridges in contact and their area of contact with increasing assembly forces, mean ridge deformation over the taper length also increased with increasing assembly force (Fig 9). For an assembly force of 500N, the total mean deformation ($-0.05 \pm 0.14 \mu\text{m}$) was below the measuring accuracy. An assembly force of 2000 N resulted in a mean permanent ridge deformation of $0.1 \pm 0.14 \mu\text{m}$, an assembly force of 4000 N resulted in $0.21 \pm 0.22 \mu\text{m}$ and an assembly force of 8000 N resulted in $0.96 \pm 0.25 \mu\text{m}$. The increase of mean permanent deformation of the ridges was linearly related to assembly force ($R^2 = 0.953$, Fig 9). Significant differences in permanent ridge deformation were observed only for comparisons of 8000 N with lower assembly forces ($p \leq 0.009$).

magnitudes for all ridges, even for the high (8000 N) assembly force (Fig 7). A very high assembly force would be expected to generate the safest situation, with the greatest resistance to relative motion. However, assembly forces of 8000 N or higher, cannot be applied with hammer blows due to the risk of bone fracture. It is noted that lower proportions of permanent deformation for lower assembly forces do not suggest a poor local press fit, but simply indicate that stresses remained within the elastic range of the material.
