Initial experience with magnetic resonance imaging-safe pacemakers

A review

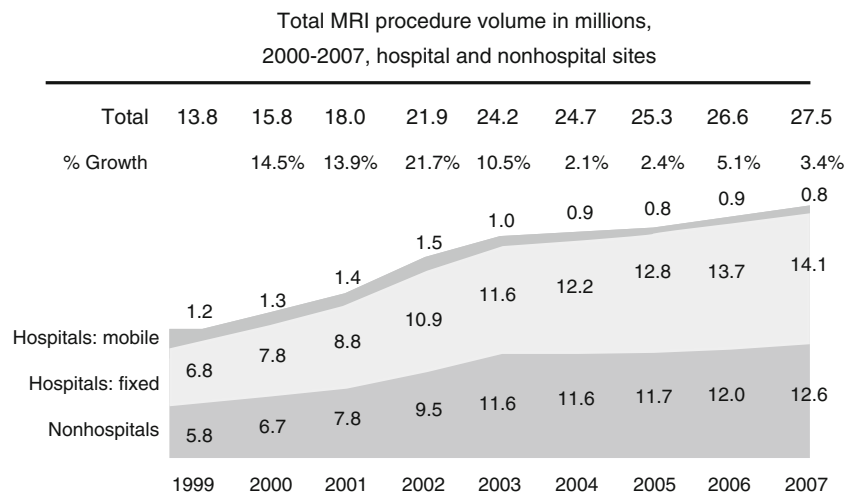
Fig. 1 Total MRI procedure volume in millions, 2000–2007, hospital and nonhospital sites [2]. Reprinted with permission from AuntMinnie.com

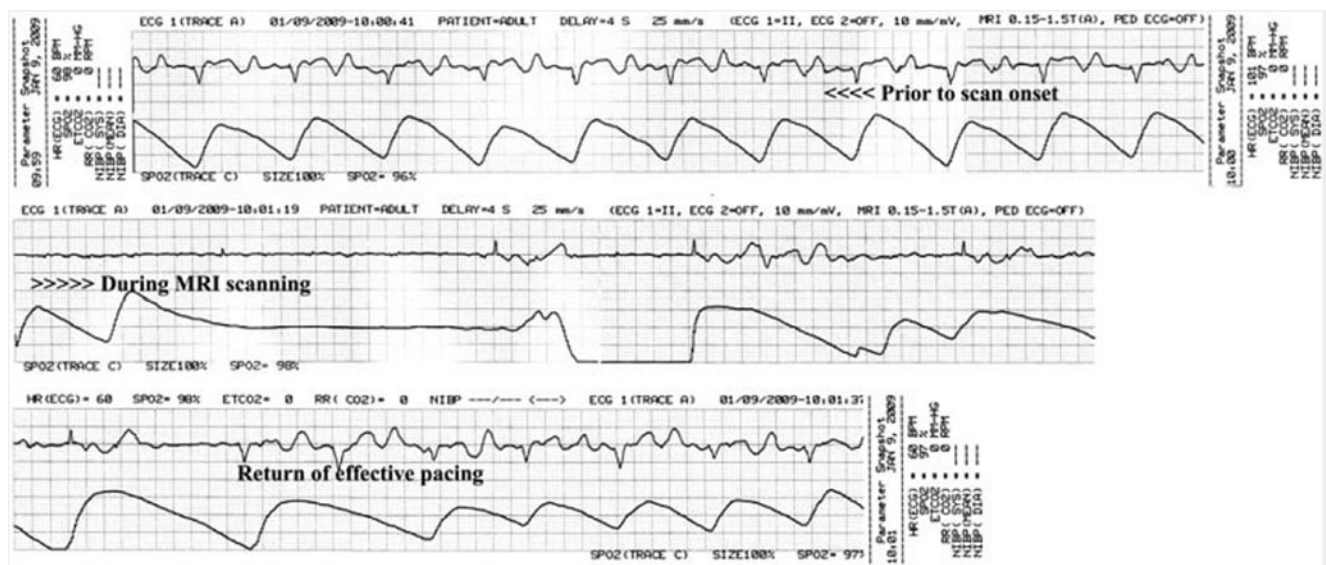
Fig. 2 Potential for inhibition of pacing [26]

The potential for inhibition of pacing is illustrated in Fig. 2 and was demonstrated in a study conducted by Mollerus and colleagues [13]. In this study 52 nonpacemaker-dependent patients with a total of 119 leads underwent 59 MRI scans of any landmark, using standard peak absorption rate settings for the scan. Devices were
