# Fatigue life and damage tolerance of postbuckled composite stiffened structures with indentation damage

The fatigue life and damage tolerance of composite stiffened panels with indentation damage are investigated experimentally using single-stringer compression specimens. The indentation damage was induced to one of the two flanges of the stringer of every panel. The advantages of indentation compared to impact are the simplicity of application, less dependence on boundary conditions, better controllability, and repeatability of the imparted damage. The tests were conducted using advanced instrumentation, including digital image correlation, passive thermography, and in situ ultrasonic scanning. Specimens with initial indentation damage ranging between 32 and 56 mm in length were tested quasi-statically and in fatigue, and the effects of cyclic load amplitude and damage size were studied. A means of comparison of the damage propagation rates and collapse loads based on a stress intensity measure and the Paris law is proposed. The stress intensity measure provides the means to compare the collapse loads of specimens with different damage types and damage sizes, while the Paris la

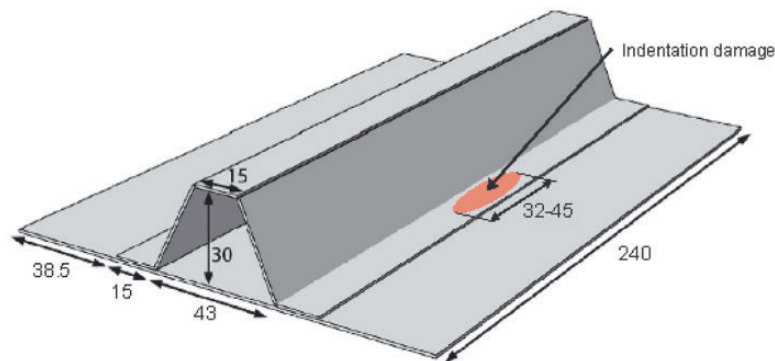
**Figure 1.** Single-stringer compression specimen (all dimensions in millimeter).

The SSC specimen is composed of a skin and a hat-shaped stringer. The dimensions of the test section of the specimen are shown in Figure 1. The skin consists of an eight-ply quasi-isotropic laminate with a stacking sequence of  $[45^\circ/90^\circ/-45^\circ/0^\circ]_S$  and a total thickness of 1 mm. The stringer consists of a seven-ply laminate with a symmetric stacking sequence of  $[-45^\circ/0^\circ/45^\circ/0^\circ/45^\circ/0^\circ/-45^\circ]$ , which results in a nominal thickness of 0.875 mm. The skin and stringer are cocured in an autoclave and the material is IM7/8552 prepreg tape. Tabs for load introduction are potted and machined at the ends of the specimen after the curing cycle. A more detailed description of the SSC specimen can be found in the literature.<sup>12–16</sup>

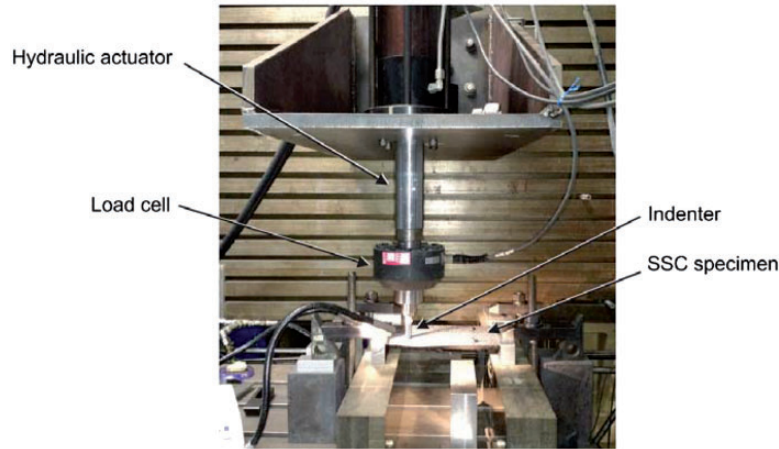
**Figure 2.** Hydraulic indenter used to induce initial damage onto flange of SSC specimens.

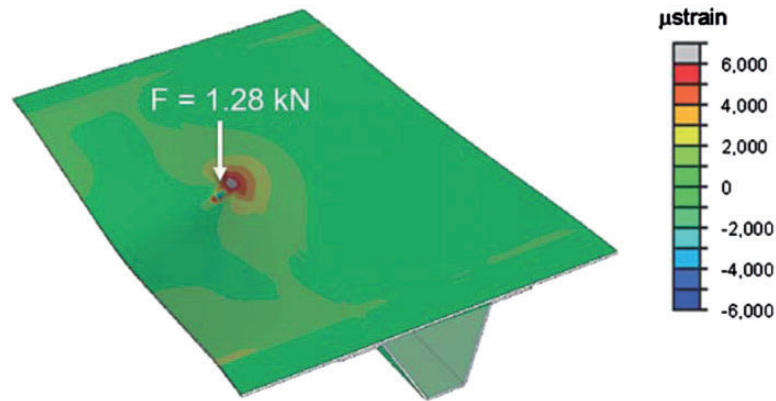
**Figure 3.** Strain plot for finite element damage model of indentation with an applied load of 1.28 kN.

To ensure that the indentation force would not cause damage in locations outside of the indentation zone, a finite element model of the indentation process was constructed using Abaqus/Std v6.14 finite element code.<sup>17</sup> The model of the SSC specimen developed in the previous studies<sup>12,13,16</sup> was used for this investigation. This model consists of two layers of S4R shell elements representing the skin and the stiffener. Wall offsets were applied so that the nodes for both shell layers were coincident in the flange sections of the stringer. The two layers are connected with COH3D8 cohesive elements. The material properties used are listed in Table 1. The analysis results, shown in Figure 3, indicate that at 1.28 kN, the predicted load for initiation of indentation damage, the strains do not exceed 4000  $\mu$ strain anywhere outside of the immediate indentation zone. Since the fiber and matrix strains to

failure for IM7/8553 are greater than 10,000  $\mu$ strain, these results indicate that no damage other than local indentation damage will occur in the panel for loads below 2.8 kN. The analysis was not carried past the damage initiation load because the shell model is inadequate for larger amounts of damage.

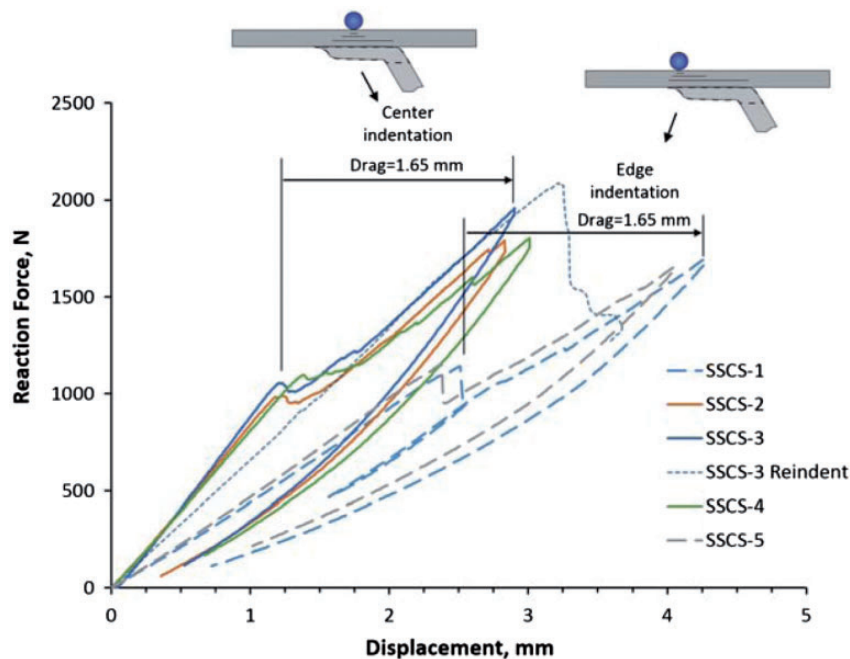
**Figure 4.** Force–displacement curves of indentations performed on specimens SSCS-1–5.

Five specimens, referred to as SSCS-1–5, were tested. Specimens SSCS-1 and SSCS-5 were indented under the flange termination (edge indentation), and the three remaining specimens were indented at the center of the flange (center indentation). Representations of the locations of both indentations are shown at the top of Figure 4.

one of two locations: at the center of the flange and at the edge of the flange. The load–displacement responses of the indentation process for all five specimens are shown in Figure 4. Although the center and edge indentation points are only 7 mm apart, the stiffness of the response for center indentations is considerably higher than that for edge indentations, as can be observed in Figure 4.

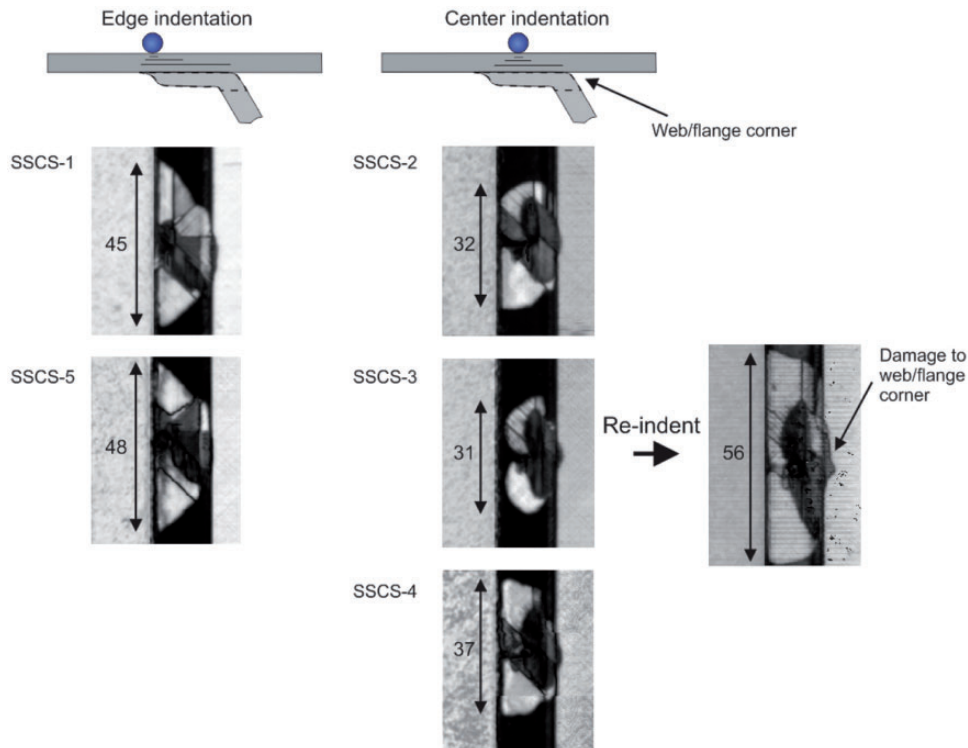
**Figure 5.** UT images of damage induced in specimens SSCS-1–5 by indenting at either the edge or the center of stringer flange. UT: ultrasonic testing.

UT images of the induced indentation damage for the five specimens are shown in Figure 5 with arrows illustrating the damage length in millimeter. An indenter drag of 1.65 mm induced a damage length of approximately 45 mm along the skin–stringer interface for the edge indentations, and approximately

35 mm for the center indentations. The longer damage length for the edge indentations, compared to the center indentations can be observed in Figure 5.

The damage length obtained by indenting SSCS-3 was considered too small for fatigue testing, so it was reindented using the same procedure as for the initial indentation. However, the initial 31 mm damage length grew unstably to 56 mm during reindentation. Additional damage was also observed at the web/flange corner, as called out in Figure 5.

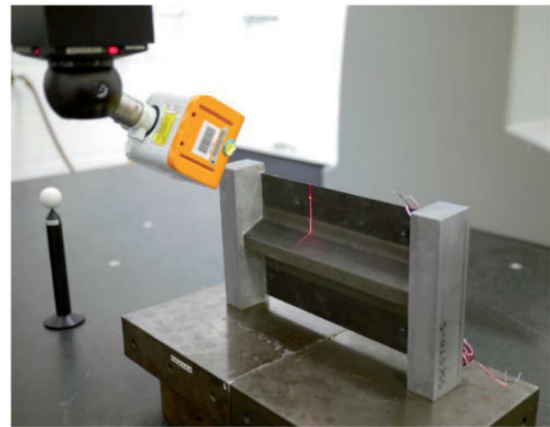
**Figure 6.** Laser scanning of indentation damage with CMM. CMM: coordinate measuring machine.

different postbuckling deformations,<sup>13,14</sup> the flatness of the skin of the specimens after the damage indentation was measured using the VIC-3D digital image correlation system.<sup>18</sup> In order to capture more detail, the depth of the indentation was also measured in a coordinate measuring machine (CMM), as shown in Figure 6. The resolution of the measurements taken with the laser scanning head shown in the figure is approximately 10  $\mu\text{m}$ .

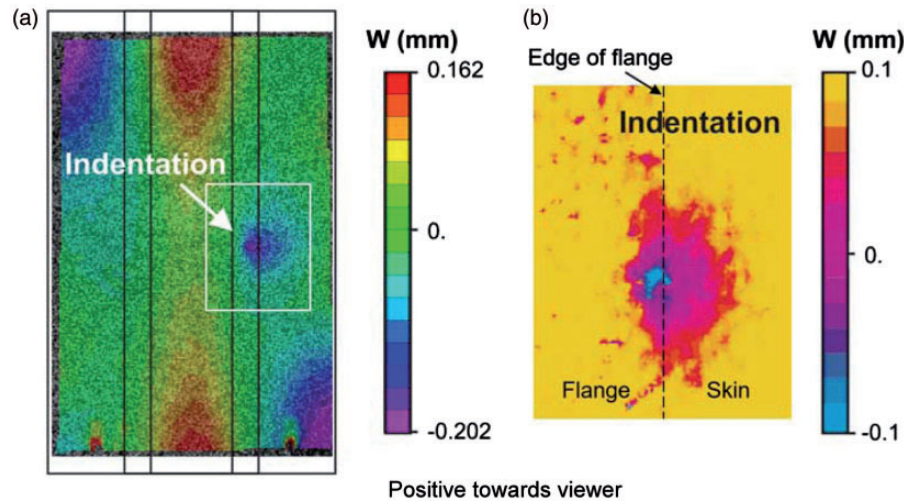
**Figure 7.** Global and local out-of-plane deformation after indentation for specimen SSCS-3. (a) Panel initial imperfection from VIC-3D and (b) local indentation depth measured from CMM. CMM: coordinate measuring machine.

A typical out-of-plane initial deformation of the skin measured with VIC-3D is shown in Figure 7(a). The nonflatness of the skin is mostly due to the residual thermal strains that develop from the curing process. It can also be observed that the panel has a slight twist. The amplitude of the deformations is approximately 0.4 mm, which is 40% of the skin thickness. A typical result from the CMM that provides details for the residual dent depth is shown in Figure 7(b). The residual indentation depth is approximately 0.1 mm.

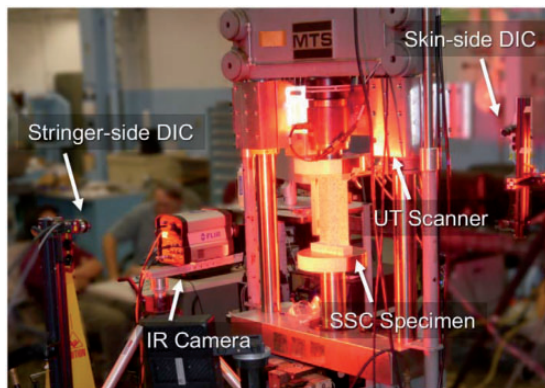
**Figure 8.** SSC specimen, load frame, and test instrumentation.

The tests were conducted using a uniaxial test frame and with instrumentation that allows a precise evaluation of the postbuckling response and damage. The test frame and the instrumentation shown in Figure 8 is the same as used in the previous test campaign conducted on SSC specimens with Teflon films and described in Dávila and Bisagni.<sup>16</sup> The primary instrumentation consists of (i) two three-dimensional digital image correlation (VIC-3D) systems<sup>18</sup> that are used to measure the postbuckling full-field deformations and strains on the skin and stringer sides of the specimen, (ii) an infrared camera for the passive thermal monitoring<sup>19</sup> with a frame rate of 60 Hz that can track the position of a delamination front during fatigue cycling, and (iii) an in situ UT scanner<sup>20</sup> mounted on the load frame which is used to obtain detailed measurements of the damage. The digital image correlation system acquired images at a rate of 0.2 Hz, the infrared camera at 60 Hz,

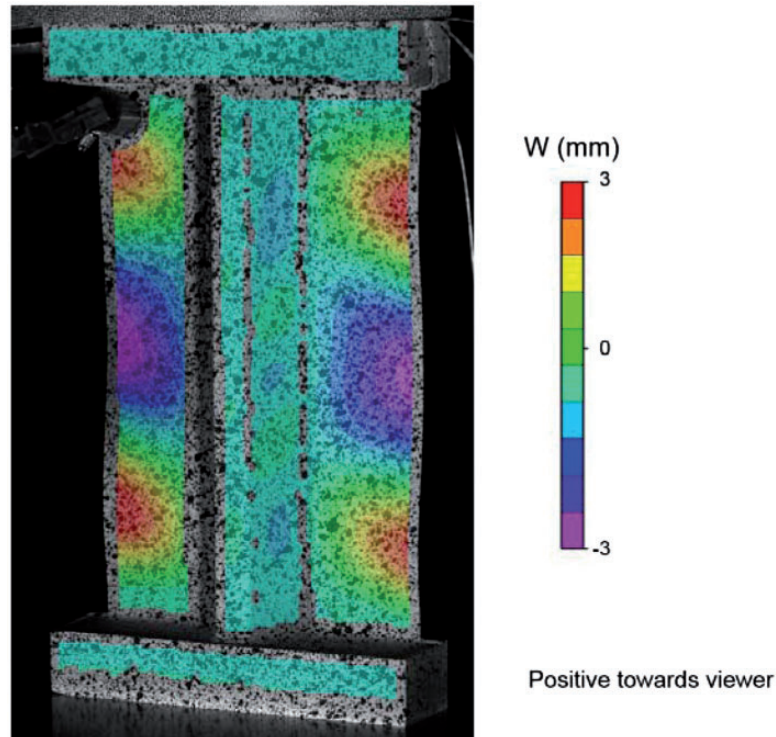
**Figure 9.** Out-of-plane displacement during quasi-static test of specimen SSCS-2 taken with VIC-3D from stiffener side immediately before collapse (34.5 kN).

The postbuckling deformation was characterized by a mode composed of three half waves along the length in the skin on both sides of the stiffener. The deformation at a load of 34.5 kN immediately before collapse is shown in Figure 9 using the out-of-plane displacements measured by the digital image correlation system. The deformation was symmetric with respect to two orthogonal planes and no damage was detected. The maximum amplitudes of the out-of-plane displacements at the center of the free edges were approximately 3 mm in the direction opposite to the viewer. The specimen collapsed suddenly, and the failure was characterized by a separation of the stringer from the

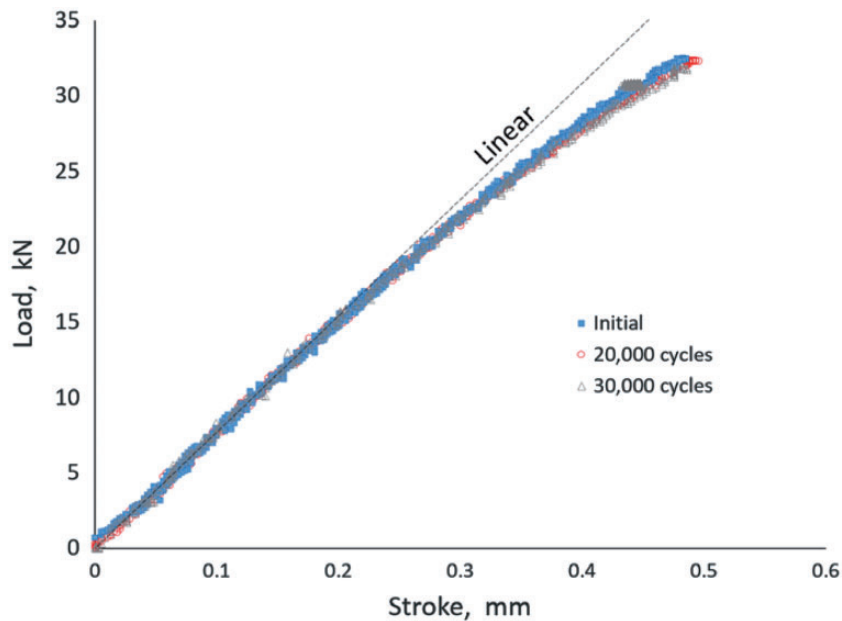
**Figure 11.** Quasi-static load-stroke curves at three stages of the fatigue life of specimen SSCS-5.

Quasi-static load-shortening curves for specimen SSCS-5 are shown in Figure 11, which is representative of what was observed for all specimens. It can be seen that the initial response is nearly identical to that at

20,000 and 30,000 cycles. Clearly, the global response of the SSC specimens retains a constant nonlinearity and is only mildly affected by the progression of fatigue damage. The specimen collapsed at 33,623 cycles.

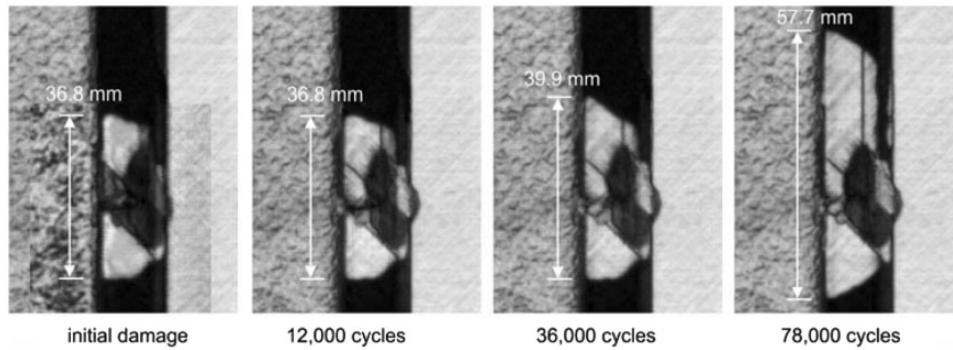
**Figure 12.** UT images showing damage propagation for specimen SSCS-4 at different cycle counts. UT: ultrasonic testing.

As was described earlier, the fatigue tests were conducted in stages so that UT scanning of the indented area of the panel could be performed at regular intervals. To illustrate the typical propagation of damage, a sequence of images for SSCS-4 obtained by the UT scans immediately after indentation and at 12,000, 36,000, and 78,000 cycles are shown in Figure 12. The

images show an extension of the initial skin–stringer separation along the length of the specimen. Collapse of the specimen occurred at cycle 78,135, shortly after the last image was taken.

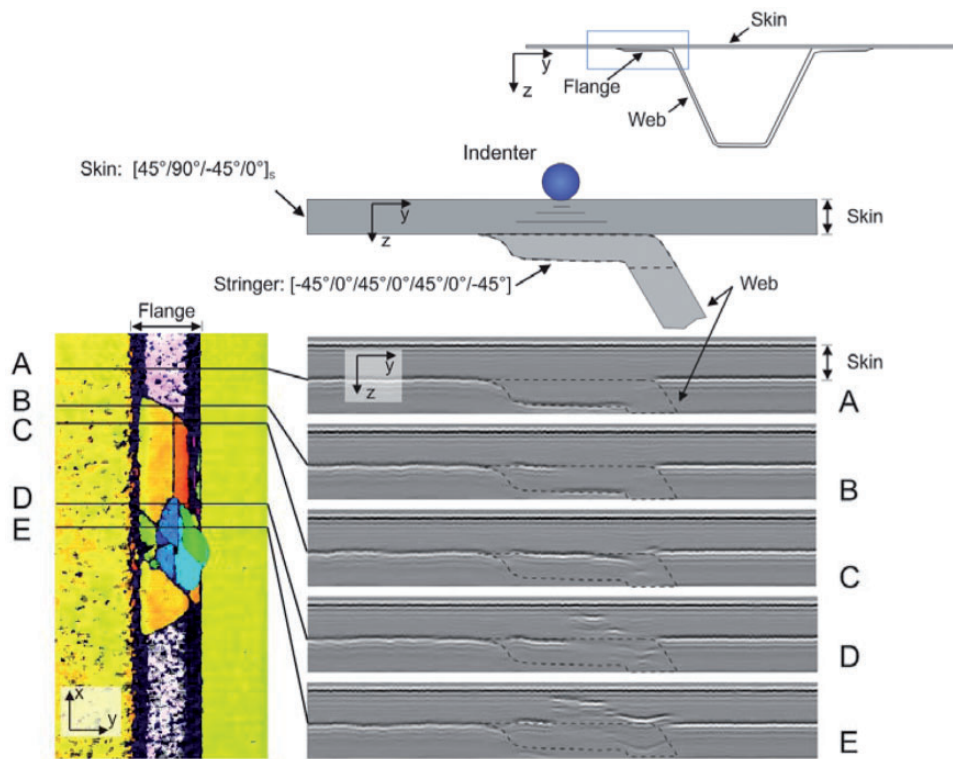
**Figure 13.** UT images using “time-of-flight” processing for depth location of delaminations (SSCS-4). UT: ultrasonic testing.

To examine the morphology of the damage, the UT scan of specimen SSCS-4 at 78,000 cycles was processed and colorized according to “time of flight” (TOF). TOF is the delay between the emitted ultrasonic sound wave and the reflected echo, which is a relative measure of the depth of the surface closest to the probe. The resulting image, shown in Figure 13, identifies the

depth of the various delaminations. Five cross-sections of the skin and stringer flange are examined. The results indicate that only two delaminations propagate during cyclic loading and that both delaminations propagate together: one interface is at the skin–stringer interface, and the other one is one-ply deep into the stringer flange, at the  $-45/0$  interface. The smaller delaminations in the skin do not appear to grow under fatigue.

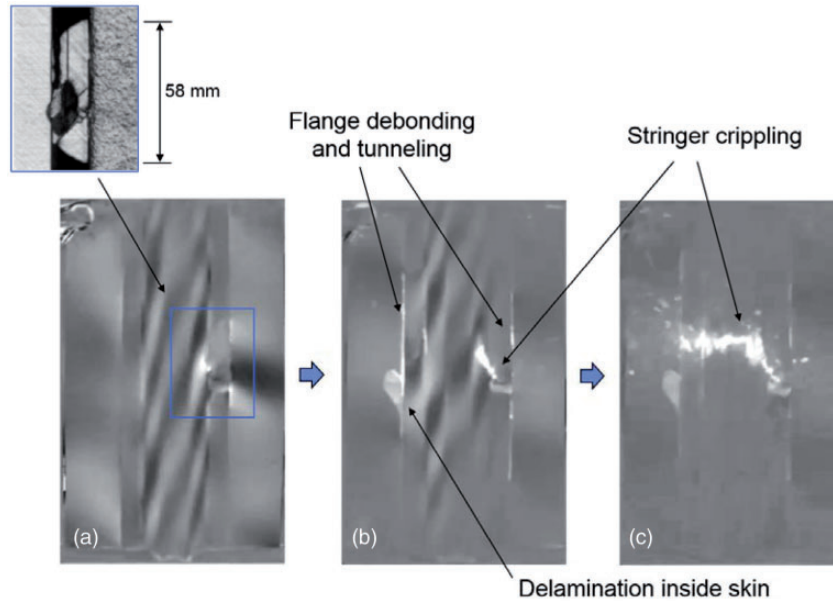
**Figure 14.** Infrared images illustrating sequence of collapse (SSCS-4). (a) Delamination reaches critical size, (b) unstable tunneling, and (c) stringer crippling.

loading, it was found to be particularly capable for capturing the sequence of damage events that occur during collapse. The sequence of three infrared images shown in Figure 14 illustrates the collapse of specimen SSCS-4 after 78,135 cycles. The heating, represented by lighter regions of the image, can be seen at the strain gauges and along the delamination front at the skin–stringer interface. The postbuckling deformation of the stringer appears as oblique lines in Figure 14(a). A faint outline of the damage at the skin–stringer interface can also be observed. A UT

image of the damage zone recorded after 78,000 cycles is shown for comparison, and the area of the UT scan is highlighted with the blue rectangle in Figure 14(a). Note that the thermal image was captured from the stringer side of the specimen, while the UT scans were performed from the skin side of the specimen. Therefore, the UT image was flipped horizontally to match the orientation of the infrared image.

The images in Figure 14(b) and (c) indicate that the collapse of the specimen, which occurs in about 1/60th of a second, consists of debonding of both flanges of the stringer, followed by the crippling failure of the stringer. In addition, a delamination internal to the skin grew in the region of the flange opposite to the initial indentation damage during the final instances of the collapse.

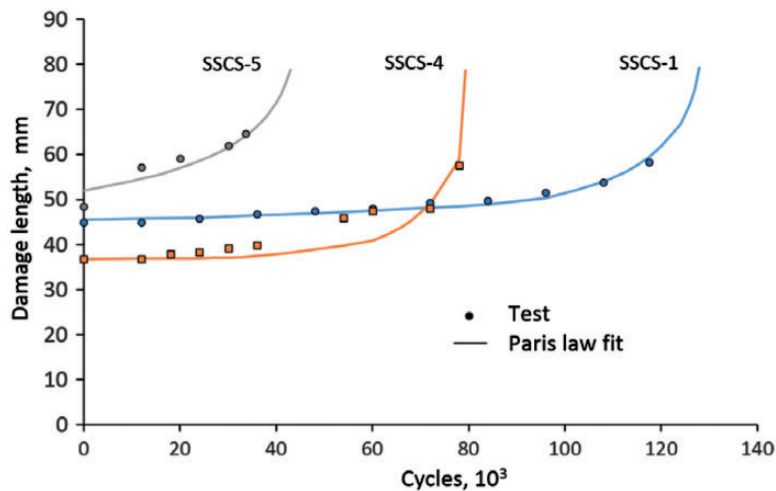
**Figure 15.** Damage length as a function of loading cycles for specimens SSCS-1, SSCS-4, and SSCS-5.

The results of the fatigue damage propagation are illustrated in Figure 15, where the experimental results are represented by symbols, and the lines correspond to the damage lengths calculated with the Paris law. Two values of *C* were determined by curve fitting: one for edge indentation and a different one for center indentation:  $C_{Edge} = 1 \times 10^{-36}$  and  $C_{Center} = 50 \times 10^{-36}$ . For simplicity, the exponent  $m = 14.9$  was kept the same for both types of indentations.

As can be observed in Figure 15, a single set of Paris law parameters provides a good fit to both specimens

with edge indentation (SSCS-1 and SSCS-5). This indicates that similar propagation laws characterize the damage growth in both specimens in spite of the differences in initial damage size and cyclic load. It is also apparent that the rate of propagation for center indentation (SSCS-4) is about 50 times higher than for edge indentation, perhaps because center indentation causes more damage toward the highly loaded web/flange corner than edge indentation.

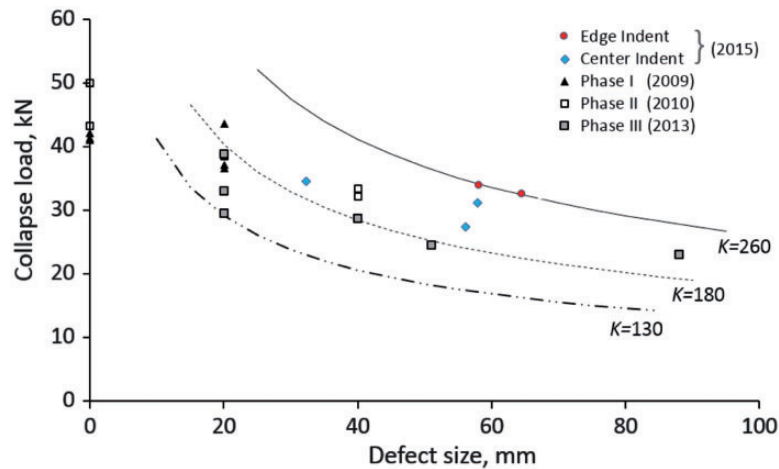
**Figure 16.** Effect of defect size on collapse load of SSC specimens.

a critical load that causes a collapse of a SSC specimen. The collapse load as a function of defect size is shown in Figure 16. In addition to the results from the phase IV test campaign, results from the three previous experimental phases<sup>12,14,16</sup> are included. For quasi-static tests, the defect size is the initial defect size, and for fatigue tests, the defect size is the damage length at the moment of collapse. The damage length at the moment of collapse is estimated by adding an incremental extension of the damage length calculated from the Paris Law equations determined above to the last measured damage length.

Following the concept used in the previous section, it may be useful to compare the results of different tests according to the stress intensity measure. Using Figure 16, it can be observed that the edge indentation specimens collapsed at approximately  $K = 260 \text{ kN} \times \text{mm}^{0.5}$ . The center indentation specimens failed within the range  $196 \leq K \leq 237 \text{ kN} \times \text{mm}^{0.5}$ . It appears that specimens from previous test campaigns failed at lower values of  $K$ , which indicates that indentation damage may be less severe than a Teflon insert of the same size. A number of additional contributing factors that deserve the attention of future work, such as the shape of the postbuckling deformation, also contribute to the damage tolerance of a postbuckled panel. Therefore, the proposed classification of the collapse strength of similar specimens according to their stress intensity measure provides a useful means to assess different aspects of the response on the damage tolerance of stiffened structures with defects.
