Zhenyu Zhang, Dongdong Liu, Xingqiao Deng *et al.*
The damage mechanism in copper studied using *in situ* TEM
nanoindentation

The damage mechanism in copper studied using *in situ* TEM nanoindentation†

Dong Wang,^{ab} Zhenyu Zhang,^{ID}*^a Dongdong Liu,^{*a} Xingqiao Deng,^{*c} Chunjing Shi,^d Yang Gu,^e Xiuqing Liu,^e Xiaoyu Liu^e and Wei Wen^f

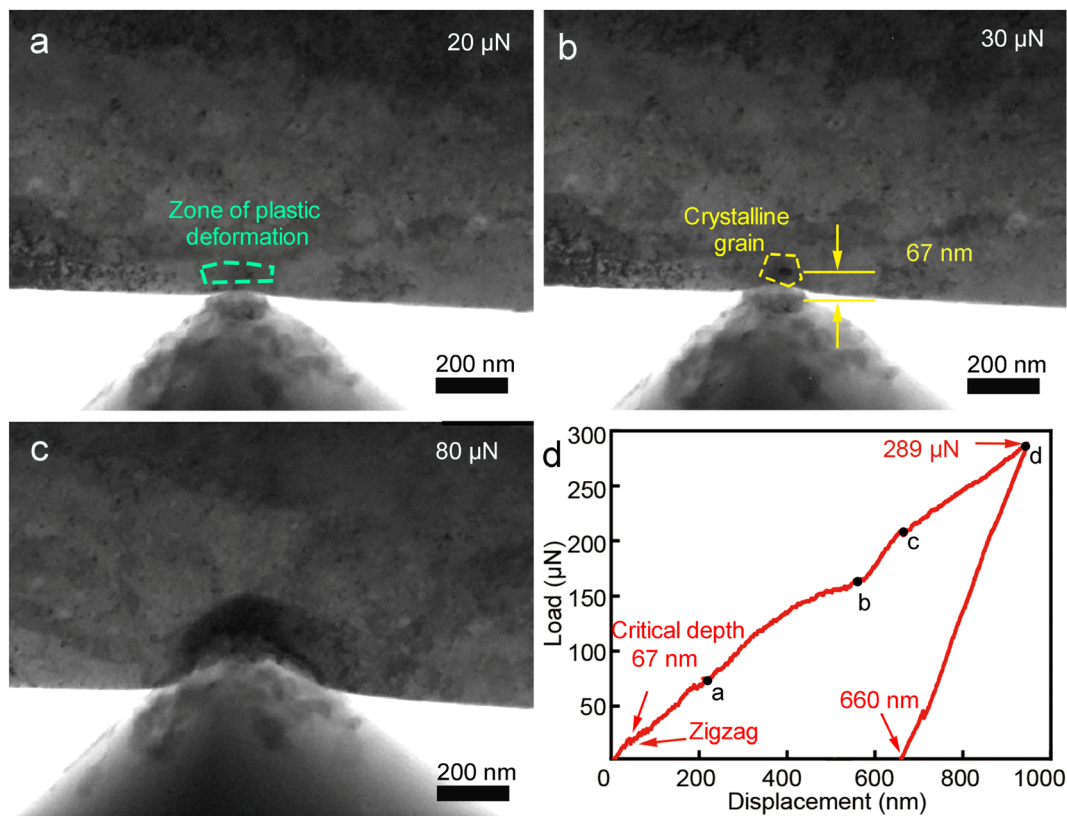
Fig. 1 Snapshots of TEM images of the nanoindentation area at sequential loads of (a) 20, (b) 30, and (c) 80 μN ; (d) load–displacement curve of nanoindentation.

In situ TEM nanoindentation was performed to interpret the damage mechanism of the copper surface during machining. Fig. 1 shows a series of video snapshots during *in situ* nanoindentation of single-crystal copper nanoplates under a range of

applied loads. Prior to indentation, the sample surface remained flat. As depicted in Fig. 1(a), upon applying a load of 20 μN with a depth of 45 nm, slight irreversible plastic deformation occurred on the sample surface, along with the appearance of a minor zigzag in the load–displacement curve (Fig. 1(d)). These features are attributed to dislocation and stacking fault formation, sudden stress release, and instantaneous load drop.³⁵ TEM imaging confirmed that plastic deformation occurred in the indentation area without the formation of new grains at 20 μN, as shown in Fig. 1(a). Continuing to increase the load to 30 μN, Fig. 1(b) marks the onset of small grain formation within the single crystal, observed at the tip of the diamond indenter. A nano-sized grain is evident within the sample, indicated by the blue dashed line in Fig. 1(b), and a sudden load drop was observed in the load–displacement curve, indicating grain breakage in the single-crystal nanoplate at a depth of 67 nm under 30 μN. Further increasing the load to 80 μN, corresponding to a displacement of 219 nm, as shown in Fig. 1(c), the nanoplate experienced severe plastic deformation accompanied by the generation of new grains. Moreover, the serrated features observed on the load–displacement curve are a result of significant grain fragmentation. With further increases in the load, plastic deformation primarily occurred during the ‘ab’ stage, accompanied by grain fracture. In the ‘bc’ stage, due to excessive loading, the entire nanoplate sample undergoes overall elastic deformation, along with plastic deformation. The stiffness during the ‘bc’ stage is greater than that during the ‘ab’ stage. Finally, during the ‘cd’ stage, the plastic deformation of the sample further increases, and severe irreversible plastic deformation occurs in the indentation area. Loading was concluded when the displacement reached 900 nm.

As stress levels escalated, the damaged area witnessed an initial onset of dislocation motion and the emergence of stacking faults. Subsequently, grain fracture took place. Stress during the sample loading process was meticulously calculated. As illustrated in Fig. 1(d), grain fracture occurred in mono-crystalline nanoplate when the load reached 30 μN, corresponding to a displacement of 67 nm. In the realm of nanoindentation experiments, the equation employed to calculate the stress is as follows³⁶

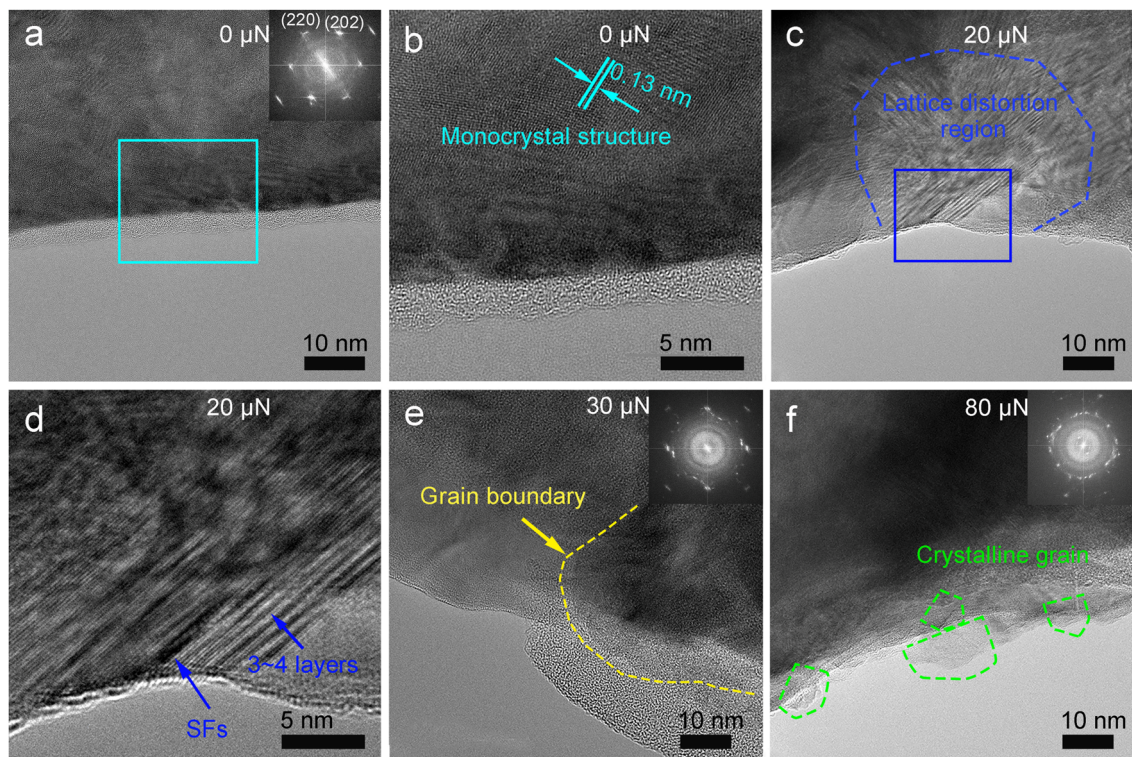
Fig. 2 HRTEM images of the damage evolution process at sequential loads of (a and b) 0, (c and d) 20, (e) 30, and (f) 80 μN . The insets of (a), (e), and (f) show the respective FFT patterns.

To further substantiate the above experimental results, a high-resolution observation of the damaged area was conducted. Fig. 2 presents an analysis of the damage structure of single-crystal copper nanoplates under different loads during

the *in situ* nanoindentation process. As shown in Fig. 2(a), before indentation, the sample surface remained single-crystalline, with a 2 nm amorphous layer originating from the FIB processing damage. Moreover, the inset of Fig. 2 further illustrates that the sample presents a monocrystalline state before indentation. In Fig. 2(b), the crystal plane on the vertical surface is (220), indicating that the loading direction is $\langle 220 \rangle$ orientation. In Fig. 2(c), when a load of 20 μN was applied, upon magnification of the indented area, a high density of dislocations can be observed beneath the indentation. These dislocations are distributed within a semi-spherical three-dimensional plastic deformation zone, indicating severe plastic deformation in the region near the center of the indenter. This plastic deformation zone has also been observed in other metals and alloys, consistent with the traditional nanoindentation plasticity theories.^{38–40} Further magnification of the region near the indenter center revealed a significant number of stacking faults with a width of 3 to 4 atomic plane spacings (Fig. 2(d)). As the load increases to 30 μN , high-resolution characterization of the damaged surface, as shown in Fig. 2(e), revealed a larger grain on the upper right side of the indented area, as marked by the yellow dotted line. Further, the fast Fourier transform (FFT) pattern presents multiple sets of diffraction spots (inset of Fig. 2(e)). This suggests that at 30 μN , the damage mechanism in the indented area transitions from stacking faults to grain fragmentation. When the load reaches 80 μN , structural

characterization of the damaged region, as shown in Fig. 2(f), reveals multiple fractured grains at the center of the indentation. The FFT pattern shows polycrystalline characteristics (inset of Fig. 2(f)). This indicates that with increasing stress, larger grains further undergo fragmentation and transform into smaller grains, namely, grain refinement.

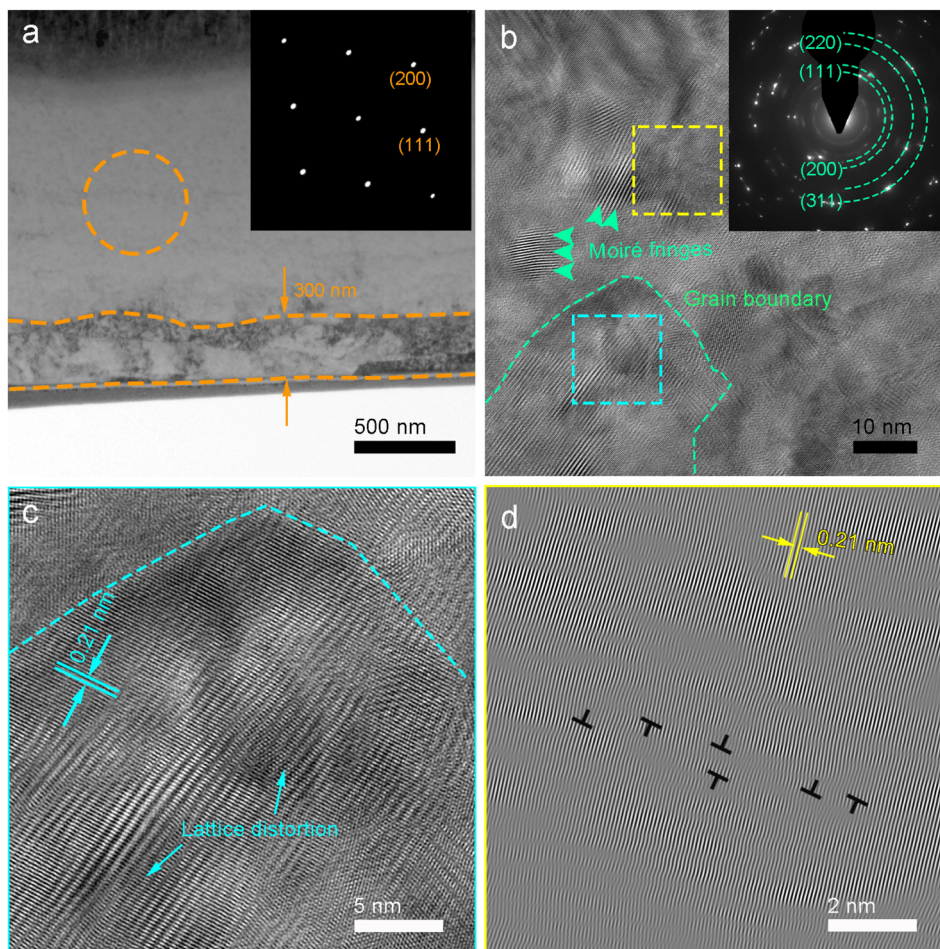
Fig. 4 TEM characterization of copper subsurface after lapping. (a) A low magnification TEM image of subsurface damage, (b) an enlarged TEM image of the damaged area, (c and d) high-resolution TEM images obtained to visualize the damaged area, with distinct damage types corresponding to specific zones marked by cyan (c) and yellow (d) squares. The insets in (a) and (b) are their SAED patterns.

defects.^{41,42} Fig. 4 presents the TEM results for lapping with consolidated abrasive. In Fig. 4(a), the TEM investigation unveiled that the thickness of the lapping-induced damaged layer was 300 nm. Before lapping, the copper sample demonstrated a remarkably monocrystalline state, as visually depicted in the inset of Fig. 4(a). Nevertheless, following the lapping procedure, a transition from a monocrystalline pattern to a polycrystalline state was observed in Fig. 4(b), which indicates grain breakage happening during lapping. The damaged area was further analyzed to gain deeper insights into the damage types that arose from the lapping process. In the lower leftmost region of the damage site, monocrystal structural breakage occurred due to the presence of high abrasive stress. This resulted in the emergence of conspicuous moiré fringes and grain boundaries, as indicated by the green arrows and dotted line in Fig. 4(b). These fringes originate from the overlapping and intersection of two crystalline grains.⁴³ Additionally, within the fractured crystal grains (Fig. 4(c)), regions of severe lattice distortion became apparent. Moving further into the interior of the damaged layer, as the abrasive stress diminishes, a distinct dislocation becomes discernible, clearly delineated by the

yellow square (Fig. 4(d)). The inverse fast Fourier transform (IFFT) image, focusing on the region indicated by the yellow square in Fig. 4(b), unveils the presence of edge dislocations within the inner zone of the damaged layer.

In short, the damaged layer encompasses a variety of components, namely moiré fringes, grain boundaries, and edge dislocations. Within the outermost portion of the damage layer, the predominant form of damage consists of fractured grains. Nevertheless, by delving deeper into the damaged layer, defects assume a more significant role.

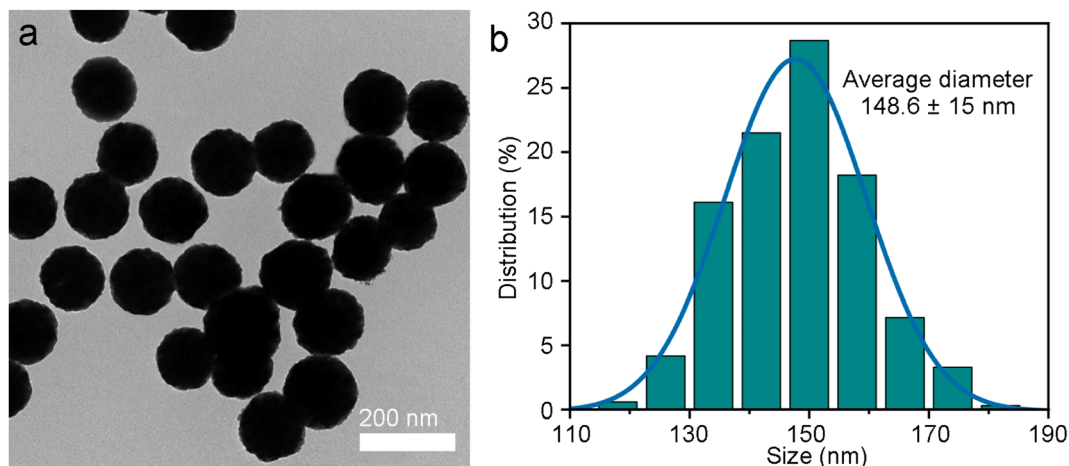
Fig. 5 (a) TEM image and (b) particle size distribution of CeO_2 abrasives.

Mechanical polishing is a precision polishing technology, that mainly relies on very fine polishing powder or polishing slurry lapping, rolling action, removing a layer of extremely thin material on the surface of the sample until the required smoothness is reached.⁴⁴ Fig. 5(a) shows the TEM image of ceria abrasive particles, indicating uniform dispersion of ceria. Particle size statistics revealed a normal distribution for ceria particles, with an average abrasive diameter of 148 nm (Fig. 5(b)).

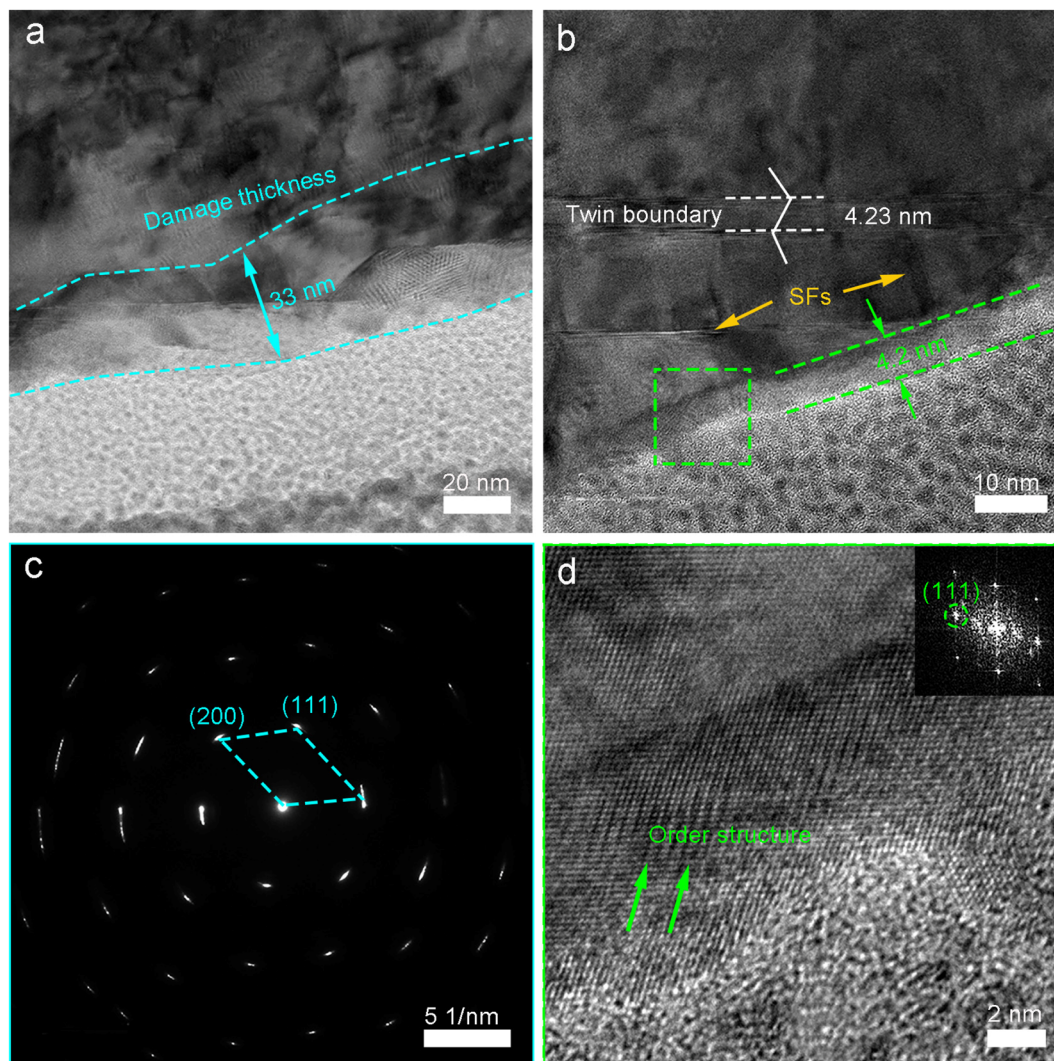
Fig. 6 (a) TEM characterization of the copper subsurface after mechanical polishing. (a) The low magnification TEM image of subsurface damage. (b) enlarged TEM image of the damaged area, (c) a SAED pattern of (a), and (d) HRTEM image of the green square in (b).

TEM. A low magnification TEM image presents a cross-sectional perspective of a mechanically polished surface, demonstrating a measured damage layer thickness of 33 nanometers (Fig. 6(a)). Additionally, the polished surface retained its monocrystalline structure (inset in Fig. 6(c)). Furthermore, the structure of the damage layer was observed. As depicted in Fig. 6(b), sporadic defects, including twin structures and stacking faults, were evident in the inner region. Notably, the width of these twin structures was measured at approximately 4.23 nm. The formation of an ordered periodic structure, as demonstrated in Fig. 6(d), was initiated through the alignment of the AB-type structure of two (111) planes within the superficial region, resulting from the vast stacking fault structure. In short, as the depth of the damage layer increases, the stress experienced by the sample gradually decreases, and the defect density also decreases accordingly.

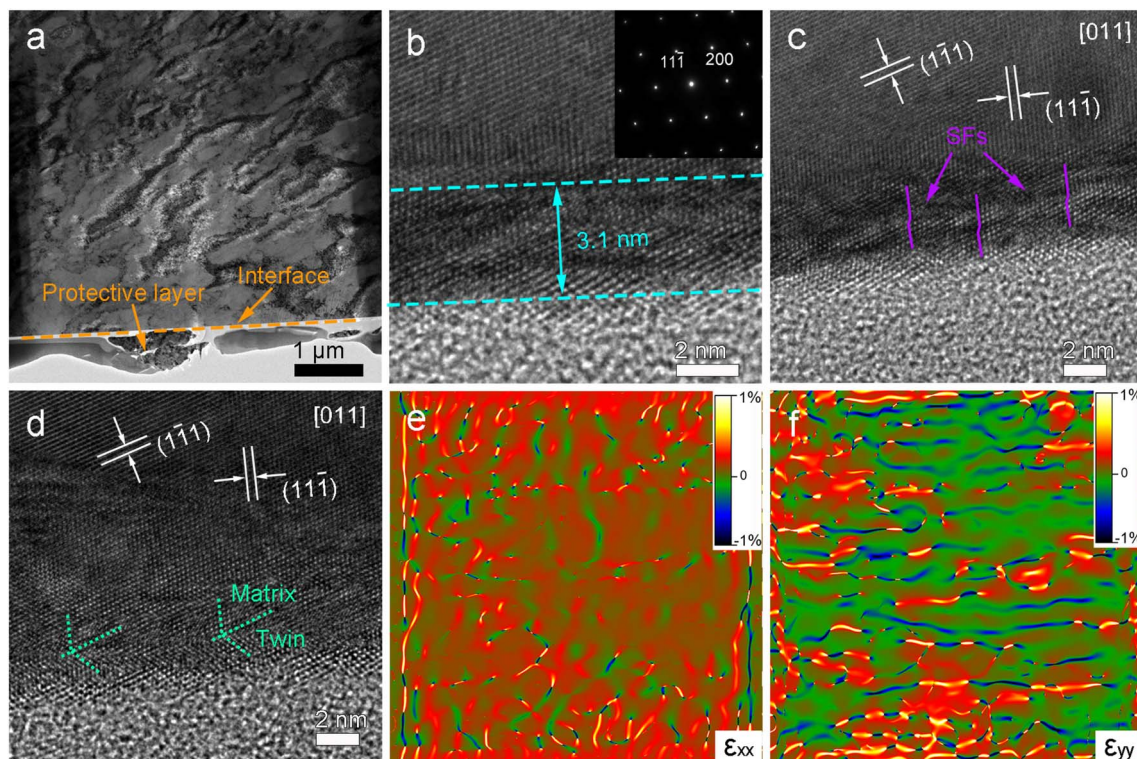
Fig. 7 TEM characterization of the copper subsurface after chemical mechanical polishing. (a) A low-magnification cross-sectional TEM image of subsurface and surface damage, (b) enlarged TEM image of the damaged area, (c) and (d) HRTEM images of different structure defects in different damaged regions, strains maps (e) ε_{xx} and (f) ε_{yy} obtained by GPA. The inset in (b) shows the SAED pattern of (b).

After conducting CMP, a TEM cross-section sample was meticulously prepared by employing FIB technology, enabling an in-depth analysis of the damage incurred during the polishing process. As illustrated in Fig. 7(a), a protective layer was strategically employed to shield the damaged layer from the potentially deleterious effects of the ion beam. Within the subsurface realm of the copper sample, a remarkable preservation of its single-crystal state was observed, as vividly presented in the inset of Fig. 7(b). Subsequently, upon scrutinizing the damaged area with precision, it was determined that the thickness of the damaged layer on the polished copper wafer was measured at a mere 3.1 nm, as depicted in Fig. 7(b). Furthermore, diverse damaged areas at distinct locations were meticulously characterized, revealing the presence of stacking faults composed of single-layer atoms, as impeccably exemplified in Fig. 7(c). Fig. 7(d) offers valuable insights into the core structure of twins, each measuring approximately 2 nm in length. To comprehensively assess the stress introduced by the polishing process, a microstrain analysis was conducted on the high-resolution TEM image employing geometric phase analysis (GPA) techniques, as elaborated in prior studies.^{45,46} The strain maps meticulously charted the variations along $[11\bar{1}]$ and

$[200]$ directions (Fig. 7(b)). Within these strain maps, regions colored blue denoted compressive strain, whereas red and green regions signified tensile strain and an absence of strain, respectively. Notably, a conspicuous variation in strain was particularly pronounced along the $[11\bar{1}]$ direction, whereas the $[200]$ direction exhibited a notable lack of substantial stress distribution (ϵ_{xx} in Fig. 7(e)). It is worth mentioning the presence of a considerable degree of compressive stress between the $(11\bar{1})$ planes (ϵ_{yy} in Fig. 7(f)). The findings highlight that the CMP technology generates processing stress, notably manifesting in a direction parallel to the wafer's surface.

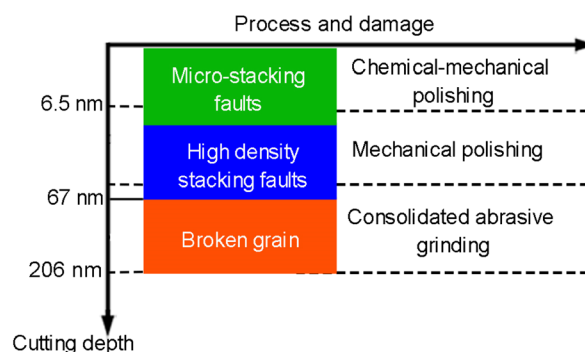
Fig. 8 Diagram of damage evolution under different process conditions.

Cutting depth is a crucial parameter that affects the quality of machining surfaces and the structure of the damage layer. According to the above experimental results, a relationship between the cutting depth and the damage generated during precision machining is established. The cutting depth for different processes was calculated, with specific details explained in the ESI.† The surface damage layer produced by the lapping process contains defects such as lattice distortions, broken grains, and edge dislocations. The surface of the sample was subjected to higher lapping stress, resulting in more severe damage, with a large number of broken grains in the damaged layer. The subsurface, on the other hand, experiences lower lapping stress, leading to relatively lower damage, characterized

by the presence of numerous crystal defects such as high-density stacking faults in the damaged layer (Fig. 8). During the mechanical polishing process, the stress on the copper surface exceeds the MPa level.¹⁹ The damaged layer contains a significant amount of dislocation structures, and the density of dislocations decreases with increasing depth of the damaged layer. Moreover, in chemical mechanical polishing, copper atoms are collectively removed under mechanical and chemical action, forming micro-stacking faults composed of only a few atomic layers on the surface (Fig. 8). In high-precision machining, severe damage caused by broken grains significantly affects the surface quality and material mechanical
