Article

Damage Development on the Surface of Nickel Coating in the Initial Period of Erosion

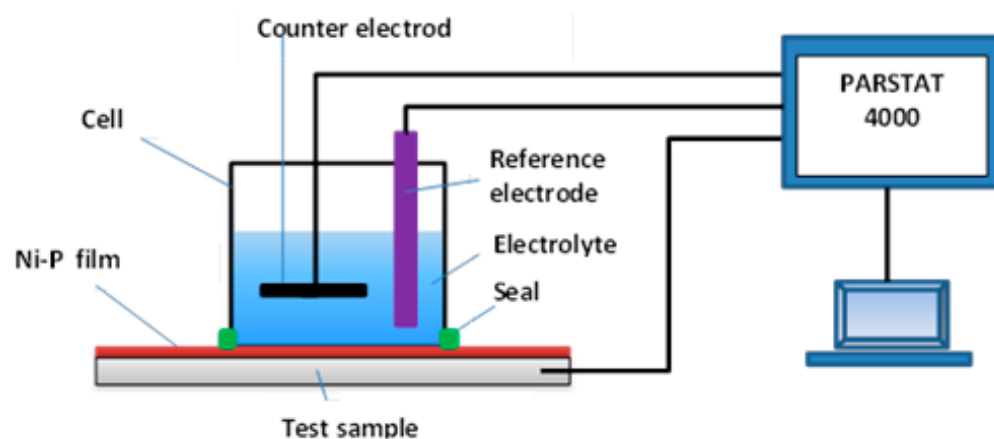
Figure 1. Scheme of the system for measuring the resting potential.

The electrochemical measurements of the nickel coatings were performed in 35 g dm^{-3} NaCl electrolyte. The solution was prepared from ppa chemicals. The electrochemical measurements were performed with the potentiostat galvanostat EIS Analyzer PARSTAT 4000 made by AMETEK (Oak Ridge, TN, USA). A dedicated cell working with three-electrode mode was used (Figure 1). A platinum foil was used as a counter electrode and an Ag | AgCl electrode in the saturated KCl solution was used as a reference electrode. The coated sample was used as a working electrode.

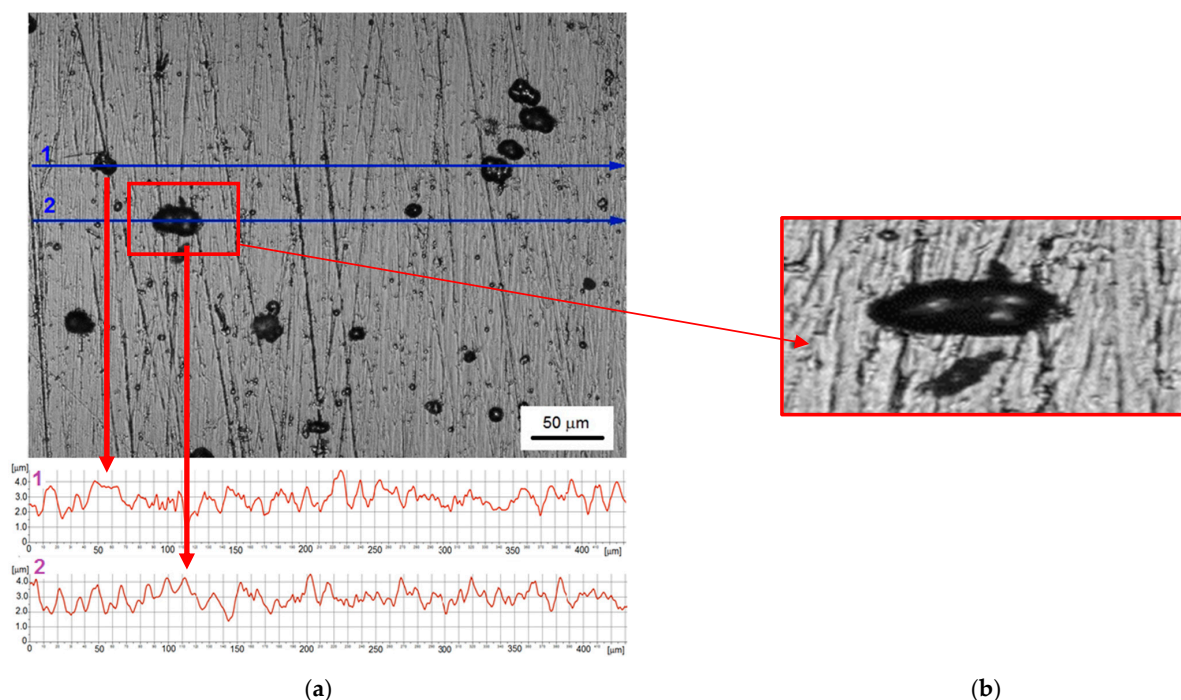
Figure 2. Nickel coating before cavitation erosion tests: (a) surface morphology with roughness profiles along the selected measurement lines; (b) 3D profile of a surface defect.

The Ni coating investigated in the presented studies is shown in Figure 2. The microscopic observation revealed the coating reflected the substrate very well and numerous defects with diameters ranging from 2 μm to even 46 μm were formed. The median size of defects was 9.6 μm the standard deviation was 8.7 μm . In addition, the roughness measurements showed that the surface unevenness had a height up to 2.5 μm and the defects were convex. Nevertheless, the coating was applied evenly to the substrate, and the observed unevenness was due to the unevenness of the substrate surface due to the low thickness of the nickel coating (about 10 μm).

The microscopic observations of the coating before cavitation tests showed that the surface irregularities were reflected by the coating due to its small thickness. However, the height of surface unevenness decreased by about 0.8 μm : from $2.63 \pm 0.29 \mu\text{m}$ to about 2 μm . In addition, defects with a wide range of diameters were formed during coating deposition. According to [49], defects in electroless Ni coatings are related to the phosphorus content and coating thickness. Thus, the cause of the numerous and large defects was likely the high content of phosphorus.

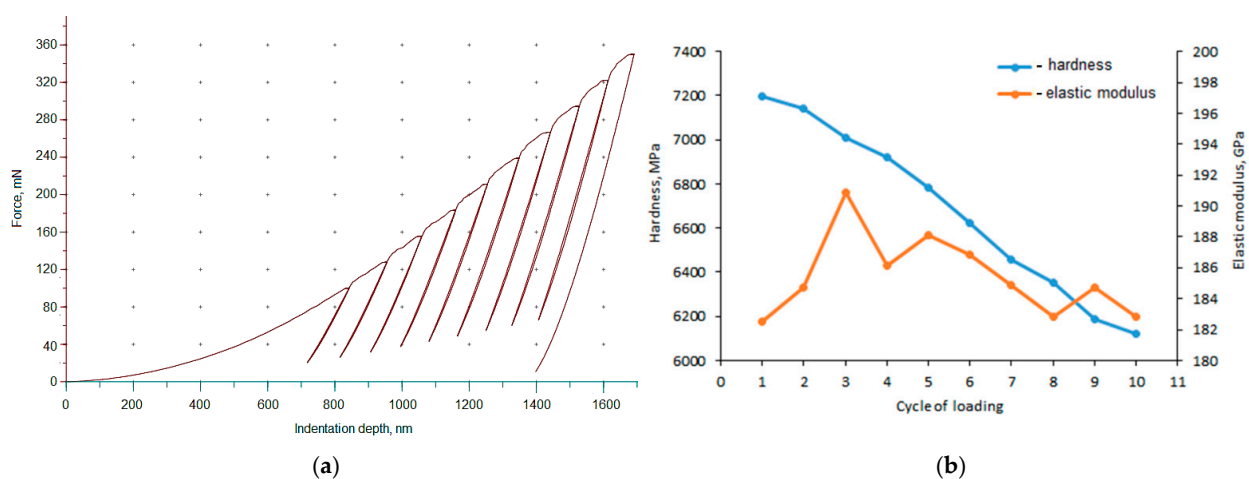
Figure 3. Force versus indentation depth curves for a Ni–P coating: (a) hardness and elastic modulus change with loading cycle (b).

The results of cycling loading are shown in Figure 3. The first load caused an indentation depth of about 0.8 μm , so it was less than 1/10 of coating thickness. With increasing cycles of load, the indentation depth increased as well. The maximum indentation depth during the third cycle was approx. 1.05 μm . Thus, starting from the third cycle, the indentation depth was higher than 1/10 of the coating thickness and the substrate began to have an influence on the results obtained. After all cycles, the maximum indentation depth was approx. 1.7 μm and the permanent indentation depth was 1.4 μm . With the increasing number of cycles, hardness decreased. After 10 cycles, hardness decreased over 1000 MPa. Thus, the softening effect occurred. In addition, the bigger drop of hardness arisen at the third cycle, which is related to the depth of indentation. However, the subsequent cycles resulted in a steady drop in hardness at a rate of 150 MPa per cycle. The modulus of elasticity increased during the first three cycles but then decreased. This study shows that the cyclic load significantly influenced the hardness and modulus of elasticity of the tested Ni–P coating and steel substrate, especially after the 3rd cycle, when the depth of the indentation is so deep that the substrate influences the deformation process of the entire coating-substrate system. Changes in hardness and modulus of elasticity made the coating more susceptible to plastic deformation.

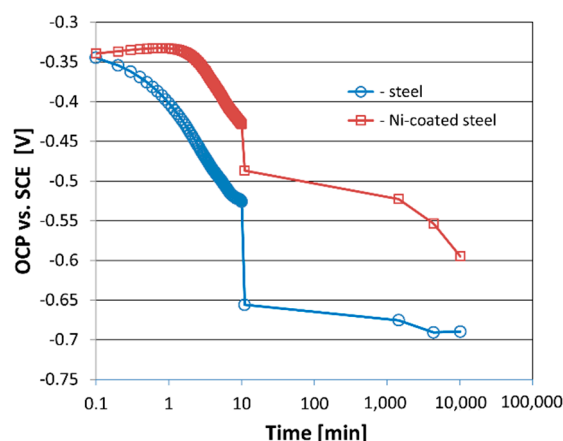
Figure 4. The dependence of the electrode potential versus the time after immersion to 3.5% NaCl solution.

The open circuit potential (OCP) value and its change within immersion time indicate resistivity of the coating against corrosion processes. The OCP data acquisition was started immediately after the introduction of the sample to the solution (c.a. 10 s after immersion of the sample). The measurements were recorded non-linearly. In the first 10 min, the measurement was performed every second. Then the period between the following measurements was extended to 1, 5, 24, 72, and 168 h, respectively. The OCP results are collected in Figure 4. The OCP measurements on Ni–P layer coated steel are compared to the Nimax steel substrate. The OCP value for Ni–P coated steel is found higher more than 100 mV when compared to the Nimax steel. Such behavior indicates corrosion protection of steel substrate by Ni–P coating. The observed slight increase of the OCP value for Ni–P coated steel at the very beginning of corrosion process can be assigned to the change in corrosion process at Ni–P surface caused by adsorption of $[\text{PO}_4]^{3-}$ ions as suggested by Lee et al. [40]. The observed lack of stabilization of the corrosion process for Ni–P coating after relatively long time of 10,000 min, can be a result of pits formation under the coating layer [40–42].

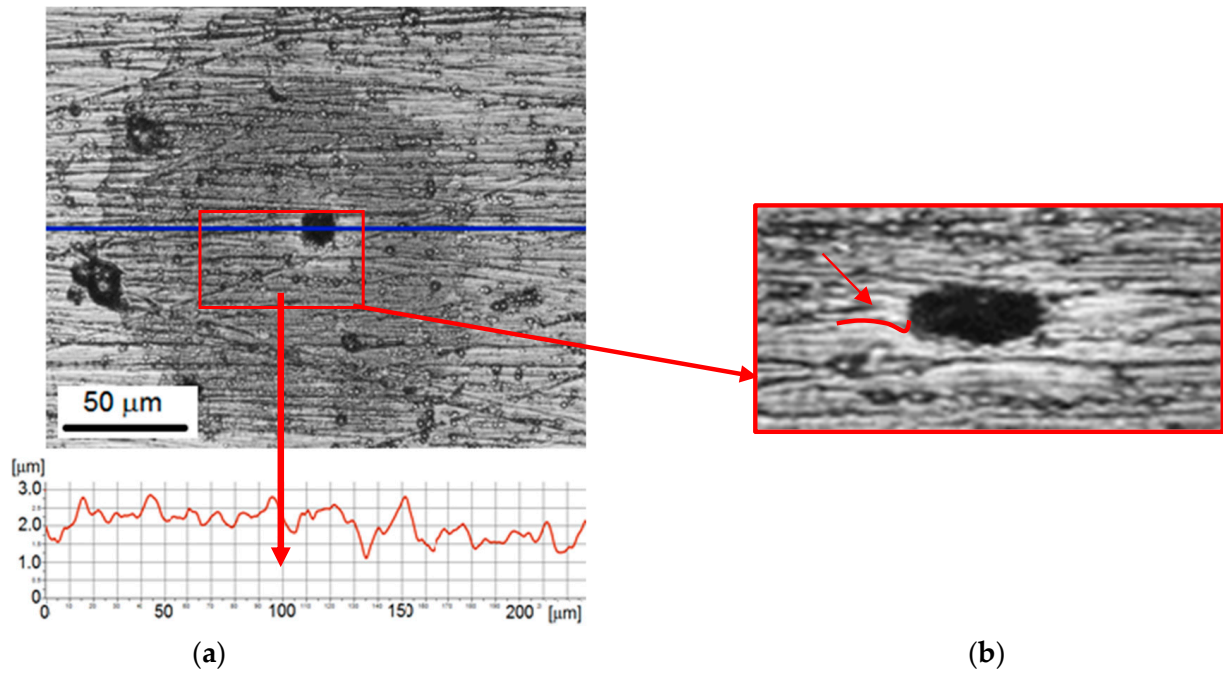
Figure 7. Nickel coating after 10 min of the cavitation erosion tests: (a) surface morphology with roughness profile along the selected measurement line; (b) 3D surface profile.

Microscopic observations of the surface after 10 min of the cavitation test revealed circular shadings around the formed cavities on the observed surface (Figure 7). The round shading has become darker and more pronounced. The diameter of shaded circles around the pits was in a range from $200\ \mu\text{m}$ to $400\ \mu\text{m}$, while the diameter of the pit from $20\ \mu\text{m}$ to about $30\ \mu\text{m}$. Thus, the pit diameter was comparable to 5 min of testing. However, the edge of the pit was no longer concave but became convex (denoted by a red line and an arrow). The appearance of shading may be related to the oxidation of nickel (corrosion of nickel). According to research by Suslicek et al. [43], in the last stage of cavitation bubbles collapsing, the temperature inside the bubble exceeds $1000\ \text{K}$, and can even reach $5000\ \text{K}$. The high temperature and water environment in which cavitation tests are carried out meet the conditions necessary for the nickel oxidation process. The product of nickel oxidation is nickel oxide (NiO), which in the form of a thin film covers the eroded surface [44]. The performed observations showed that the appearance of shadows did not affect the 3D profile and surface roughness profile. The round shape of the shadows, in line with the shape of the imploding cavitation bubble, is also consistent with the assumption of nickel oxidation made. Thus, the observed shadows may be a thin layer of nickel oxide. On the other hand, it is known that the generated temperature inside the bubble drops sharply as a result of flowing cold water. It follows that only those cavitation bubbles that are in direct contact with the coating contribute to the oxidation of nickel and the formation of the observed dark shadows.

Extending the test duration to 10 min did not affect the pit diameter, but increased the shading diameter almost 3 times. Such a large increase in the diameter of the shading may be caused by the softening of the coating, as shown by the research on the influence of cyclic loading. Because of the decrease in the hardness of the coating, the coating deformed more due to the collapse of the bubble, which increased the contact surface with the coating. The effect of high temperature described before could likely lead to an acceleration of the oxidation process and the increase of the shading diameter.

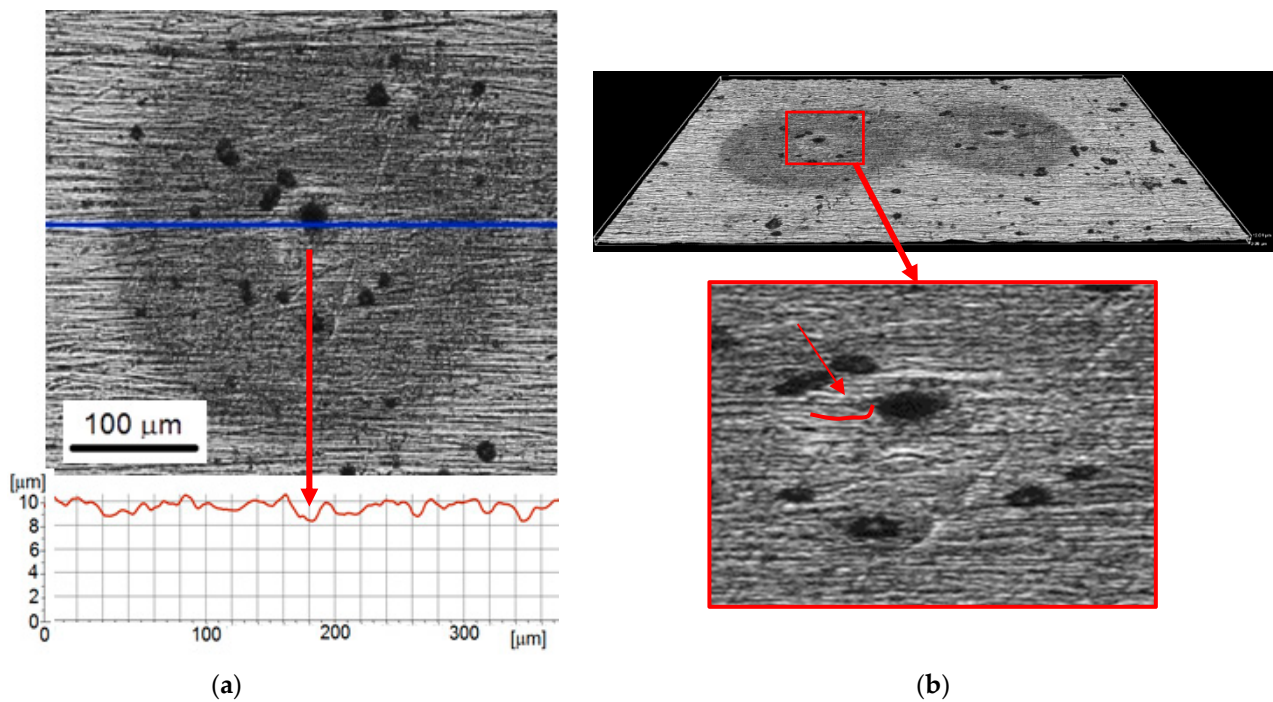
Figure 8. Nickel coating after 30 min of the cavitation erosion tests: (a) surface morphology with roughness profile along the selected measurement line; (b) 3D surface profile.

Extending the test duration to 30 min slightly affected the diameter of the shadows but had a significant effect on the change in the diameter of the pits (Figure 8). The diameter of shadows was about 300–400 μm , while the diameter of the pits was in the range from 20 to 40 μm . Thus, the diameter of the pits increased. In addition, Figure 8b shows that pits had a characteristic shape: the surface just around the pit was slightly convex, and next to it was concave. The roughness profile (Figure 8a) shows the pit depth of about 2 μm . As the possibilities of surface analysis with an optical profilometer are limited, the formation of a microcrack at the bottom of this pit cannot be excluded. This damage shape was likely the reason for corrosion development. Corrosion tests (c.f. Section 3.2) have shown lower corrosion resistance of the steel substrate in comparison to the Ni coating. The other factor influencing the development of corrosion was an increase in stress level in the coating. Elongation of the test duration means an increase in the number of impacting cavitation pulses. Although some of them are too weak to cause a pit in the hard nickel coating, they are able to supply some of the impact energy and stresses to the surface layer. The increase in stresses promotes the acceleration of corrosion processes.

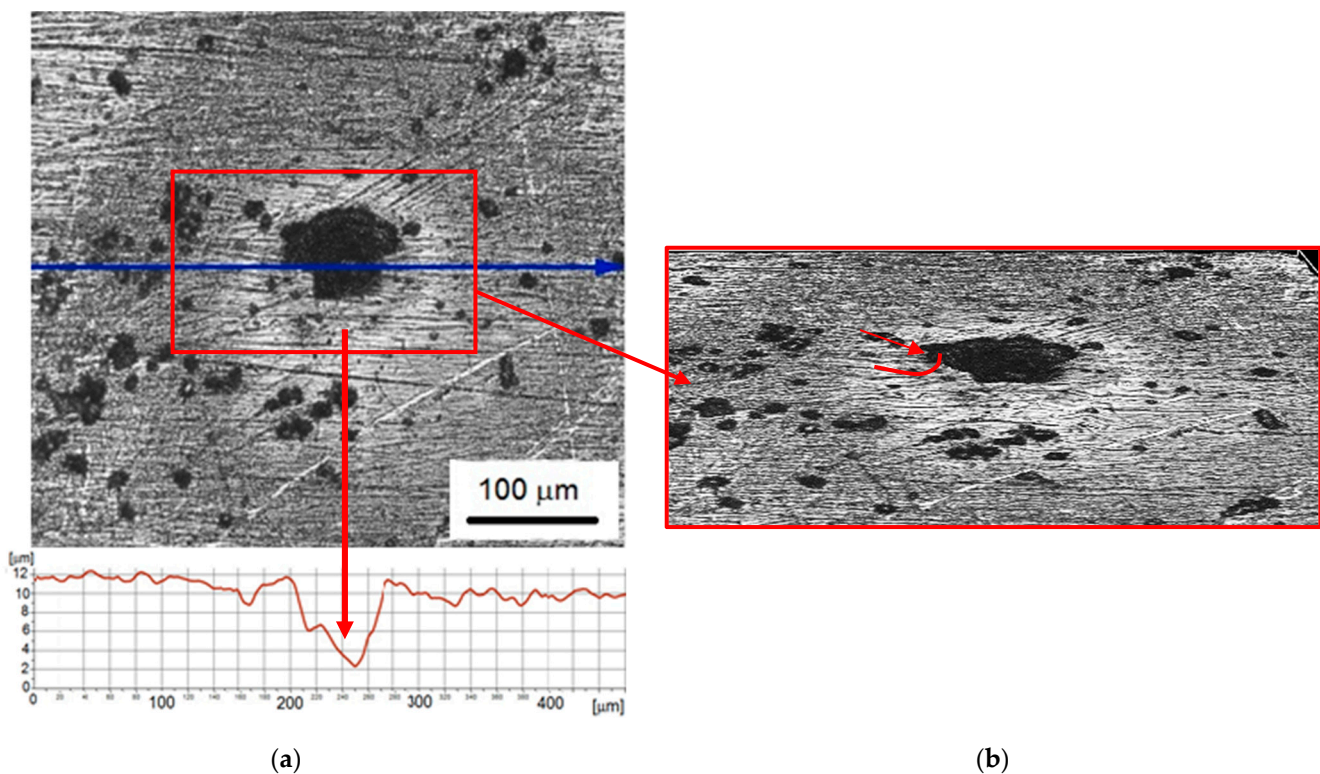
Figure 9. Nickel coating after 60 min of the cavitation erosion tests: (a) surface morphology with roughness profile along the selected measurement line; (b) 3D surface profile.

With the increase of the exposure time to 60 min, the previously formed pits increased in diameter and depth (Figure 9a). The diameter of the pits ranged from about 35 μm to about 75 μm , the depth of the pit shown was 10 μm . Moreover, the diameter of the shadows around the pits increased even to 450 μm . The volcanic shape of the rim of the pit is even more visible—the edge of the pit became more and more convex. The conducted research shows that pitting corrosion accelerated with the increase of the duration of the cavitation erosion test. Pitting corrosion occurred in the form of pits initiated at the site of damage to the passive oxide layer. The damaged pits were the anode where the steel dissolves. Due to the small area of the anode, corrosion developed deeper into the tested steel. Moreover, the surroundings of the pitting were the cathode, and oxygen reduction could take place there. Corrosion pits can also have a negative effect by acting as stress risers. Fatigue and stress corrosion cracking may start at the base of corrosion pits [24,36,37].

Further extending the test duration to 60 min increased the pit diameter to 75 μm , the pit depth to 10 μm , and the diameter of the shadows to 450 μm . Thus, the diameter of the pits and round shadows still increased with the duration of the test. More than a twofold increase in the pit diameter (from 30 to 75 μm) indicates that the decrease in coating hardness was so great that the micro-jet was able to cause puncture and removal of the coating. This development of the degradation process was also influenced by the difference in the electronegativity of the coating and the substrate and the increase in a complex stress state, which favored galvanic corrosion. The steel becomes the anode and the coating becomes the cathode. The resulting galvanic currents concentrate on the anode with a small area, which accelerates the anodic dissolution reaction [55,56]. Due to the lower corrosion resistance of the substrate steel and the introduced state of stress, the degradation of the coating-substrate system developed mainly in the steel substrate.
