Mitigating bit flips or single event upsets in epilepsy neurostimulators[☆]

Alice X. Dong^a, Ryder P. Gwinn^b, Nicole M. Warner^b, Lisa M. Caylor^b, Michael J. Doherty^{b,*}^a Department of Biochemistry, University of Washington, Seattle, WA 98105, USA^b Swedish Epilepsy Center, 550 17th Ave Suite 540, Seattle, WA 98122, USA

Objectives: The objective of this study was to review software errors known as single event upsets (SEUs) or bit flips due to cosmic rays in epilepsy neurostimulators.

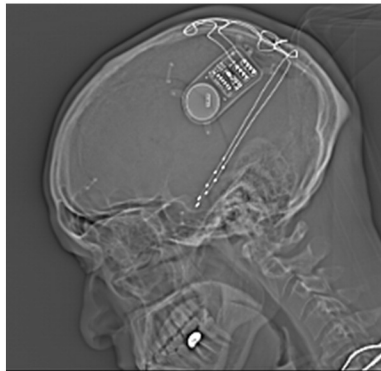
Fig. 2. Lateral skull films showing RNS device and 4 contact depth electrodes over left and right hippocampi.

with hopes of altering the burden of refractory complex partial seizures with secondary generalization. Detection and stimulation electrodes were placed in his hippocampi, both of which were atrophic on MRI, while the neurostimulator was placed within the parietal bone (Figs. 1, 2). The neurostimulator was programmed to detect early seizure onsets and stimulate zones of onset to prevent seizure propagation. In clinical trials, the RNS System was shown to significantly reduce seizure frequencies in patients with medically intractable partial epilepsy, an outcome this patient shared [6].
