Arthroplasty Today 13 (2022) 82-88

Case report

Femoral Condyle Insufficiency Fracture After Total Knee Arthroplasty Using a Stemless Femoral Component With a Midlevel Constraint Articular Surface

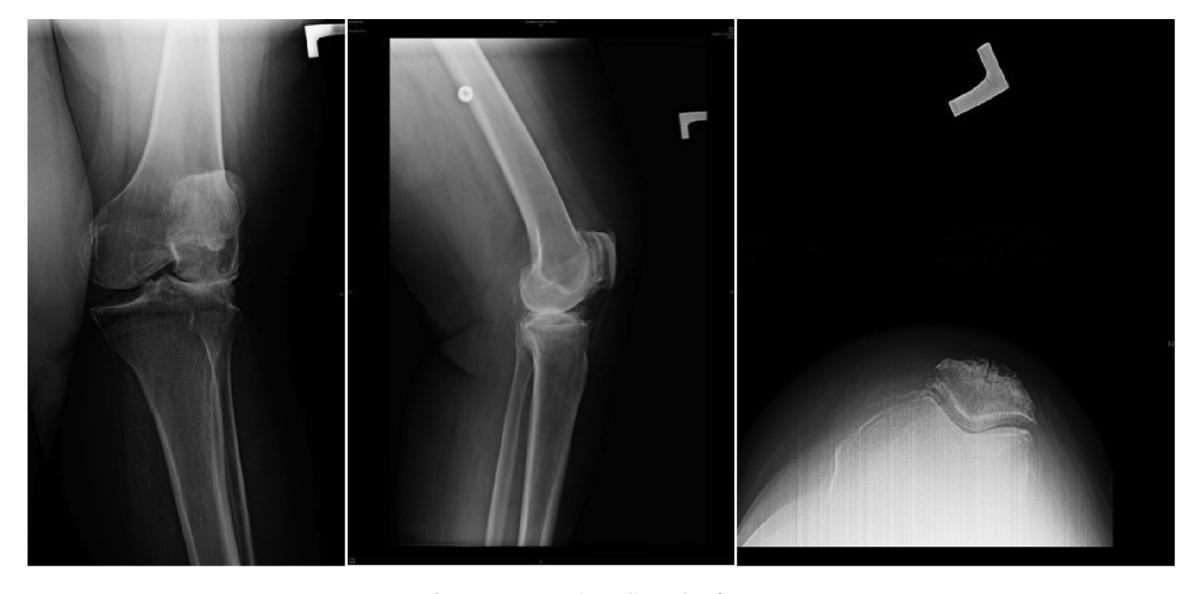
Figure 1. Preoperative radiographs of case 1.

A 72-year-old female (height = 64 inches, weight = 200 lbs, body mass index [BMI] = 34.3 kg/m²) with a preoperative range of motion (ROM) of 20° -80° and severe valgus deformity of 23° (Fig. 1) underwent a cemented primary left TKA with the Zimmer Biomet

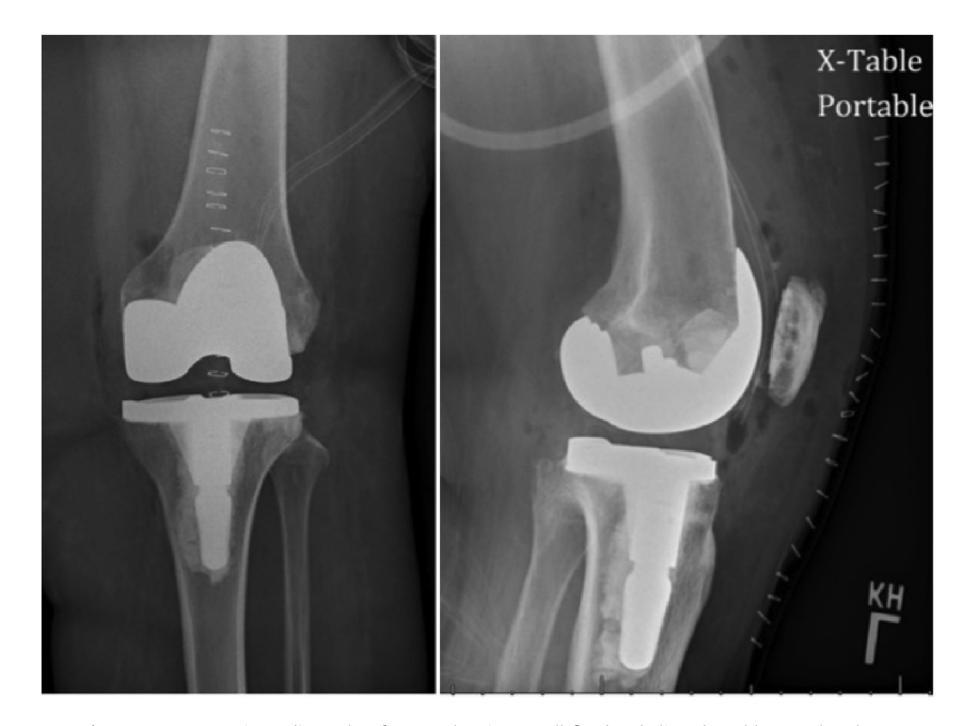
Figure 2. Postoperative radiographs of case 1 showing a well-fixed and aligned total knee arthroplasty.

Persona Knee System (Zimmer Biomet, Warsaw IN). At index surgery, a pie-crusting lateral release was performed alongside implanting a primary femoral component, a primary tibial component with a short and cemented stem, and a 12-mm MLC articular surface (Fig. 2).

We hypothesize that the cause of this insufficiency fracture is multifactorial. All of the patients were postmenopausal females predisposed to osteoporosis. The preoperative valgus stress likely results in increased osteopenia in the relatively unloaded medial femoral condyle. After primary TKA using an MLC bearing surface, the increased stress at the host bone and prosthetic interface combined with the restoration of neutral alignment leads to increased load upon the medial tibiofemoral compartment, overwhelming already susceptible bone resulting in fracture. Furthermore, compared with a CR or PS TKA design, increased bone is resected from the femoral notch when using an MLC bearing, leaving a smaller bony bridge at the metadiaphyseal junction to load share at the medial distal femur and thus enhancing the risk for fracture. Suboptimal surgical technique may also lend itself to further increased risk of fracture as excessive medialization of the femoral component leads to a diminished weight-bearing surface area of the weakened medial femoral condyle. Although the appearance of the radiographs may be due to rotation, one could argue that there is a slight unintended medialization of the femoral component on the immediate postoperative films of the patient in case 1 (Fig. 2).

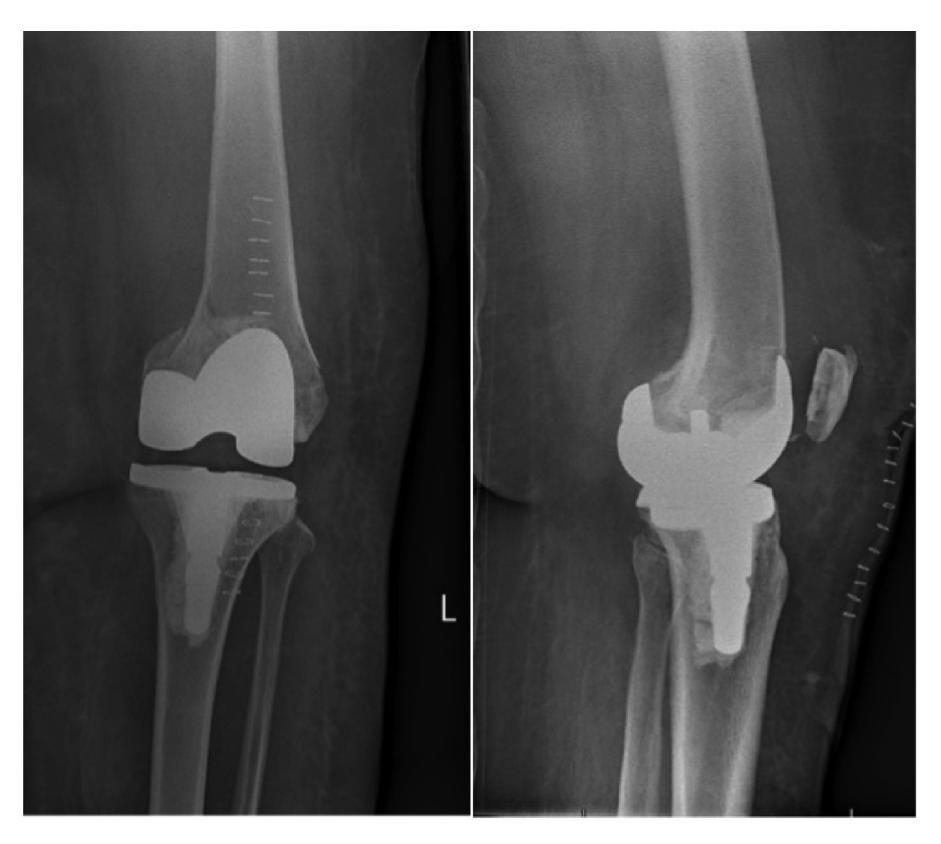
Figure 3. Radiographs of case 1 showing an insufficiency fracture of the medial femoral condyle with collapse and varus deformity of the knee.

The patient presented to the emergency department (ED) 6 days after surgery complaining of severe left knee pain that prevented her from weight-bearing. She stated the knee had buckled while standing. Radiographs demonstrated medial subsidence of the femoral component associated with a medial condylar fracture (Fig. 3). Intraoperatively, the fracture was noted to be more extensive, involving most of the medial femoral condyle and more comminuted than initially suspected on the radiograph. Secondary to the large amount of bone loss in conjunction with resultant instability, the patient was ultimately revised to a distal femoral replacement. The patient tolerated the procedure well without complication (Fig. 4).

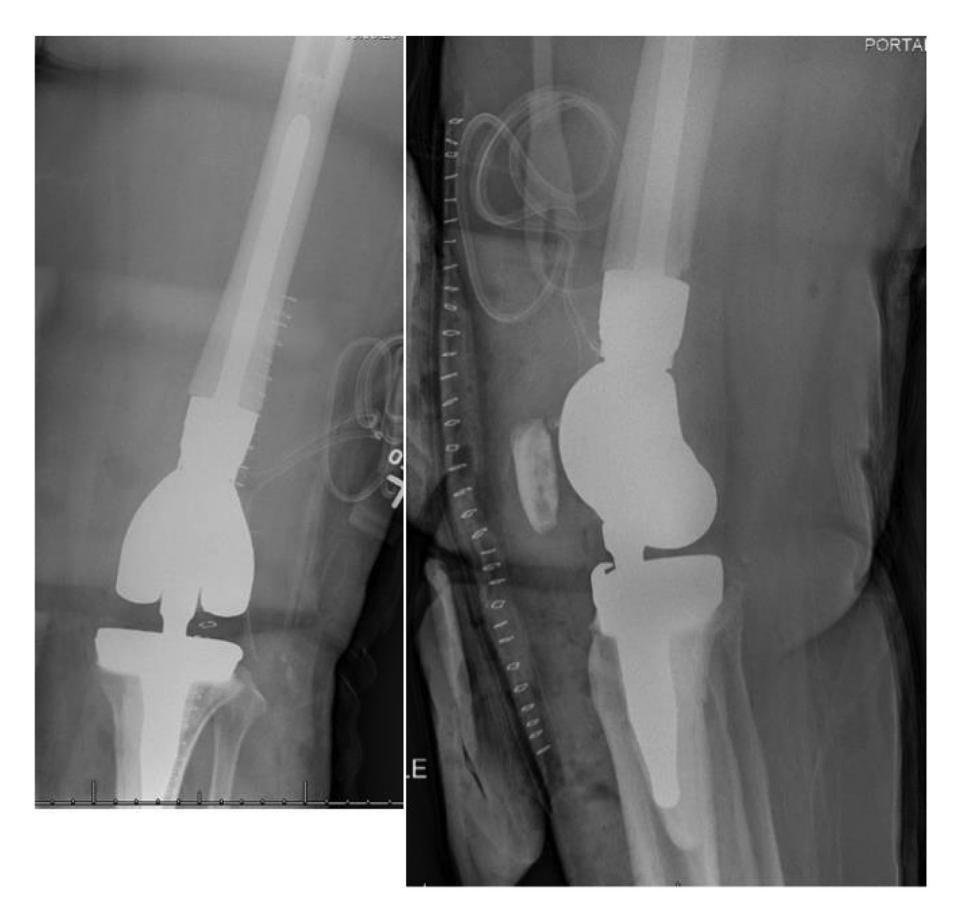
Figure 4. Postoperative radiographs of case 1 status after revision to a distal femur replacement.

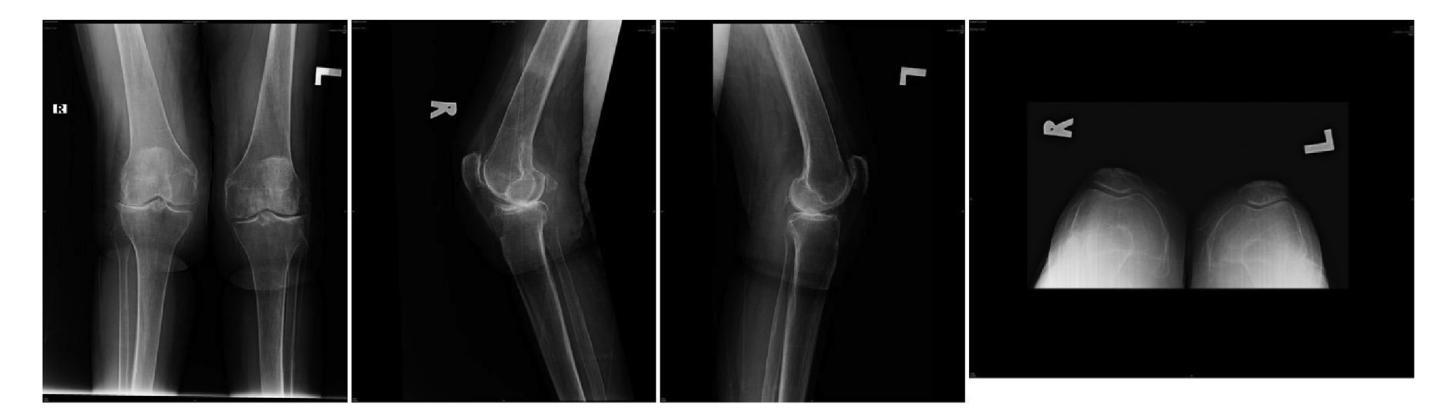
Figure 5. Preoperative radiographs of case 2 with osteoarthritis of bilateral knees with severe valgus deformity of the right knee and mild varus deformity of the left knee.

An 82-year-old female (height = 63 inches, weight = 131 lbs, BMI = 23.2 kg/m²) underwent cemented simultaneous bilateral TKA. Preoperatively, the patient was ambulating using a forearm crutch. The right knee had a severe valgus deformity of 18° and a ROM of 20°-105°, whereas the left knee had a mild valgus deformity and a ROM of 5°-110° (Fig. 5). Stemless femurs, stemmed tibias, and MLC inserts were implanted into both knees. Lateral

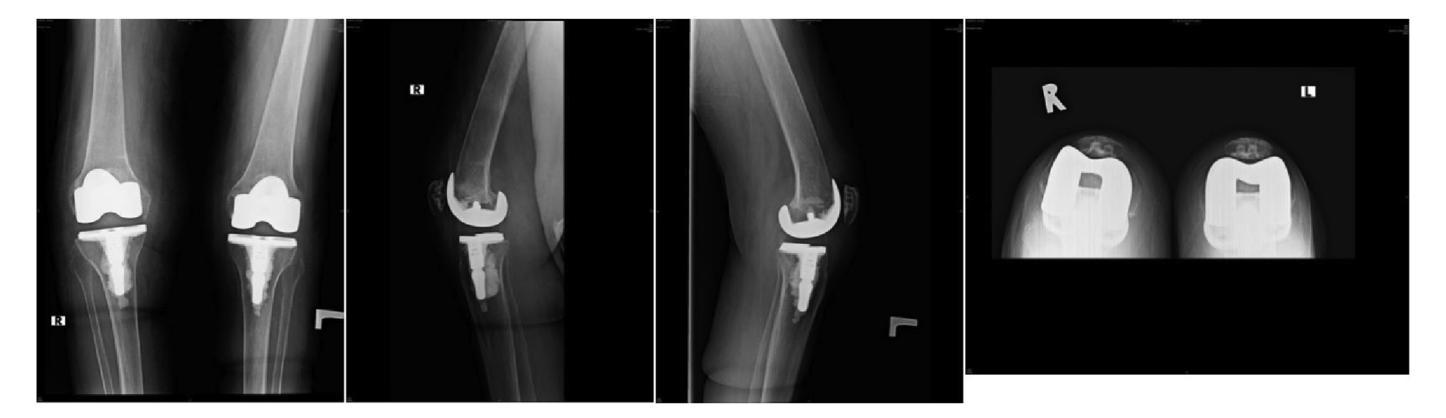
The patient was doing well until her 6-week visit at which point subsidence of the right femoral component into varus alignment was noted (Fig. 6). The patient reported increase in pain after a physical therapy session. Her ROM in the left knee was 0° -115° compared with 5°-100° in the right knee.

Figure 6. Six-week postoperative radiographs of case 2 after bilateral TKA with a medial femoral condyle insufficiency fracture with varus collapse.

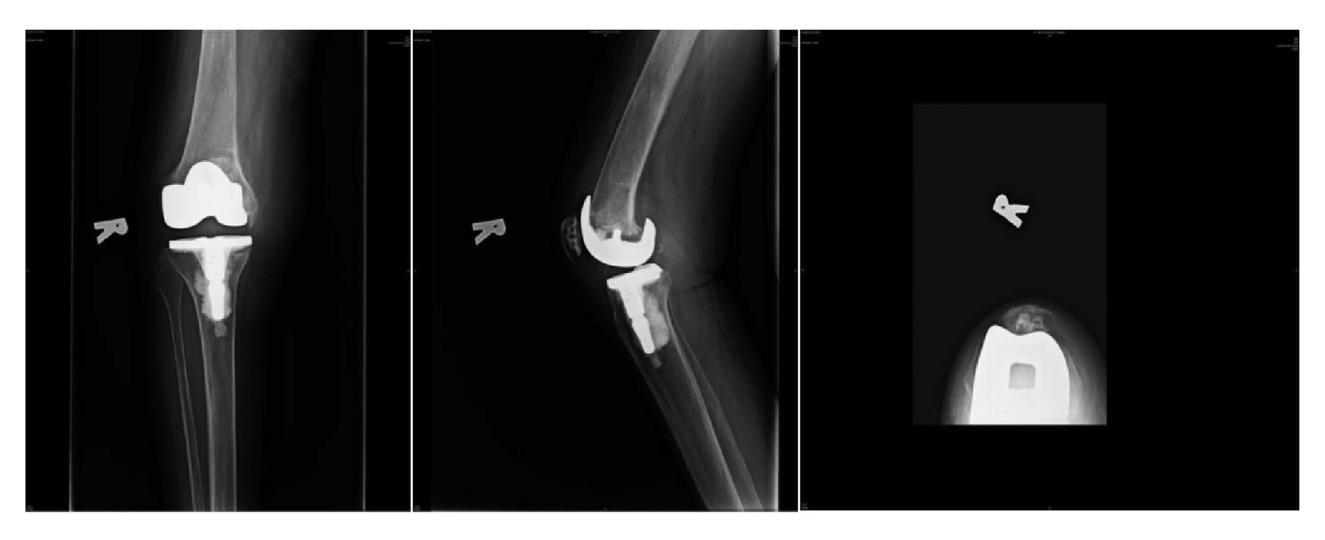
Figure 7. Four-month postoperative radiographs of case 2 showing progression of subsidence of the femoral component after medial femoral condyle insufficiency fracture diagnosis.

Despite the recommendation for surgical intervention, the patient initially opted for a period of observation and protected weight-bearing. Her symptoms did improve somewhat over time. She was last seen for a 24-month evaluation at which point radiographic evaluation showed further subsidence of the femoral component (Fig. 7). The patient remained reluctant to proceed with surgery despite warnings of possible further progression of the subsidence or worsening periprosthetic fracture as she was able to ambulate with a cane and had minimal pain.
