Research Article

Clinical Classification of Bone Augmentation Procedure Failures in the Atrophic Anterior Maxillae: Esthetic Consequences and Treatment Options

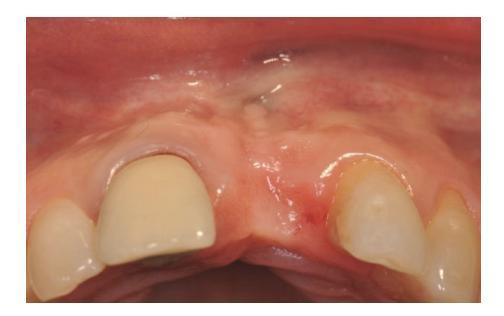
FIGURE 3: Clinical view showing a lack of the upper left central incisor.

2.2. Treatment Option for a Class 1 Complication. This case shows the loss of the upper left central incisor due to endodontic failure (Figure 3).

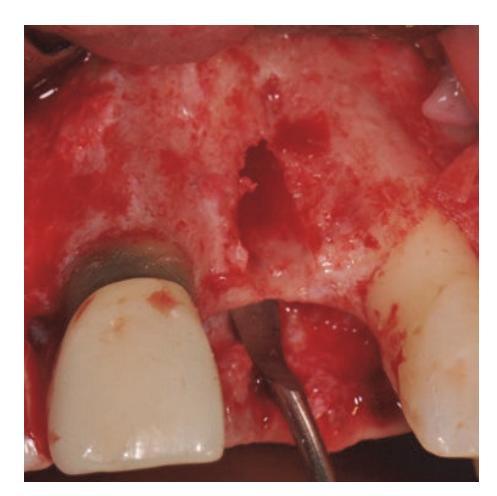
FIGURE 4: Surgical view of the socket; the whole buccal bony wall is missing.

Four months after the extraction, a full thickness flap was raised; the socket was still present, but the whole buccal bony wall was missing (Figure 4).

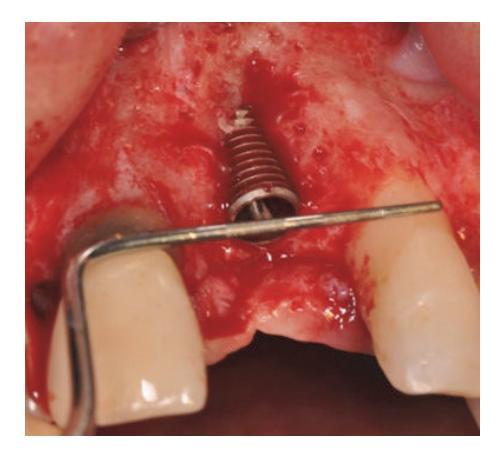
FIGURE 5: One implant is placed in the socket with all its coronal buccal part exposed.

One implant (Megagen AnyRidge, Megagen, Korea) was placed in the socket with all its coronal buccal part exposed (Figure 5).

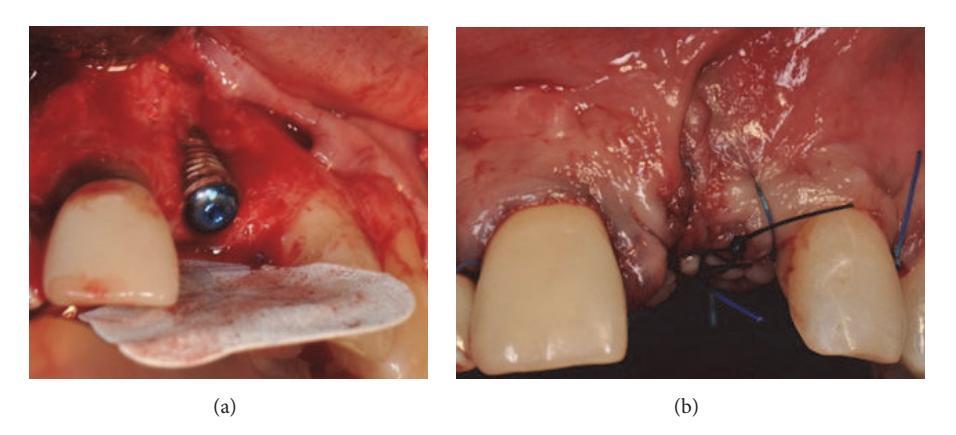
FIGURE 6: (a-b) GBR procedure performed using a microtextured titanium-reinforced PTFE membrane, fixed by one pin.

Using a microtextured titanium-reinforced PTFE membrane (Cytoplast® Ti-250, De Ore®, Italy), fixed by one pin (Pro-fix® Membrane Fixation System, Osteogenics Biomedical, Texas, USA), a GBR procedure was performed in order to gain the amount of bone necessary to reestablish a correct profile (Figures 6(a) and 6(b)).

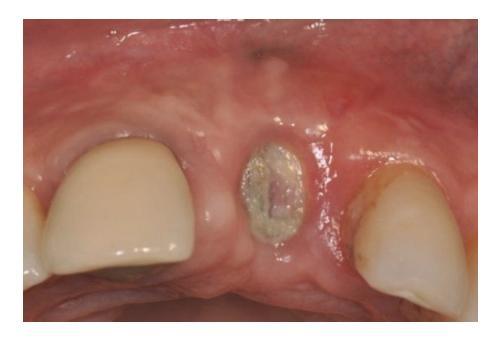
FIGURE 7: Membrane exposure after three weeks of healing.

After three weeks of healing, the membrane was exposed in its coronal part (Figure 7).

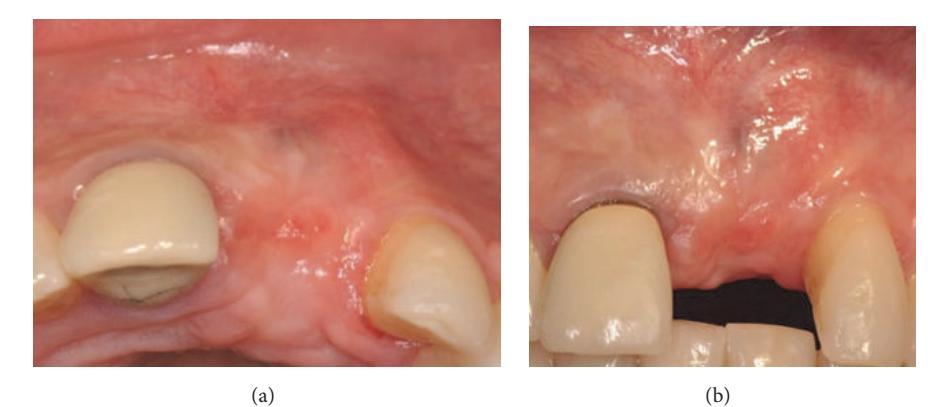
FIGURE 9: (a-b) Healing of the soft tissues with a reduced thickness of buccal profile.

After 45 days of healing, the soft tissues were healthy and keratinized tissue was present, but the buccal profile was still not sufficiently thick (Figures 9(a) and 9(b)).

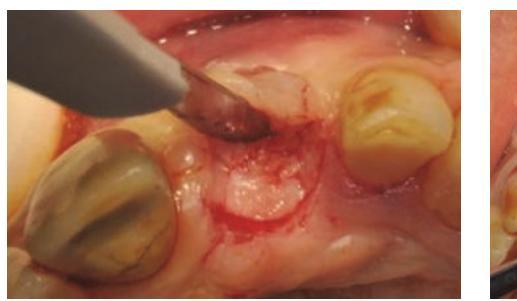
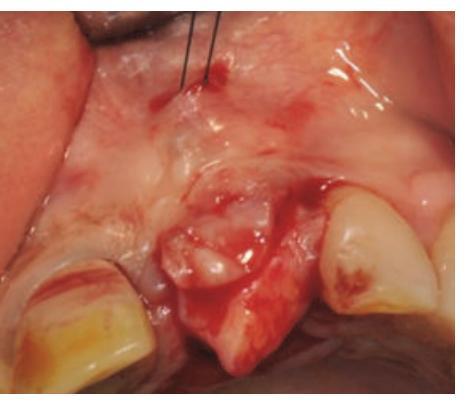
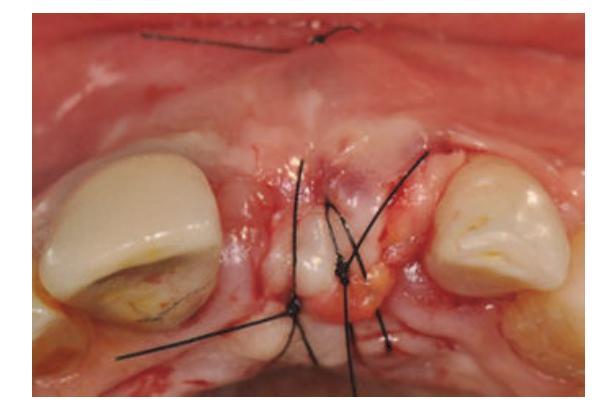
FIGURE 10: (a-b-c-d) A partial thickness flap is created to house a second connective tissue graft, harvested from the right palate and placed buccally.

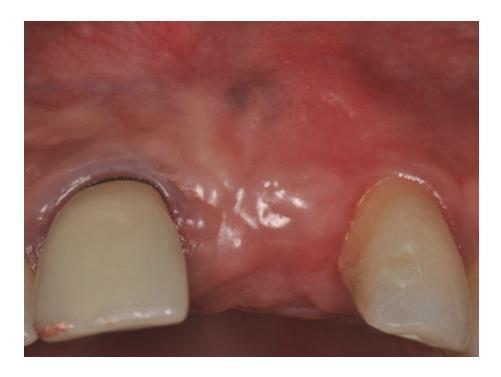
FIGURE 11: Clinical view of the edentulous area: reduced soft tissue volume at the level of the distal papilla.

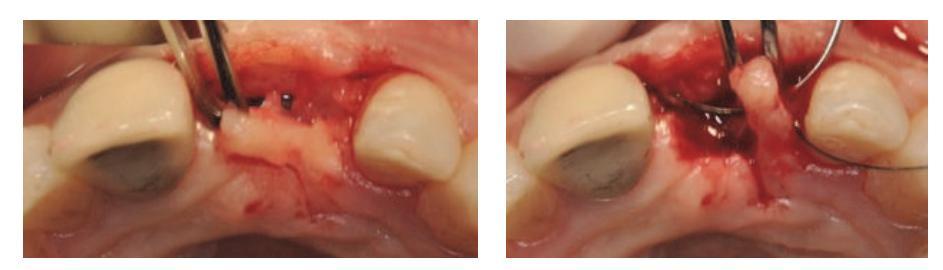
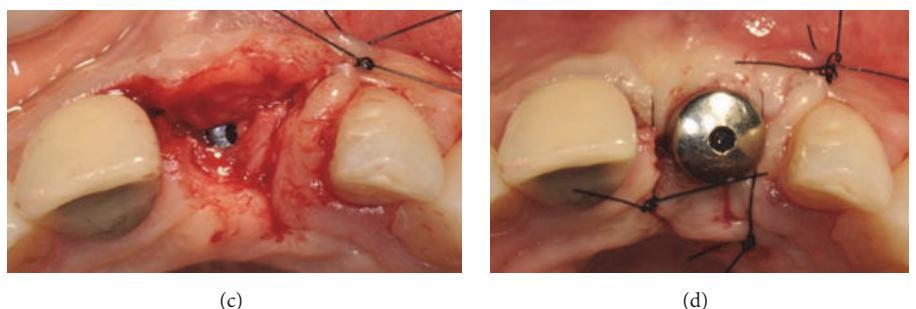
FIGURE 12: (a-b) A narrow part of the palatal flap is cut to half-thickness and rotated distally against the lateral upper left incisor. (c-d) The papilla mesial to the lateral incisor is disepithelized and the microflap is sutured over the original papilla.

To solve this final problem, which may have prejudiced the final esthetic result, a laterally translated microflap was created (Figures 12(a), 12(b), 12(c), and 12(d)).

A narrow part of the palatal flap was cut to half-thickness (Figure 12(a)) and rotated distally to the lateral upper left incisor (Figure 12(b)). The papilla mesial to the lateral incisor

was disepithelized and the microflap was sutured over the original papilla (Figures 12(c) and 12(d)).

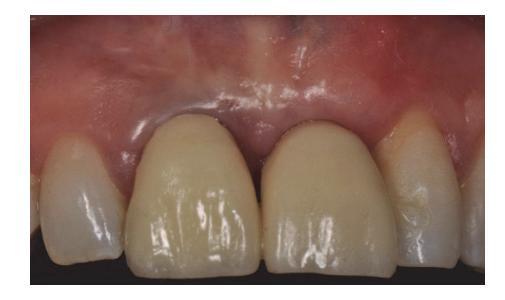
FIGURE 13: Provisional crown delivered with a slight compression on the newly formed papilla, after three weeks of healing.

After three weeks of healing a provisional crown was inserted with only a slight compression on the newly formed papilla (Figure 13).

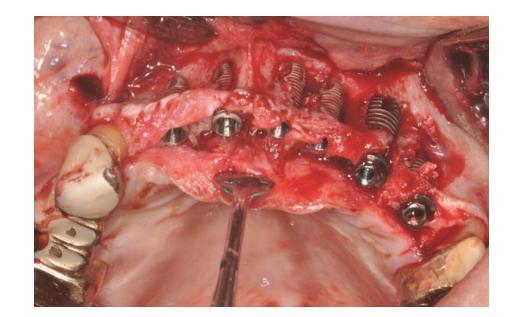
FIGURE 16: Placement of six dental implants with the bone surrounding only their coronal part.

Taking advantage of the presence of a thick amount of crestal cortical bone, six dental implants (ExFeel, Megagen[®], Korea) were placed with the bone surrounding only their coronal part (Figure 16).

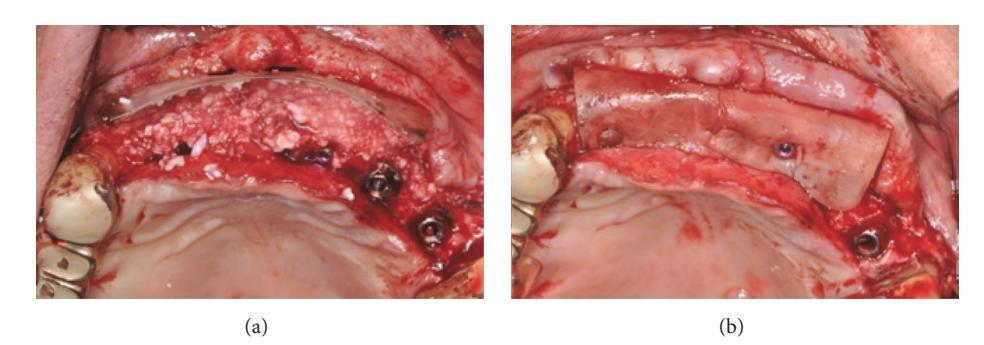
FIGURE 17: (a-b) Granules of biomaterial are placed between the implants and in excess on the buccal side, covered by a semi-rigid resorbable polylactic acid membrane and fixed with implant cover screws and resorbable tacks.

To cover the buccal aspect of the implants and in order to compensate for the lack of regenerate bone, granules of biomaterial (Mp3, Osteobiol, Italy) were placed between the implants, in excess on the buccal side, covered by a semi-rigid resorbable polylactic acid membrane (GTR Biodegradable membrane, Inion[®], Finland), fixed with both implant cover

screws and resorbable tacks (GTR Tack, Inion[®], Finland) (Figures 17(a) and 17(b)).

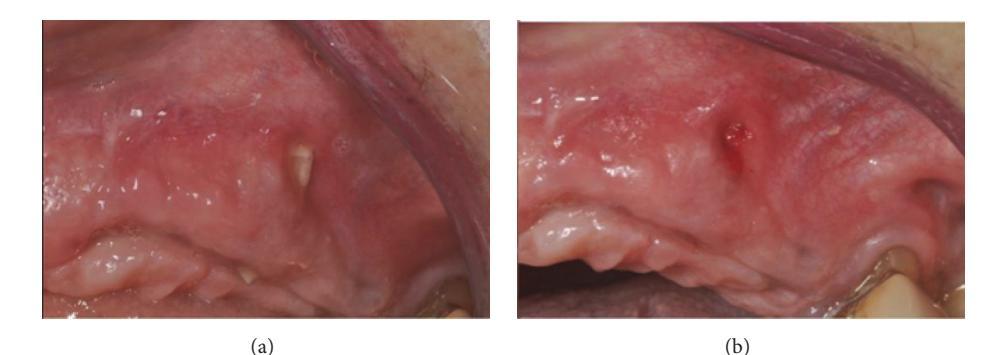
FIGURE 18: (a-b) Partial exposure of an angle of the membrane, which occurred after four months and was treated with a little plastic.

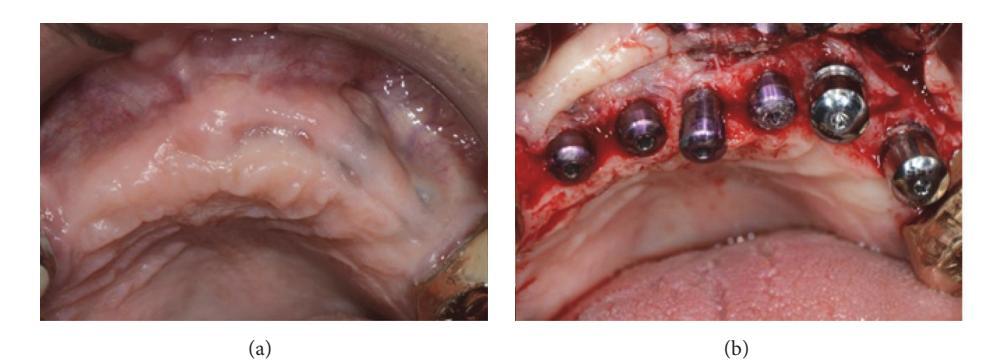
FIGURE 19: (a-b) Eight months after the implant therapy, the implants appeared stable and well osseointegrated, but the buccal profile was still not sufficiently thick.

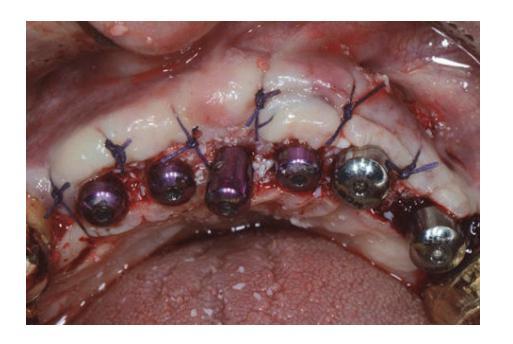
FIGURE 20: Grafting material is placed buccally under the flap to improve the thickness of the profile and the flaps are left to heal for a second intention.

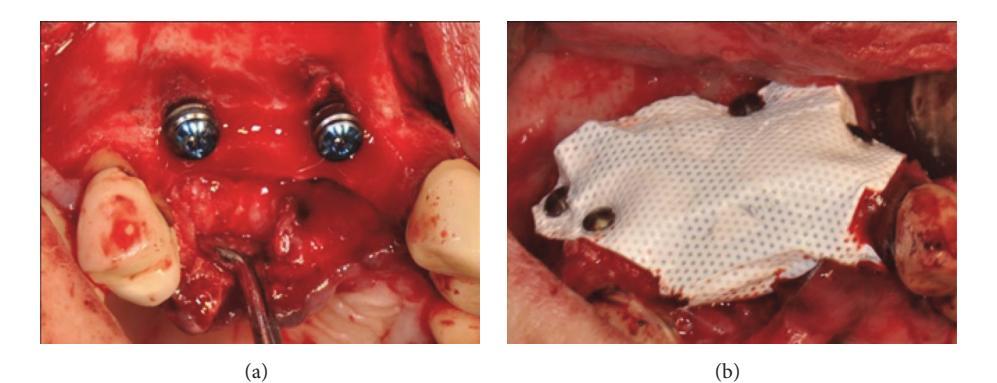
FIGURE 23: (a) Two implants placed supracrestally in sites #13 and #11. (b) The lack of crestal and buccal bone volume is compensated for with a 1:1 mixture of particles of bovine derived xenograft and autogenous bone harvested from the premaxilla and the palate with bone scrapers. The bone graft is covered with a microtextured titanium-reinforced PTFE membrane and fixed by pins and miniscrews.

Implants (AnyRidge, Megagen, Korea) were placed supracrestally in sites #13 and #11 and the lack of crestal and buccal bone volume was compensated for with a 1:1 mixture of particles of bovine derived xenograft (Bio-Oss®, Geistlich, Switzerland) and autogenous bone harvested from the premaxilla and the palate with bone scrapers. The bone graft was then covered with a microtextured titanium-reinforced

PTFE membrane (Cytoplast[®] Ti-250, De Ore[®], Italy) and fixed by pins and miniscrews (Pro-fix[®] Membrane Fixation System, Osteogenics Biomedical, Texas, USA) (Figures 23(a) and 23(b)).

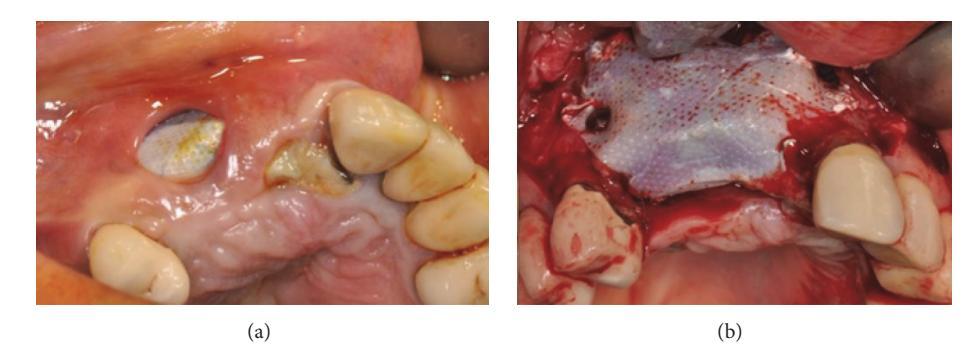
FIGURE 24: (a) Exposure of the membrane on the buccal aspect of the area after five months of healing. (b) Clinical situation after reopening the flap; the membrane, pins, and screws were removed.

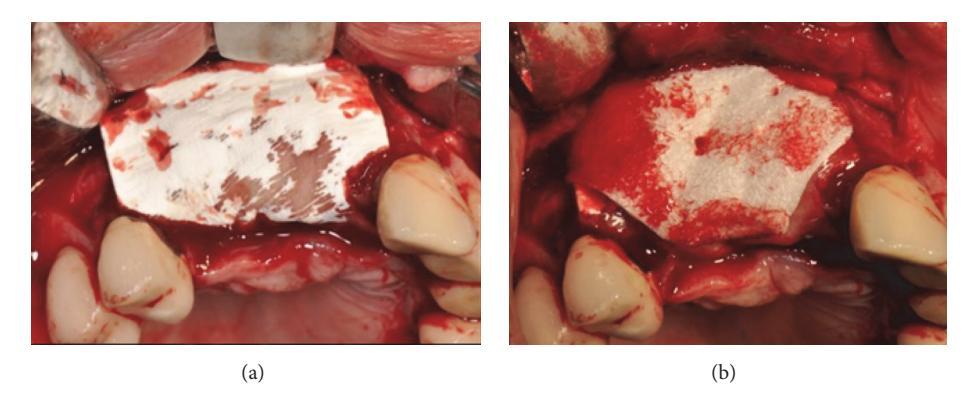
FIGURE 25: (a-b) A resorbable membrane is placed, covered by a collagen sponge, in order to create a double-layered barrier protecting the bony area that required regeneration.

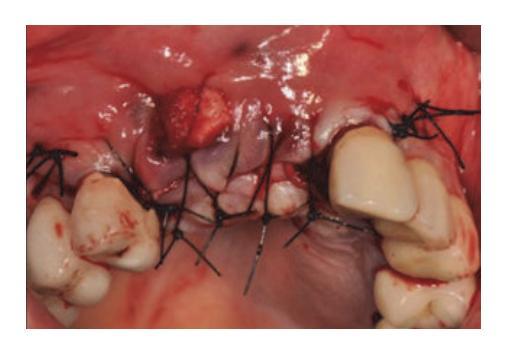
FIGURE 26: Closure of the flap is obtained after suturing with a deliberate lack of first intention; the fenestrated buccal area is left to heal for a second intention over the collagen sponge.

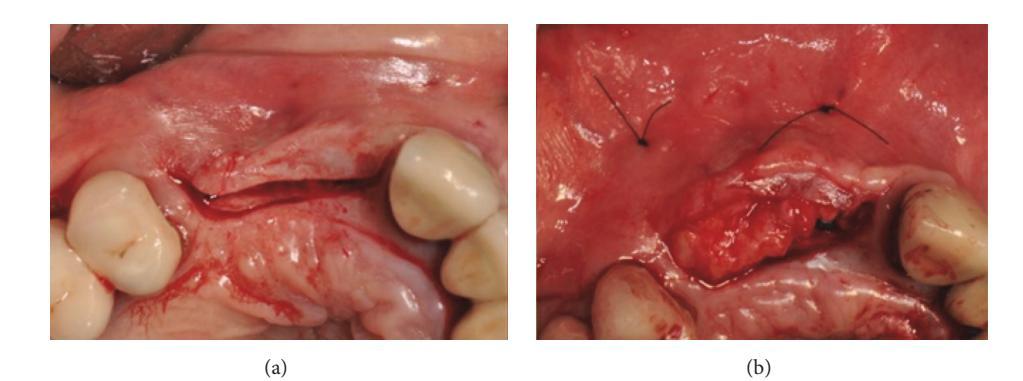
FIGURE 28: (a-b) A connective tissue graft is harvested from the palatal left premolar area and placed buccally under the epithelium to compensate for the lack of volume of the buccal alveolar crest.

In order to finalize the procedure, a connective tissue graft was harvested from the palatal left premolar area and placed buccally under the epithelium to compensate for the lack of volume of the buccal alveolar crest (Figures 28(a) and 28(b)).

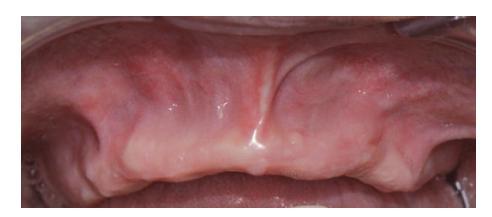
FIGURE 30: Clinical view of the severe bone resorption of the upper maxilla.

2.5. Treatment Option for a Class 4 Complication. This case presents a severe bone resorption of the upper maxilla due to early tooth loss (Figure 30). The treatment plan considered an onlay block graft procedure followed by implant placement.

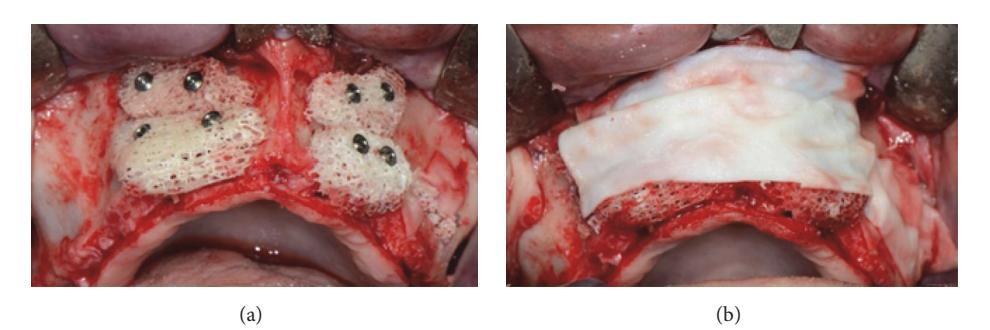
FIGURE 32: (a) Placement and adaptation of four cancellous bone blocks to the recipient site, fixed to the basal bone by miniscrews. (b) The whole grafted area is covered by a resorbable membrane.

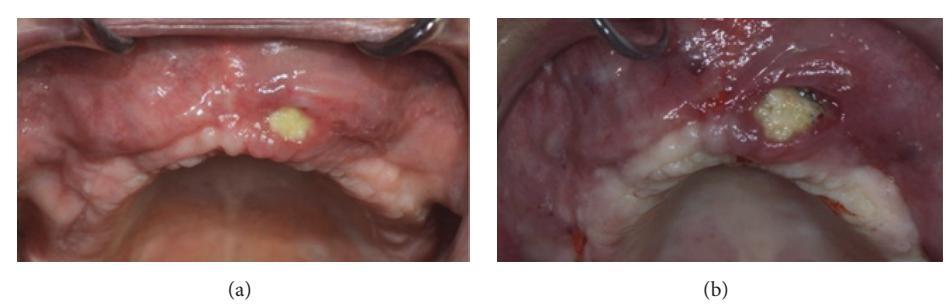
FIGURE 33: (a) Dehiscence of the flap after six months of healing. (b) Clinical view of the dehiscence: a part of one of the blocks is exposed.

After six months of healing, a dehiscence of the flap was reported and, two weeks later, part of one block was exposed (Figures 33(a) and 33(b)).

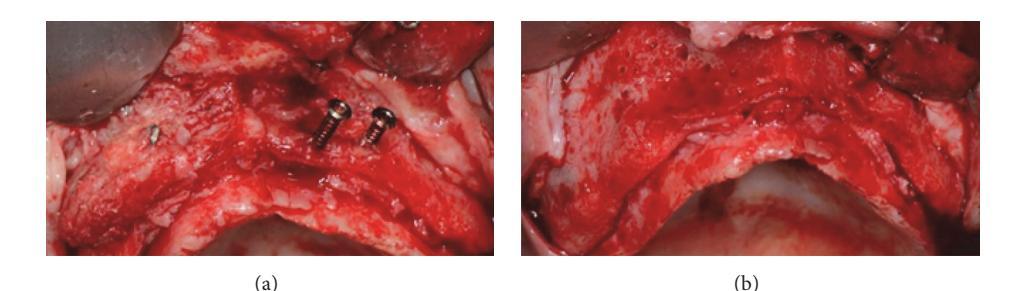
FIGURE 34: (a-b) During surgical reentry, the grafted blocks appear to be not integrated and the presence of infection and fibrous granulation tissue is evident. The blocks and screws were removed and the whole area was cleaned.

The flaps were raised again and, from a clinical point of view, the grafted blocks appeared not integrated with the presence of infection and fibrous granulation tissue. The blocks and screws were removed and the whole area was cleaned (Figures 34(a) and 34(b)).

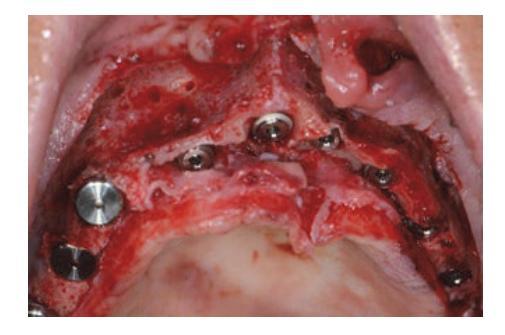
FIGURE 35: Placement of ten implants in the residual patient native bone.

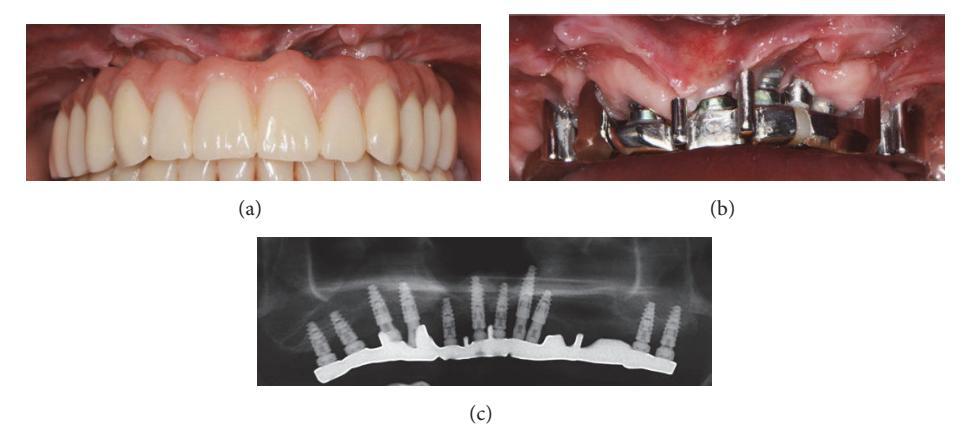
FIGURE 36: (a-b) The implant-retained combined fixed-removable denture delivered to the patient four months after implant therapy. (c) Panoramic X-ray of the final prosthesis.
