Article Comparison of Fracture Load of the Four Translucent Zirconia Crowns

Suchada Kongkiatkamon ^{1,*}, Kittipong Booranasophone ¹, Apichat Tongtaksin ¹, Valailuck Kiatthanakorn ¹ and Dinesh Rokaya ²

Abstract: Recently, translucent zirconia has become the most prevalent material used as a restorative material. This study aimed to compare the crown fracture load of the four most common different translucent zirconia brands available in the market at 1.5 mm thickness. Standardized tooth preparations for a full ceramic crown were designed digitally with software (AutoCAD) by placing a 1.0 mm chamfer margin and 1.5 mm occluso-cervical curvature for the crown sample manufacturing. Stylized crowns were chosen to control the thickness of the crown. The axial and occlusal thickness were standardized to 1.5 mm thickness except at the central pit, which was 1.3 mm thick. The STL file for the tooth dies was prepared using software (3Shape TRIOS[®] Patient Monitoring, Copenhagen, Denmark). The tooth dies were printed with a resin material (NextDent Model 2.0, Vertex-Dental B.V., Soesterberg, The Netherlands) using a 3D printing software (3D Sprint[®] Client Version 3.0.0.2494) from a 3D pr

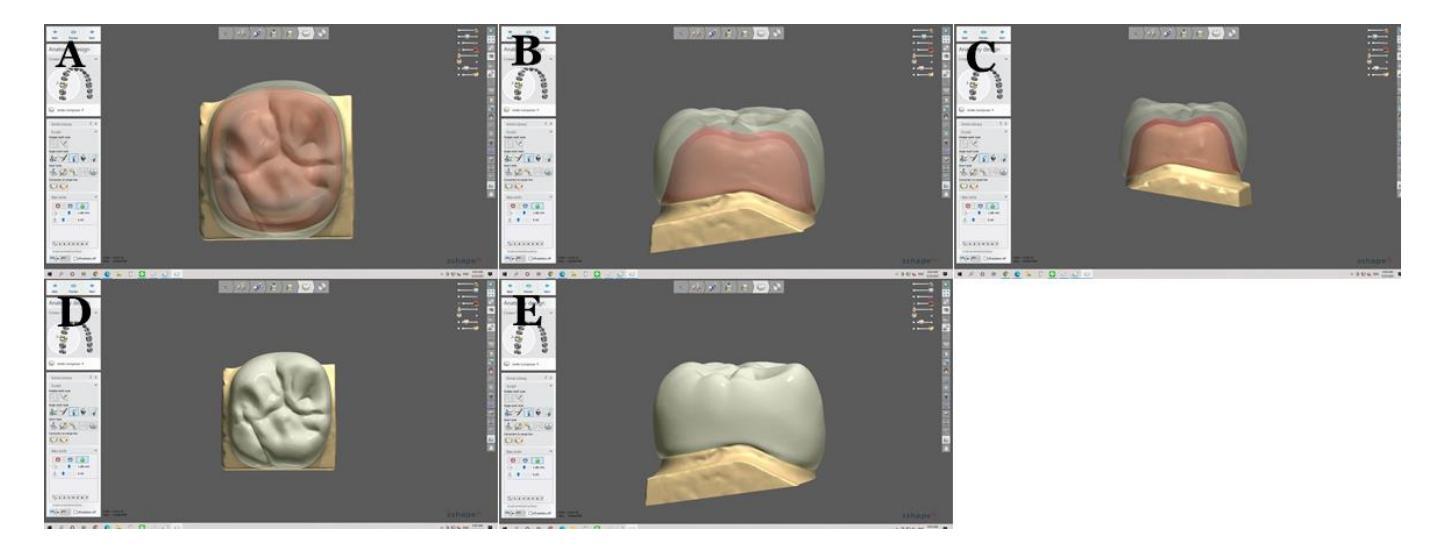
Figure 1. Crown designed digitally using 3Shape software(TRIOS®). Crown from different views (A–E).

Tooth preparations for the full ceramic crown were done digitally with software (AutoCAD) by placing a 1.0 mm chamfer margin and 1.5 mm occluso-cervical curvature for the crown sample manufacturing without periodontal ligaments and roots, since the rigidity of the specimen is taken into account [25]. Stylized (a nonrealistic, distinctive design) crowns were chosen to control the thickness of the crown. The axial and occlusal thickness were standardized to 1.5 mm thickness except at the central pit, which was 1.3 mm thickness as shown in Figure 1. The STL file for the tooth dies was prepared using computer software (3Shape TRIOS[®] Patient Monitoring, Copenhagen, Denmark). Tooth dies were printed with a resin material (NextDent Model 2.0, Vertex-Dental B.V., Soesterberg, The Netherlands) using a 3D printing software (3D Sprint[®] Client Version 3.0.0.2494) from a 3D printer (NextDentTM 5100, Vertex-Dental B.V., Soesterberg, The Netherlands). The printing layer thickness was 50 μ m. Then, a total of twenty-eight (N = 28) stylized crowns were milled out of AmannGirrbach (Amann Girrbach GmbH, Pforzheim, Germany) (n = 7), Cercon XT (Dentsply Sirona, Bensheim, Germany) (n = 7), Cercon XT (Dentsply Sirona,

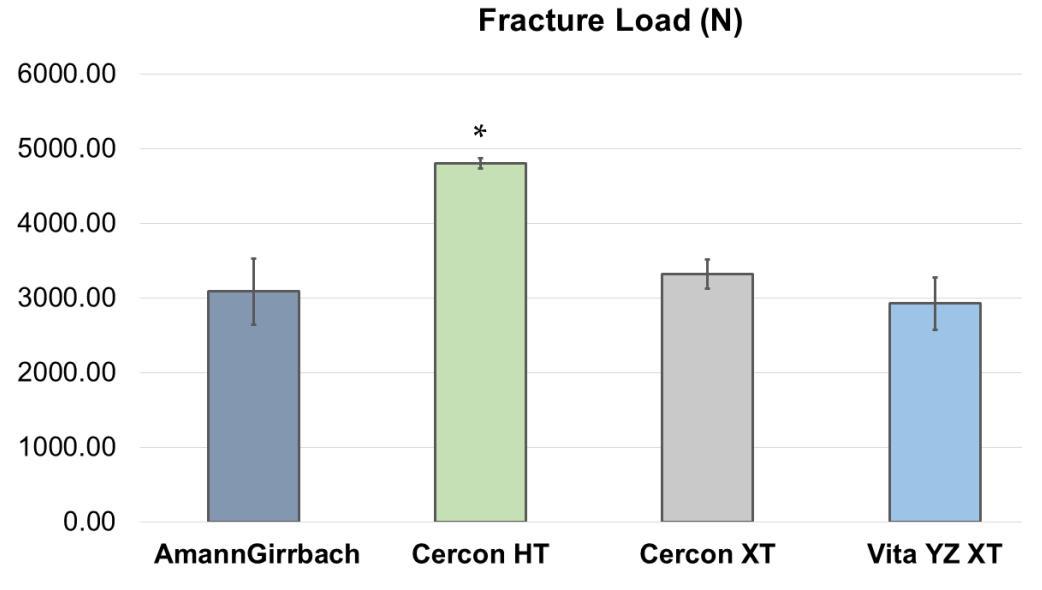
Figure 2. The mean fracture load of various zirconia; AmannGirrbach (Amann Girrbach GmbH, Pforzheim, Germany), Cercon HT (Dentsply Sirona, Bensheim, Germany), Cercon HT (Dentsply Sirona, Bensheim, Germany), and Vita YZ XT (Zahnfabrik, Bäd Sackingen, Germany). * Cercon HT presented a significantly higher fracture load compared to AmannGirrbach, Cercon XT, and Vita ZY XT (*p* value < 0.0001).

The fracture load results are shown in Table 2, Figures 2 and 3. The highest fracture load was shown by the Cercon HT. The order of fracture load was Cercon HT, Cercon XT, AmannGirrbach, and Vita ZY XT. Table 3 shows multiple comparisons of the strength of zirconia crowns among various groups. The Cercon HT presented a significantly higher fracture load compared to AmannGirrbach, Cercon XT, and Vita ZY XT (*p* value < 0.0001).

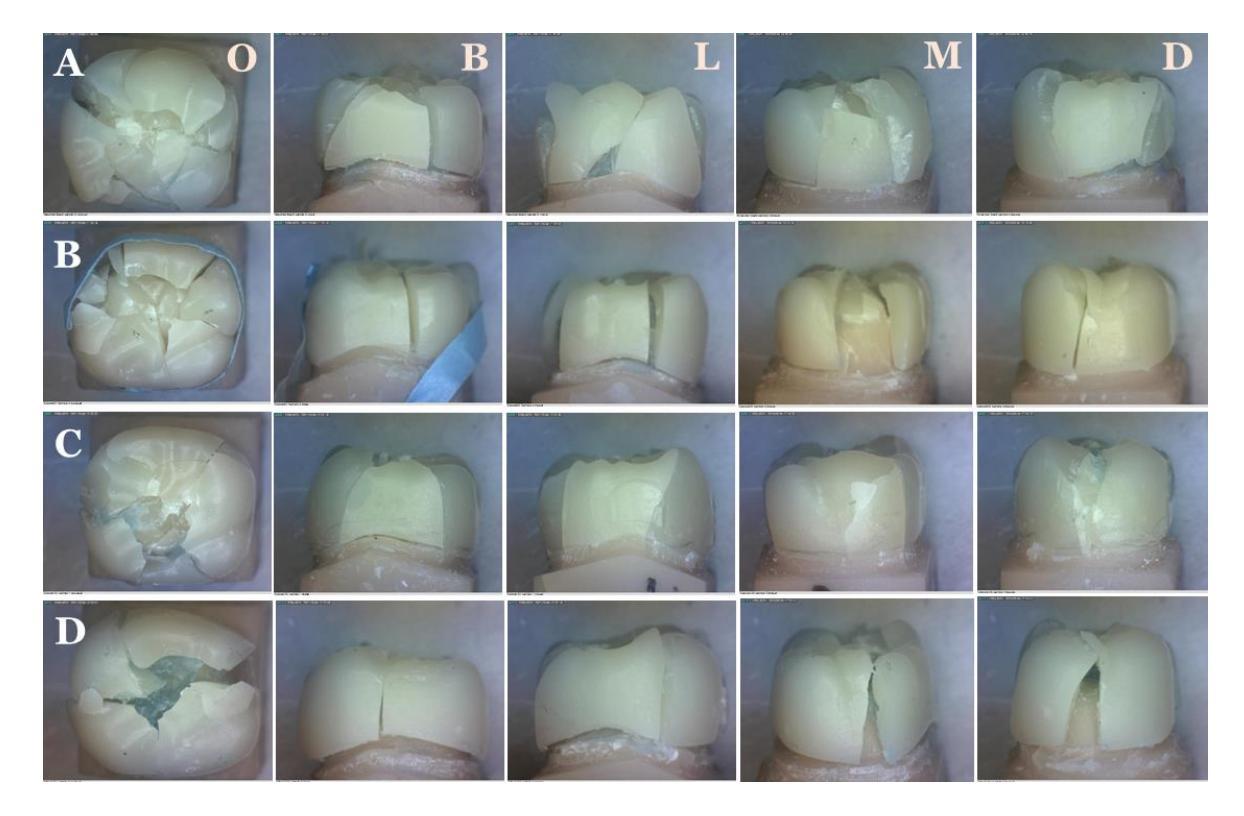
Figure 3. Crown fracture under load. AmannGirrbach (Amann Girrbach GmbH, Pforzheim, Germany) (**A**), Cercon HT (Dentsply Sirona, Bensheim, Germany), (**B**), Cercon XT (Dentsply Sirona, Bensheim, Germany) (**C**), and Vita YZ XT (Zahnfabrik, Bäd Sackingen, Germany) (**D**). O = Occlusal, B = Buccal, L = Lingial, M = Mesial, and D = Distal.

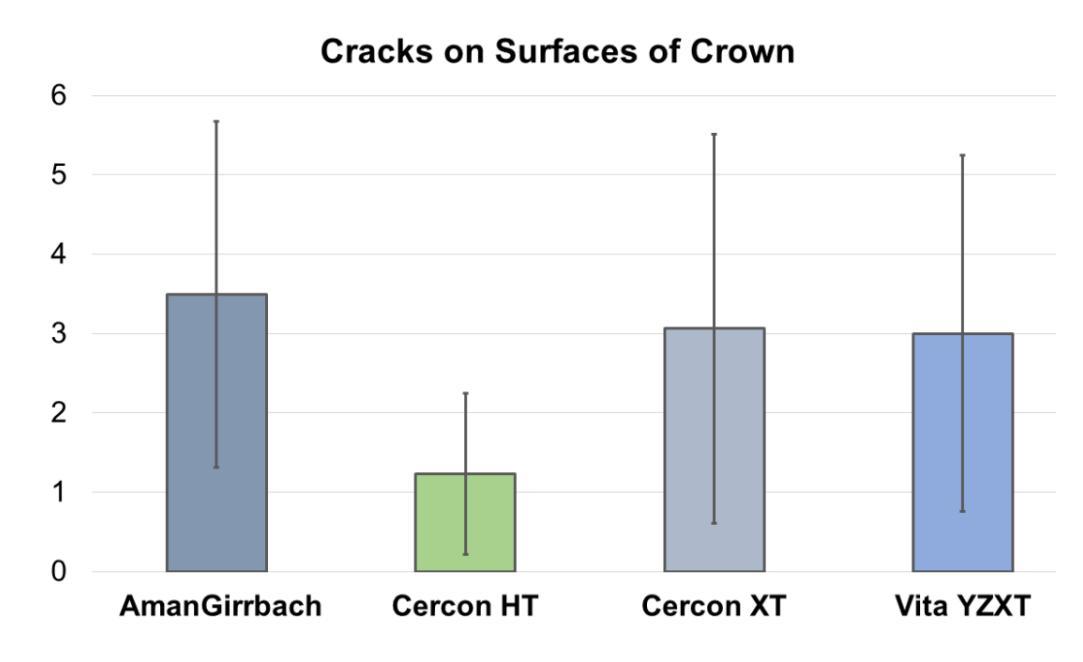
The cracks on the surfaces of zirconia crowns are shown in Figure 4. AmannGirrbach appeared to have the most overall cracks. Cercon XT had the greatest number of occlusal cracks and appeared to be the most shattered. Cercon HT had the least number of cracks. Samples 4–7 of Cercon HT were completely intact with no visible cracks. The surface with the greatest number of cracks (excluding occlusal surfaces) was on lingual for AmannGirrbach and Cercon HT, on distal and mesial for Cercon X, and on buccal for Vita YZ XT. There was a statistically significant difference between AmannGirrbach vs. Cercon HT (p value < 0.0001) and Cercon HT vs. Cercon XT (p value < 0.0001), while there was no statistical significant difference between Cercon HT vs. Cercon XT (p value = 0.844) and Cercon HT vs. Cercon XT (p value = 0.0186).

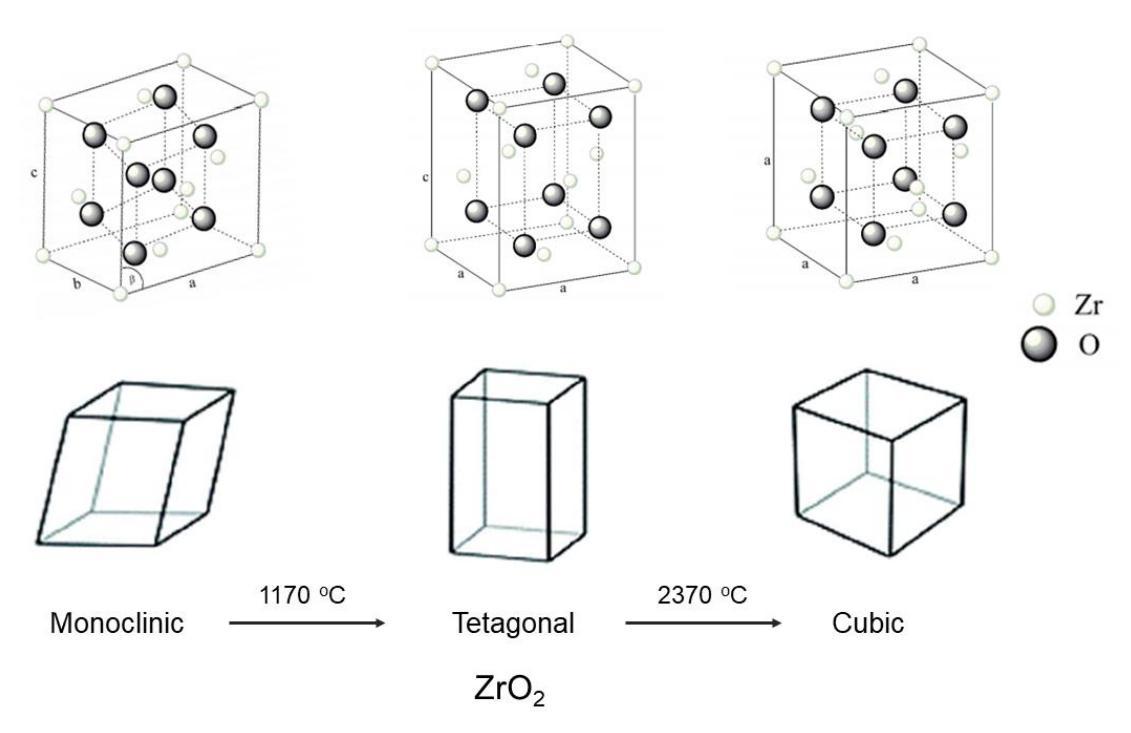
Figure 5. Structure of zirconia (monoclinic, tetragonal, and cubic). Modified from [32].

The advancement in zirconia manufacturing technology has developed various new zirconia compositions with esthetic enhancements. Zirconia is polymorphic and can be present in three crystallographic structures with the same chemical composition: monoclinic, tetragonal, and cubic [32,33]. At room temperature, zirconia is present in its monoclinic form and is stable up to 1170 °C [34,35]. Above this temperature, a transformation occurs to the tetragonal phase that is stable up to 2370 °C. Above the temperature 2670 °C, zirconia assumes its cubic form (Figure 5) [32]. On cooling from high temperatures, a cubic–tetragonal transformation takes place with a slight expansion of the unit cell volume.

The aging process results from the progressive spontaneous transformation of the metastable tetragonal phase to the monoclinic phase (t–m transformation) in the presence of water or water vapor at relatively low temperatures (approximately 30 °C up to 400 °C), which is a phenomenon known as hydrothermal or low-temperature degradation. Regarding the aging and degradation of zirconia, some theories have described the aging mechanism. Yttria, which is used as a dopant in zirconia to achieve phase stability, is exhausted through a reaction with water in the presence of moisture, resulting in a tetragonal to monoclinic (t–m) phase transformation [36–38].
