Endotracheal Tube Fastening Device-Related Facial Pressure Ulcers

Vaibhav Rastogi¹, Abraham J. Layon²

Abstract

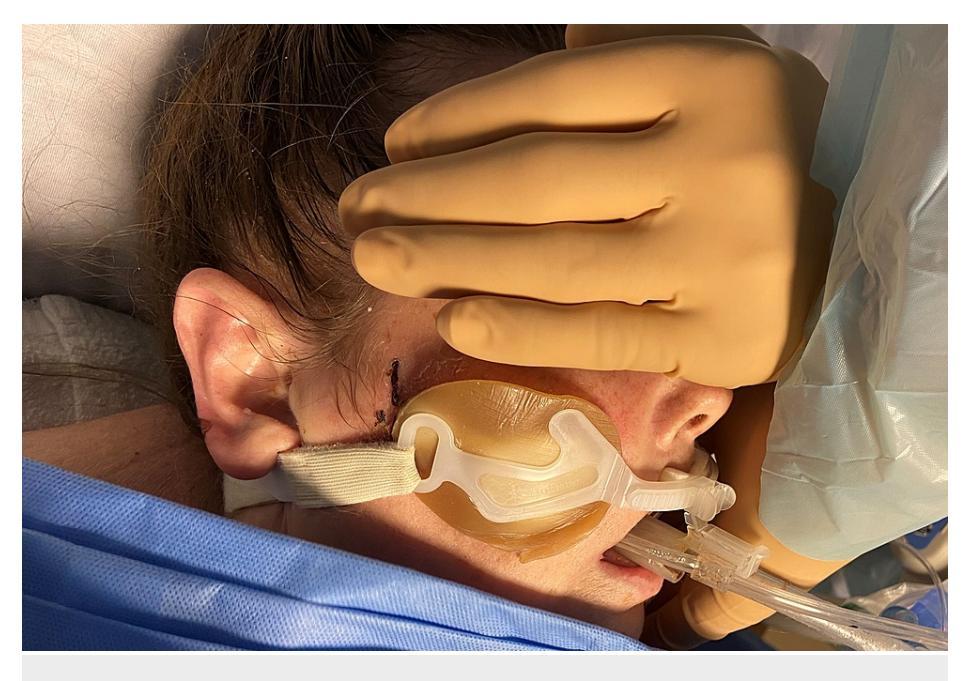
Rastogi et al. This is an open access article distributed under the terms of the Creative Commons Attribution License CC-BY 4.0., which permits unrestricted use, distribution, and reproduction in any medium, provided the original author and source are credited. After the tracheostomy had been inserted and was affixed in place, the Hollister AnchorFast oral endotracheal tube holder was gently removed, revealing - under the skin barrier pads - bilateral stage 2 pressure ulcers on her face; these had not been present prior to placement of the affixation device when the patient was endotracheally intubated (Figures *1*, *2*).

FIGURE 1: Intubated patient with Endotracheal tube fastener skin barrier pads.

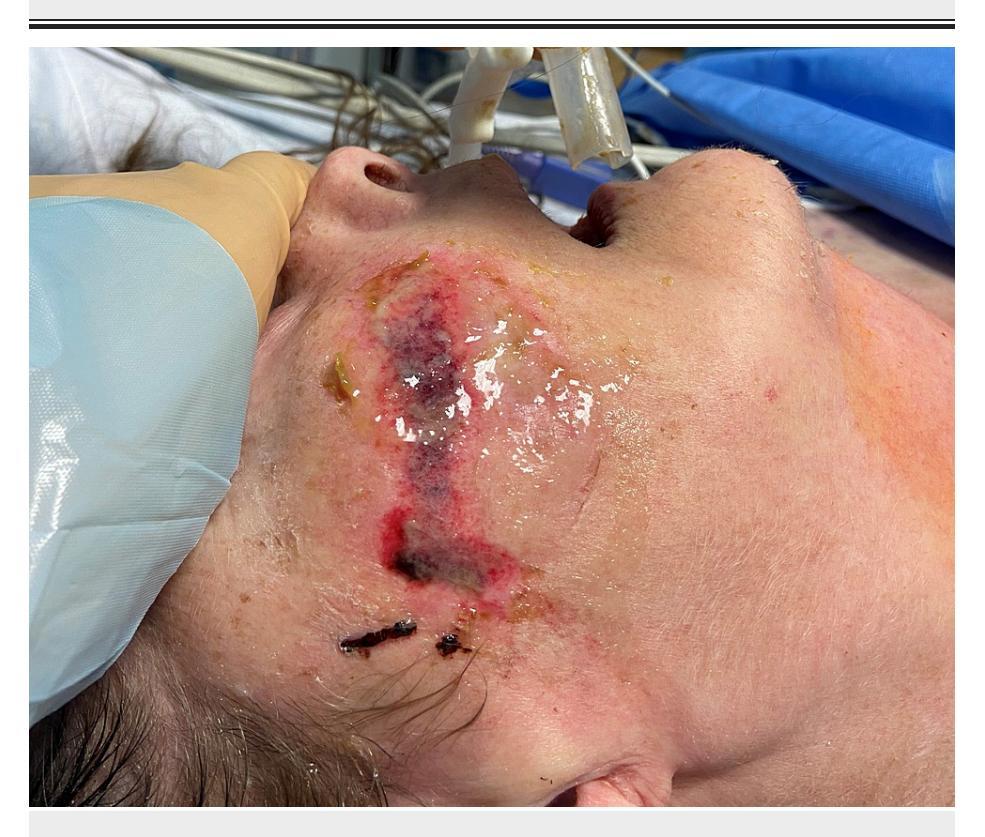
FIGURE 2: Stage 2 pressure ulcer at the site of endotracheal tube fastener skin barrier pad.

While the pressure ulcers were managed with frequent (two times a day) cleaning with saline and the

application of mupirocin our patient's medical condition continued to deteriorate and, on day #31 postintubation, her family (surrogate decision-maker) chose to withdraw life-sustaining treatment.
