Seven-year Results of a Tapered, Titanium, Hydroxyapatite-Coated Cementless Femoral Stem in Primary Total Hip Arthroplasty

Conclusions: The mechanical fixation of a tapered, titanium, HA-coated femoral implant was excellent in this study. This femoral design provided reliable osseointegration that was durable at a mean of 7 years follow-up.

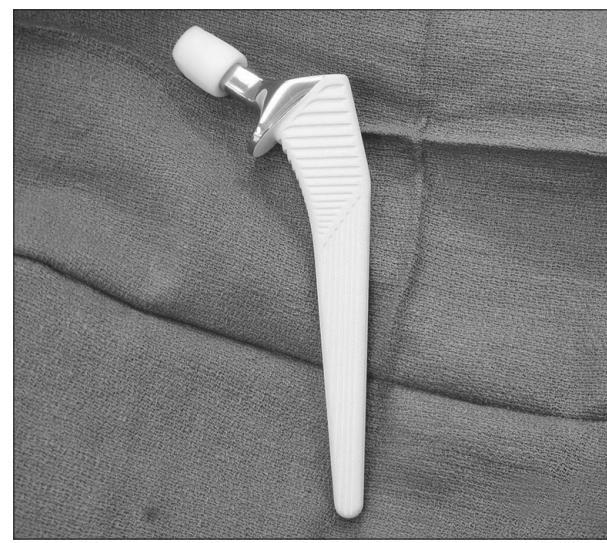
Fig. 1. Corail femoral implant:stepped geometry is oriented to minimize shear forces and maximize compression loading in host cancellous bone and proprietary hydroxyapatite coating for initial osteointegration and fixation clinically demonstrated rapid trabeculae formation leading to

During the years 1998 to 2002, we performed 86 primary total hip replacements in 78 patients. In all cases, we used using a tapered, titanium (Ti6Al4V) HA-coated femoral implant (Corail, Depuy Orthopaedics Inc., Warsaw, IN, USA) (Fig. 1). This femoral implant is available with a collared option, which was used in 22 hips. The remaining 64 hips in this series were inserted without a collar. The titanium tapered implants were entirely coated with a layer of $155 \pm 35 \,\mu\text{m}$ of HA that was applied with a plasma spray technique. The sizes of the implants used in this series were as follows: 4 size #9, 10 size #10, 19 size #11, 22 size #12, 16 size #13, 6 size #13.5, 6 size #14, 2 size #15, and 1 size #16. The size of the femoral heads used included 36 mm in 20 hips, 32 mm in 50 hips and 28 mm in 16 hips. Although the type of femoral implant was consistent during this experience, a variety of acetabular implants were used, and therefore, their performance was not the target of this investigation.

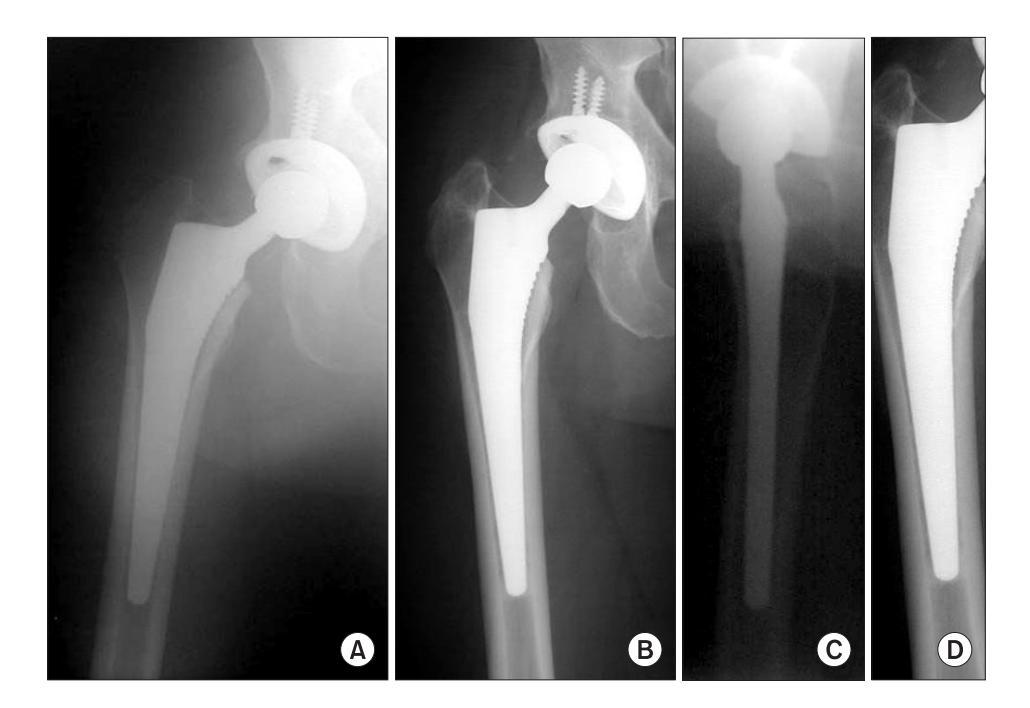
Fig. 2. Evidence of osseointegration with the so-called spot welds or periprosthetic diaphyseal endosteal bone formation seen in at least 3 zones. Zones 2 and 3 were the most reliable sites of spot welds. (A) Immediate postoperative anteroposterior radiograph. (B, C) Anteroposterior and lateral radiographs taken 7 years postoperatively. (D) Magnified anteroposterior radiograph showing reliable periprosthetic osteogenesis around the implant at 7 years follow-up.

Calcar remodeling was common with rounding of the calcar in 50% of the hips. The group with a collared prosthesis exhibited significantly less calcar rounding. All the femoral implants had evidence that the HA coating had stimulated an osteogenic response by exhibiting evidence of osseointegration with the so-called spot welds or periprosthetic diaphyseal endosteal bone formation seen in at least 3 zones; zones 2 and 3 were the most reliable sites of spot welds (Fig. 2). Subsidence was seen in 7 hips and it was less than 4 mm in each case (Fig. 3). Stress shielding was significant in only 2 cases in which the implants were preferentially bonded distally. The remainder exhibited normal or near-normal preservation of the proximal bone structure.

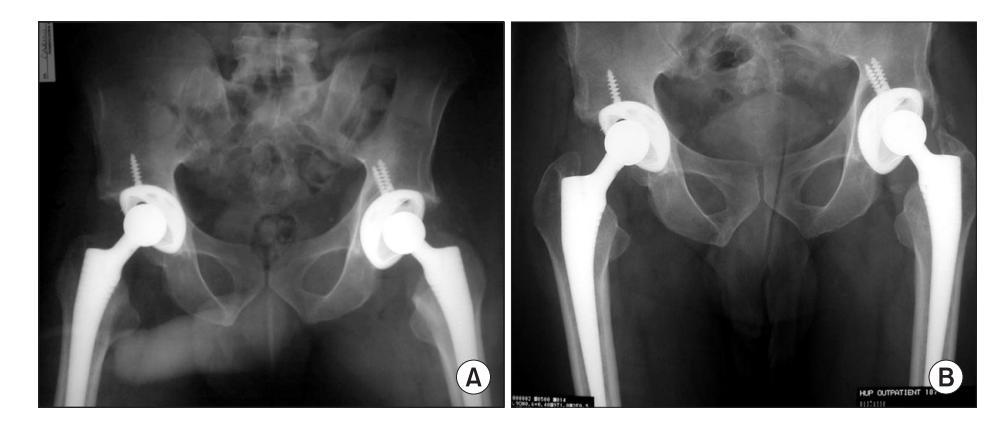
Fig. 3. Anteroposterior radiograph of each hip was obtained immediately postoperatively and at 7 years follow-up. Subsidence was assessed by measuring any change in the distance from the tip of the greater trochanter to the lateral shoulder of the femoral stem on sequential radiographs. (A) Immediate postoperative anteroposterior radiograph. (B) Seven-year follow-up anteroposterior radiograph shows 2 mm subsidence in left hip.
