Journal of Surgical Case Reports, 2021;3, 1-3

doi: 10.1093/jscr/rjab049 Case Report

# A case of a retained chest drain

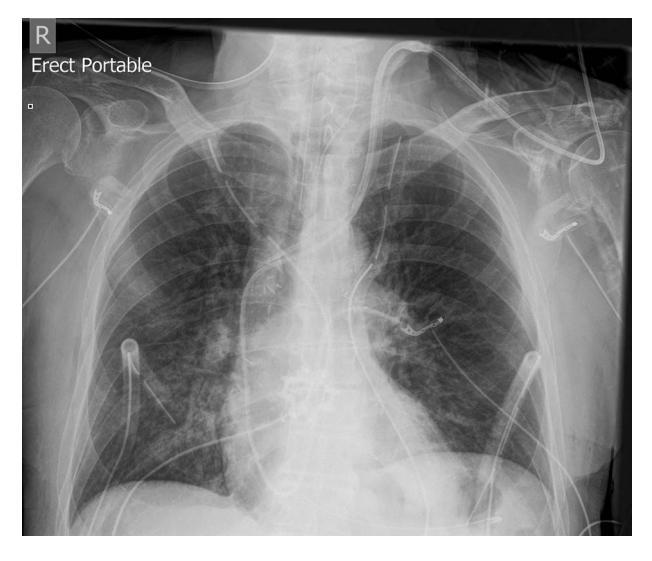
Figure 1: Chest X-ray demonstrating placement of the four chest drains.

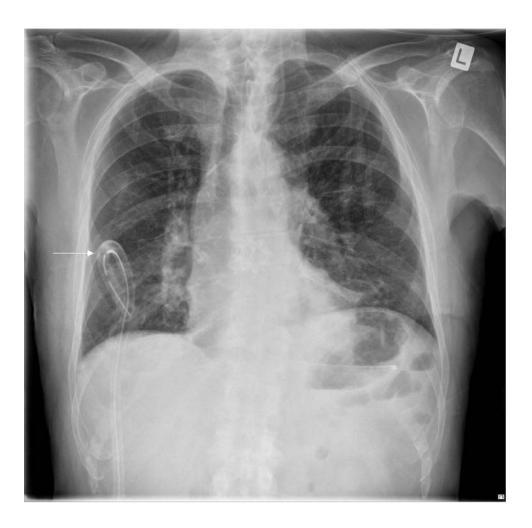
Figure 2: Chest X-ray demonstrating kinking of the chest tube around a rib on the right side.

encountered by the intern during a further attempt to remove the chest drain. A chest X-ray performed earlier in the day was reviewed (Fig. 2). It demonstrated kinking of the drain around a rib. The intern altered the direction of traction in order to account for the kinking but, during gentle traction, the chest drain fractured at the 14-cm mark (Fig. 3) and became retained within the right hemithorax (Fig. 4). The thoracostomy wound was closed and senior help was immediately sought.

Our case serves as a reminder to be mindful of intercostal drain entrapment when placing pericostal sutures. The possibility of inadvertent suture entrapment of a chest drain as a differential diagnosis to kinking observed on a chest X-ray is also highlighted.

Senior input should be obtained if significant resistance is encountered during the removal of a surgical chest drain, especially when coupled with radiographic findings of drain distortion. Doing so may prevent chest drain fracture and unnecessary patient discomfort while surgical exploration is awaited.

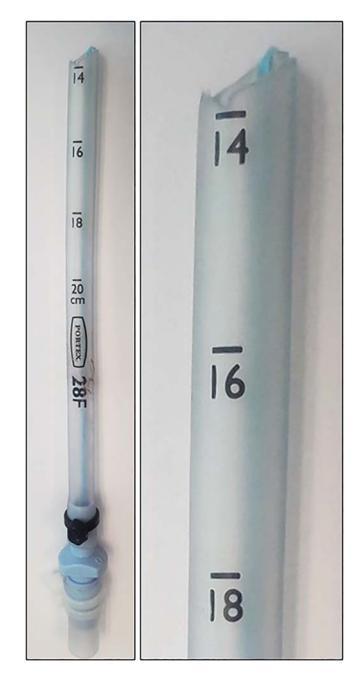
The patient was returned to the operating room several hours' later for exploratory video-assisted thoracoscopic surgery and the retained chest drain segment was removed. It was observed that a 1-0 Vicryl pericostal suture had passed around the tubing at the time of chest closure, thereby securing the 14-cm chest drain fragment against the internal chest wall. The patient's post-operative recovery was otherwise uneventful and he was routinely discharged from the hospital on Day 18. The incident was reported to the Health Quality and Safety Commission of New Zealand.

Figure 3: A 28 F chest tube that became severed at the 14-cm mark upon attempted removal.

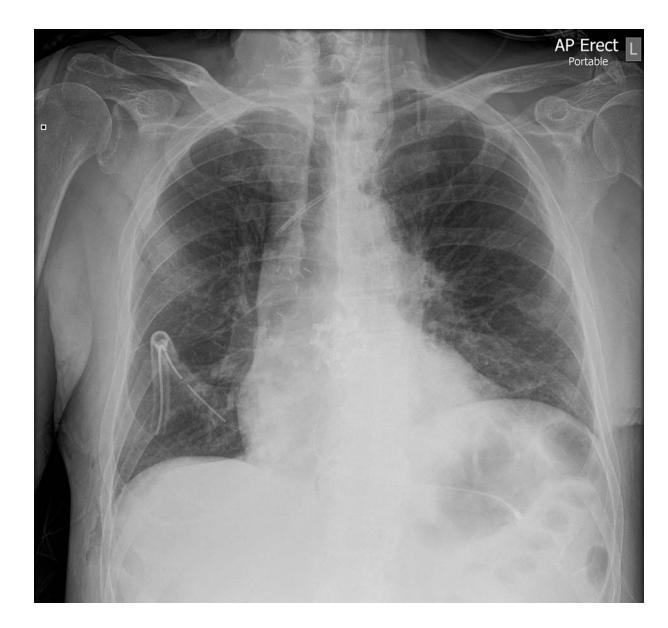
Figure 4: Chest X-ray demonstrating the retained chest tube segment on the right side.
