Ultrasonography of the rumen of dairy cows

Ueli Braun^{*}, Adrian Schweizer and Luzia Trösch

Background: This study describes the ultrasonographic findings of the rumen in 45 healthy dairy cows.

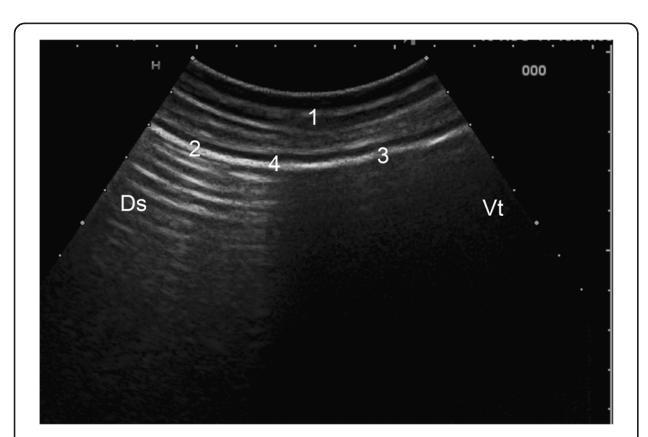
Figure 2 Ultrasonogram of the rumen. Ultrasonogram of the rumen showing the transition between the dorsal gas cap and ingesta layer viewed from the 12th intercostal space on the left side of a nine-year-old Swiss Braunvieh cow. The rumen wall appears as a hyperechoic line. Reverberation artifacts, which run parallel to the ruminal wall, reflect the gas cap and end abruptly at the transition to the fibre mat. 1 Abdominal wall, 2 Rumen wall at the level of the dorsal gas cap, 3 Rumen wall at the level of the fibre mat, 4 Transition between 2 and 3, Ds Dorsal, Vt Ventral.

craniodorsal region, where it was displaced medially by the spleen. The wall appeared hyperechoic, and the dorsal gas cap could be identified because of typical reverberation artifacts (Figure 2). Because of superimposition of the lungs, the course of the dorsal visible margin of the dorsal sac coincided with the ventral border of the lung and ran from cranioventral to caudodorsal (Figure 3, Table 1). The distance between the dorsal midline and the dorsal visible margin was largest (48.3 ± 9.24 cm) at the 9th intercostal space, decreased gradually caudally reaching a minimum (22.4 ± 3.27 cm) at the 12th intercostal space (Difference to ICS 9 P < 0.01) and then

The dorsal gas cap was imaged in all cows from the 12th intercostal space to the caudal flank. It was easily identified by characteristic reverberation artifacts, which disappeared abruptly at the transition to the fibre mat (Figure 2). It measured 20.5 ± 7.03 and 19.2 ± 6.33 cm at the 12th intercostal space and cranial flank, respectively, and 15.6 ± 5.35 cm at the caudal flank (Difference P > 0.05). The size of the dorsal gas cap changed during ruminal contractions. It was not possible to differentiate a fibre mat and a ventral fluid layer because the ingesta below the gas cap had a uniform ultrasonographic appearance.
