ISSN 1941-5923 © Am J Case Rep, 2016; 17: 43-46 DOI: 10.12659/AJCR.895415

Comparison of Superb Micro-Vascular Ultrasound Imaging (SMI) and Contrast-Enhanced Ultrasound (CEUS) for Detection of Endoleaks After Endovascular Aneurysm Repair (EVAR)

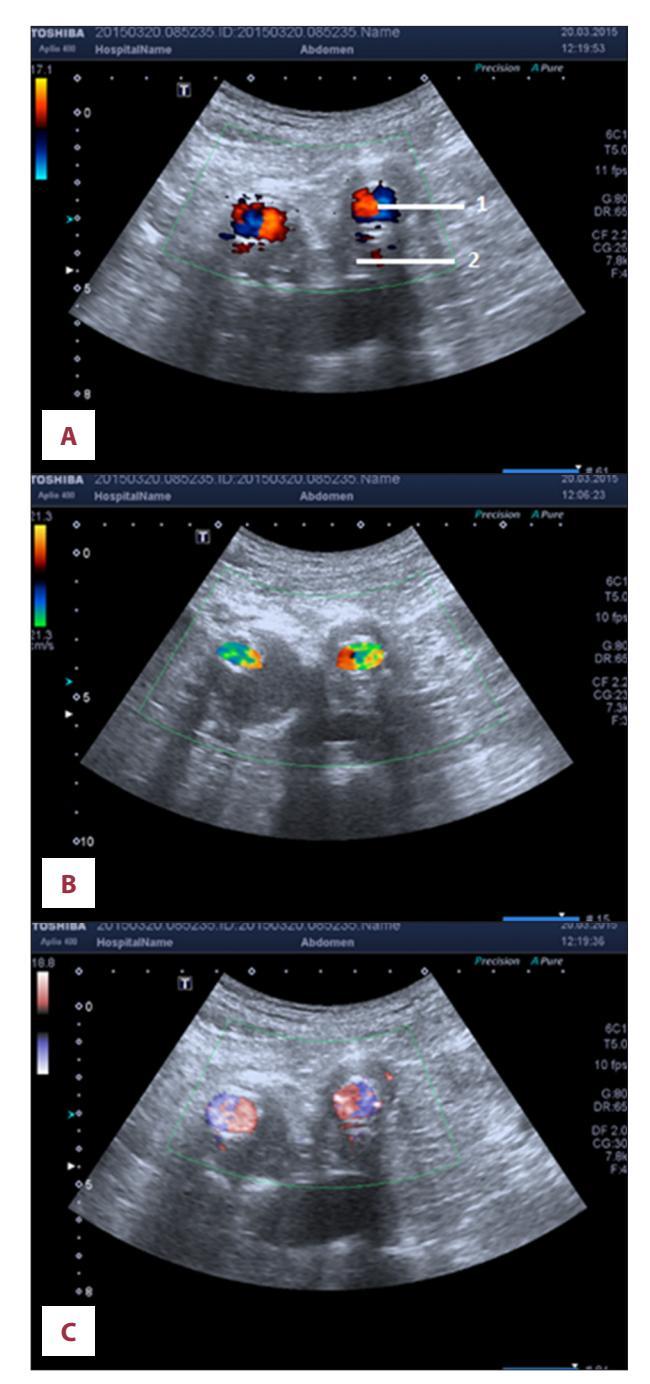
Figure 1. Cross-section through the 2 common iliac artery aneurysms. Retained patency of both legs of the stent-graft is shown by using the color Doppler mode. The blood flow in the aneurysm leg was not visualized, in addition to the lumen of the stent-graft; 1 – stent-graft lumen; 2 – aneurysm sack. Modality: (A) color Doppler, (B) power Doppler, (C) advanced dynamic flow (ADF).

The first part of the examination was a standard morphological investigation in 2D presentation (B-mode) followed by the blood flow analysis using color Doppler, power Doppler, and advanced dynamic flow (ADF) modality. The second part was a cSMI and mSMI approach. Finally, the CEUS was performed after the administration of an intravenous bolus of 2 mL of ultrasound contrast SonoVue (Bracco, Italy). During the B-mode examination the correct location of the stent-graft and the preserved continuity of its walls were clearly visible, while the color Doppler, power Doppler, and ADF examination revealed the presence of blood flow around the lumen of the stent-graft. The blood follow inside of the sack of the aneurysm was not observed (Figure 1A–1C).

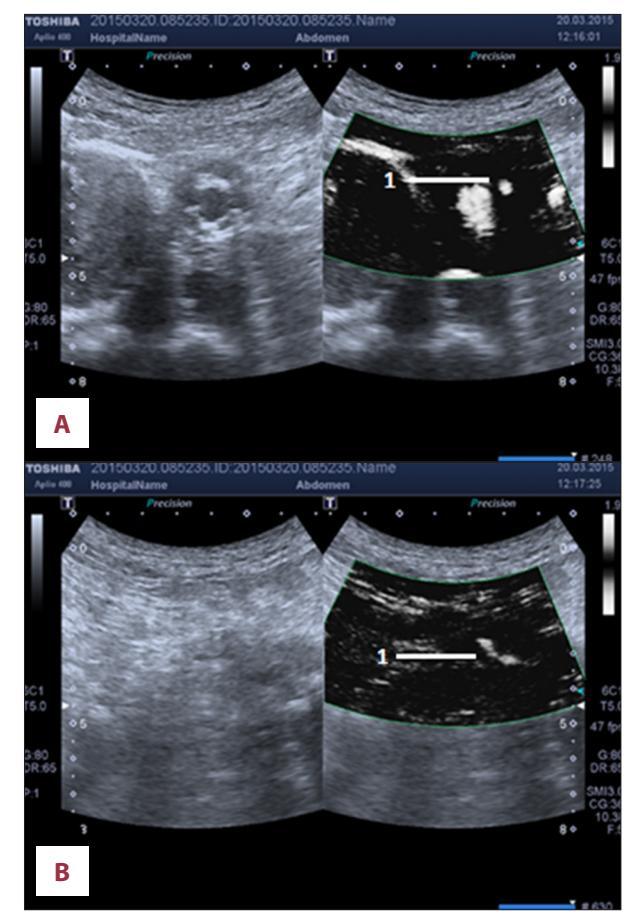
Figure 2. (A) mSMI: the cross-section through the two common iliac artery aneurysms. 1 The zone flow in the aneurysm sack of the left common iliac artery. (B) mSMI: a longitudinal section through the sack of the left common iliac artery aneurysm. 1. The zone flow in the aneurysm sack of the left common iliac artery.

In the mSMI imaging, the presence of flow in the iliac artery aneurysm was observed. The flow zone was seen in transverse and longitudinal sections (Figure 2A, 2B). cSMI imaging enabled the visualization of similar images (Figure 3) but it was less pronounced than in the case of mSMI imaging. By

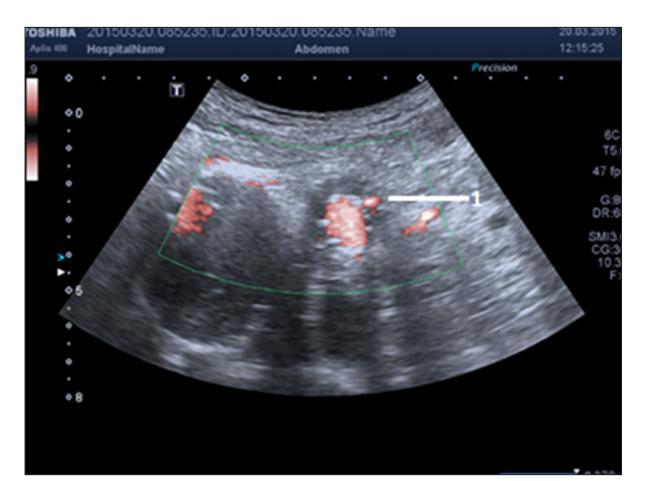
Figure 3. cSMI: The cross-section through the 2 common iliac artery aneurysms, showing retained patency of both legs of the stent-graft. 1. The zone flow in the aneurysm sack of the left common iliac artery.

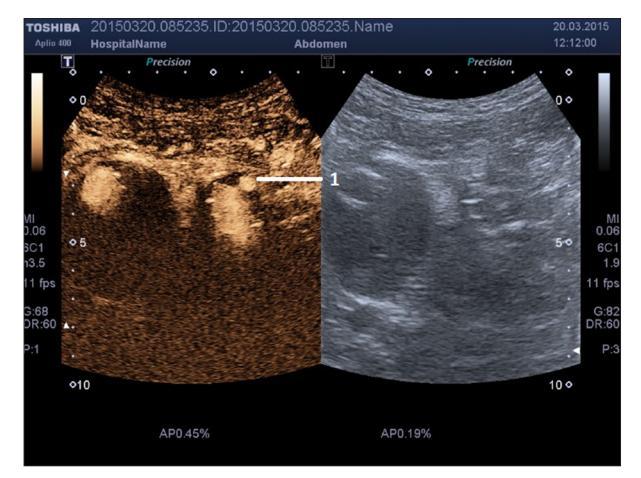
Figure 4. CEUS: The cross-section through the iliac artery aneurysms showing retained patency of both legs of the stent-graft. 1. The zone flow in the aneurysm sack of the left common iliac artery.

the end of the examination, CEUS imaging was obtained and the presence of an endoleak into the iliac artery aneurysm was revealed (Figure 4). Images obtained using cSMI, mSMI, and CEUS showed the presence of an endoleak in the same location and extent. On the CTA scanning taken 4 days after intervention, the endoleak was visible (Figure 5). Type II endoleak was suspected.

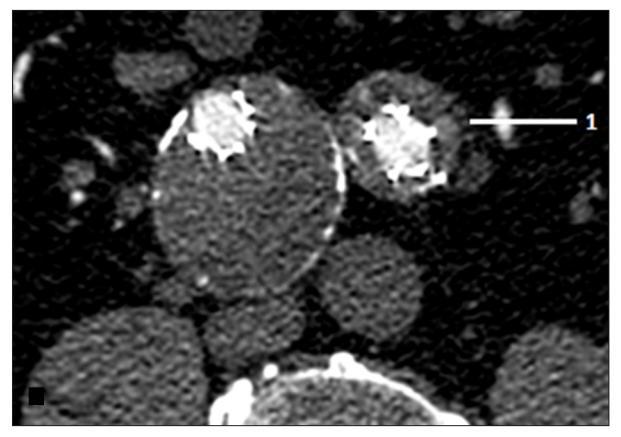
Figure 5. CT angiography: The cross-section through the 2 common iliac artery aneurysms. 1. The zone flow in the aneurysm sack of the left common iliac artery.
