LETTER TO THE EDITOR

A Safe Technique to Remove the Hip Spica

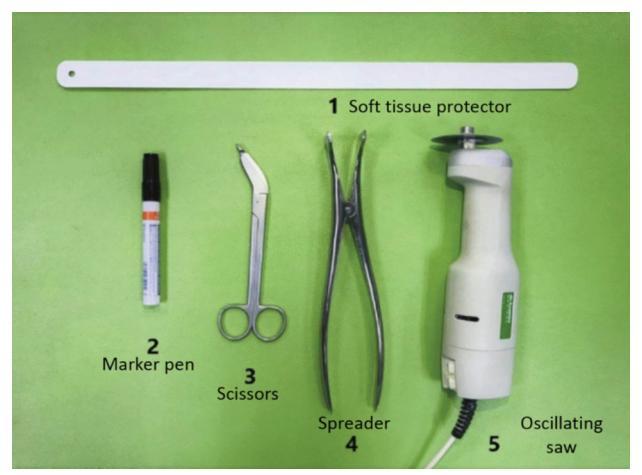
Fig. 1: Tools required for bivalving hip spica.

First, we should prepare the basic instruments for hip spica cast removal (Fig. 1). The child with spica cast is then placed in supine position. Three lines of cut are drawn over the anterior surface of the spica cast (Fig. 2). The first line is drawn from the midpoint of the superior rim vertically downwards to the groin opening. The shorter limb of the spica cast is usually on the contra-lateral to the unstable hip or fractured femur. The second line is drawn from the midpoint of the inner distal rim, extending horizontally to the groin opening. The longer limb of the cast is usually on the ipsilateral side of the pathological condition. A third anterior line is drawn from the midpoint of the inner ankle, extending proximally crossing the medial aspect of knee, and horizontally towards the groin opening. Cutting the spica cast along these lines would circumvent the groin crease, which is one of the common sites of skin injury. In addition, soft tissue protector can be inserted between the cast and skin along these lines to further reduce the risk of skin injury. Once the cuts had been performed, a spreader is used to ensure that the cuts were complete (full thickness).

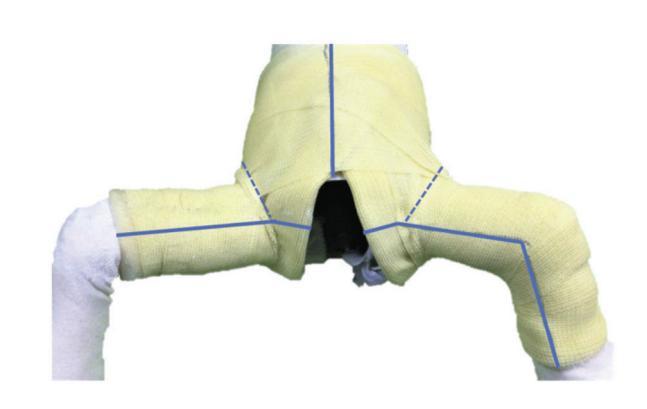
Fig. 2: Anterior aspect of hip spica. The 3 solid blue lines depicting the 3 cuts by oscillating saw which avoid groin creases (dotted lines).

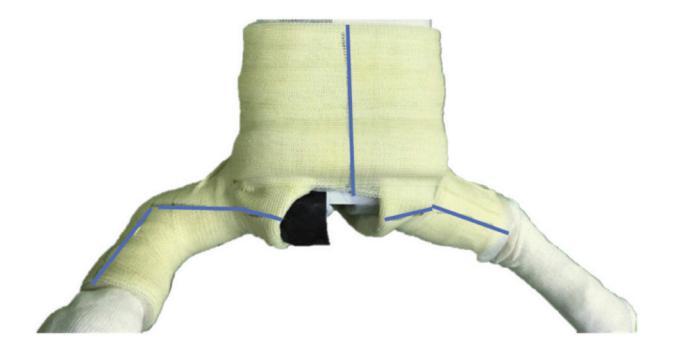
Fig. 3: Posterior aspect of hip spica. The 3 solid blue lines depicting the 3 cuts by oscillating saw.

The child with the cast is then put in prone position. Three more lines are drawn on the posterior surface of the cast (Fig. 3). The first line is a vertical line extending from the

midpoint of the superior rim, caudally towards the groin opening. The second line on the shorter limb is a horizontal line extending from the midpoint of the distal rim to the groin opening. The third line extends from the midpoint of the distal rim of the ankle, proximally on the lateral aspect of the knee, extending horizontally to the groin opening. Once these cuts have been completed, the cast can be removed.
