## Ultrasonography of a Helical Left Common Carotid Artery

**Case Presentation:** An 83-year-old woman was admitted to the intensive care unit for septic shock at which point an internal jugular central venous line was placed. The patient's common carotid artery was visualized in an atypical location, lateral to the internal jugular vein. Further inspection revealed the common carotid artery travelling in a rotational trajectory around the internal jugular vein.

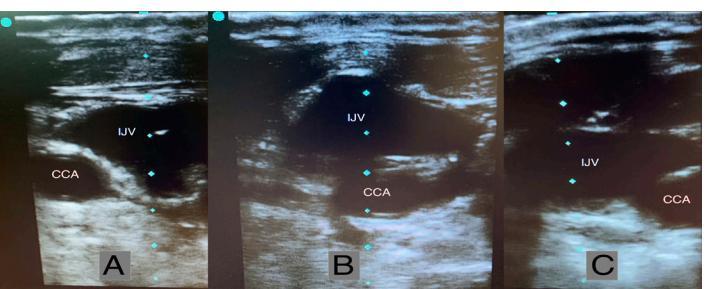
**Image.** (A) Ultrasonography of patient's left neck in a neutral position showing the common carotid artery (CCA) lateral to the internal jugular vein (IJV), (B) coursing posteriorly as it travels caudad in a rotational trajectory, and (C) ultimately reaching its typical orientation medial to the IJV.

An 83-year-old woman was admitted to the intensive care unit for septic shock. During central venous catheter placement, ultrasonography was used to guide insertion. When the probe was placed on the left side of the neck in a neutral position, the internal jugular vein (IJV) was noted to be medial to the common carotid artery (CCA) (Image, Panel A). Upon scanning caudad approximately eight centimeters, the CCA coursed medially in a rotational trajectory nearly 180 degrees (Video) ending up in its typical orientation, medial to the IJV (Image, Panel B and C).

**Video.** With the provider at the head of the bed with the ultrasound probe on the patients left neck, we initially see the common cartoid lateral to the internal jugular vein. Sliding the probe caudad, the artery dives in a spiral trajectory posterior to the vein, ultimately reaching its typical orientation medial to the vein just above the clavicle.
