A Rare Case of Open 3A VTB2W Periprosthetic Fracture around a Total Hip Arthroplasty

Open VTB2W PPF around an Exeter stem can be internally fixed if the bone cement interface is intact and the fracture can be anatomically reducible, double plating provides more stability for early weight bearing mobilization.

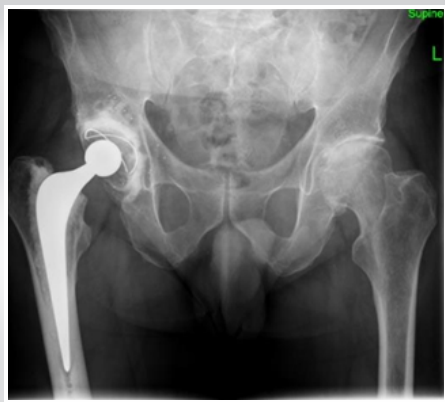
Figure 1: A well fixed 7-year-old cemented THA before PPF.

primary hip osteoarthritis (Fig. 1).

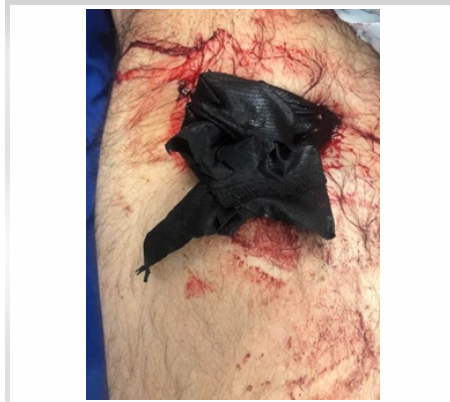
Figure 2: Cycling cloth shorts stuck at the fracture site on the anterior aspect of the patient's thigh.

He sustained an open 3A comminuted right PPF with his clothing contaminating the fracture site (Fig. 2). The open wound was present on the anterior aspect of his thigh (Fig. 3). His PPF was classified as VTB2W with no evidence of loosening at the cement bone interface (Fig. 4).

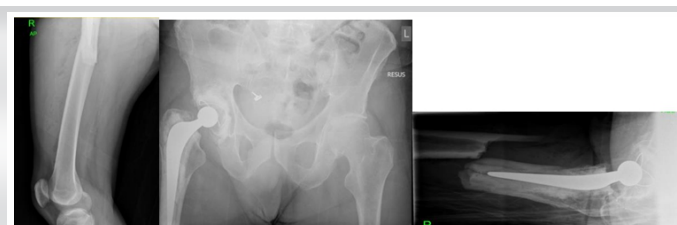
Figure 4: (a, b, c) Showing radiographs of a VTB2W PPF.

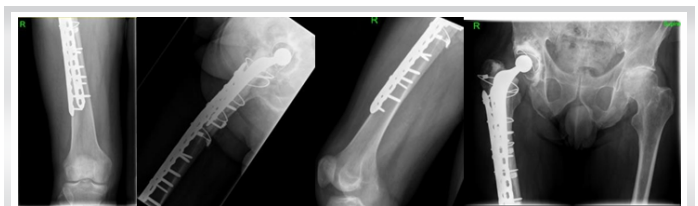
Figure 5: (a, b, c, d) AP and Lat radiographs showing a double plate fixation supplemented by cables for the PPF.

The fracture was reduced and reduction held with Kinamed Iso-elastic polymer cerclage Supercables (Camarillo, CA, USA). The fracture was then further stabilized using double plating technique with both plates at 90° to each other to provide a biomechanically stable construct. A broad curved Depuy Synthes (MA, USA) LCP 4.5 mm stainless steel plate was placed laterally and a narrow Depuy Synthes LCP 4.5 mm plate anteriorly underneath quadriceps through the same lateral incision. Non-locking screws were used to compress the plate to bone followed by locking screws to minimize the risk of plate failure. Dall Miles 2 mm Cables (Stryker Ltd, Kalamazoo, In) were then placed around both plates to supplement fixation (Fig. 5). The wound was irrigated with 9 L pressurized, pulsed saline wash followed by low pressure 6 L 0.02% aqueous Chlorhexidine wash. Absorbable Vicryl sutures were used for deep layers followed by subcuticular monofilament absorbable skin closure.
