SCIENTIFIC REPORTS

Accelerating Corrosion of Pure Magnesium Co-implanted with Titanium *in Vivo*

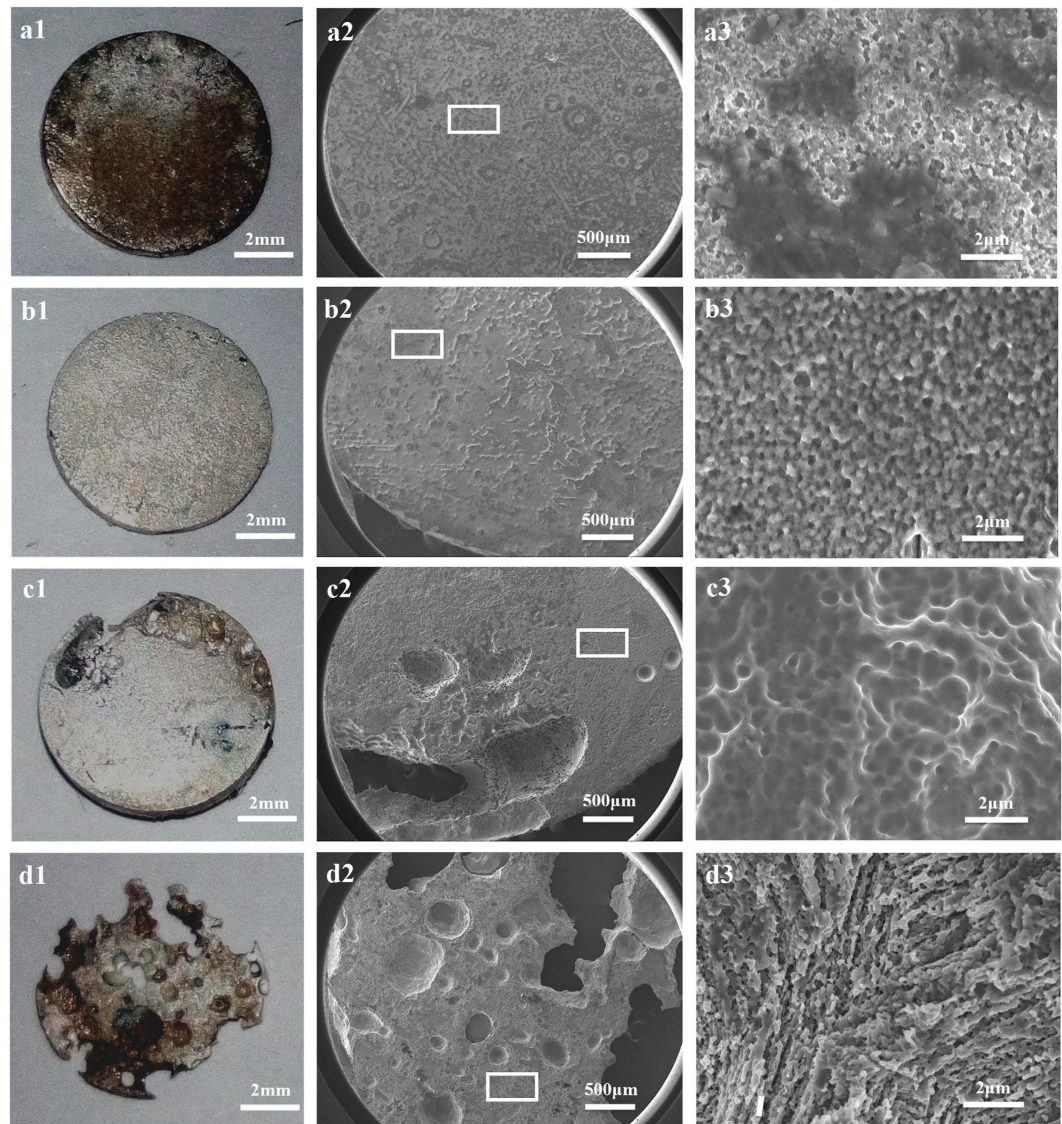
Figure 1. Gross observations (a1–d1) and SEM morphologies (a2–d2 and a3–d3) of the HP Mg discs. (a) control group; (b) Group 10; (c) Group 5; and (d) Group 0.

***In vitro* corrosion behavior of HP Mg affected by Ti.** Gross observation in Fig. 1 shows that the HP Mg discs in the control group remained integrated after 1 week of immersion. The SEM morphologies revealed that the samples experienced relatively uniform corrosion (Fig. 1a2). Only small pits could be seen on the corrosion surface. In contrast, the HP Mg discs in Group 0 suffered severe corrosion and were almost depleted. Due to the great potential difference, which is -1.6 V vs SCE for pure Mg²³ and -0.4 V vs SCE for Ti in PBS²⁴, galvanic corrosion occurred and significantly accelerated the corrosion of Mg. The SEM results demonstrated that there was a large area that had non-uniform degradation (Fig. 1d2).

It was observed that enhanced corrosion occurred in the HP Mg samples in Group 5 when the Mg and Ti disc were not in contact with each other, i.e., the galvanic corrosion unit did not formed. Several large corrosion pits could be seen on the edge of HP Mg disc according to the SEM morphology (Fig. 1c2). When the distance increased to 10 mm, the surface of HP Mg disc became relatively flat with many small corrosion pits (Fig. 1b2).

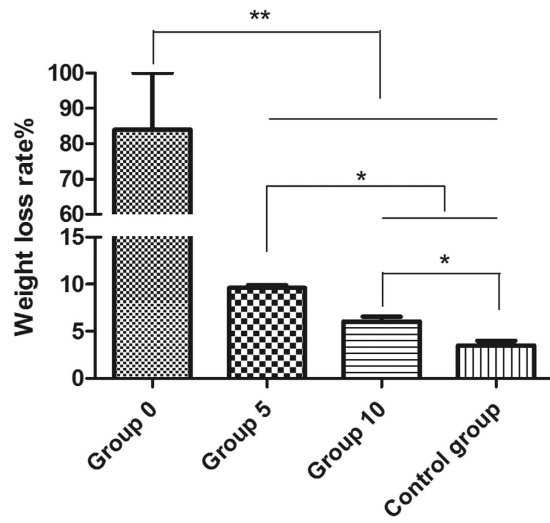
Figure 2. Weight loss rate of HP Mg disc. * $p < 0.05$; ** $p < 0.01$.

Accordingly, a significant difference ($p < 0.05$) was revealed in the weight loss rate between Group 5 ($9.6 \pm 0.4\%$, $n = 3$) and Group 10 ($6.0 \pm 0.6\%$, $n = 3$). Moreover, as illustrated in Fig. 2, the weight loss rate of both Group 5 and Group 10 are obviously higher than the Control group ($3.5 \pm 0.7\%$, $n = 3$; $p < 0.01$ and $p < 0.05$ respectively).

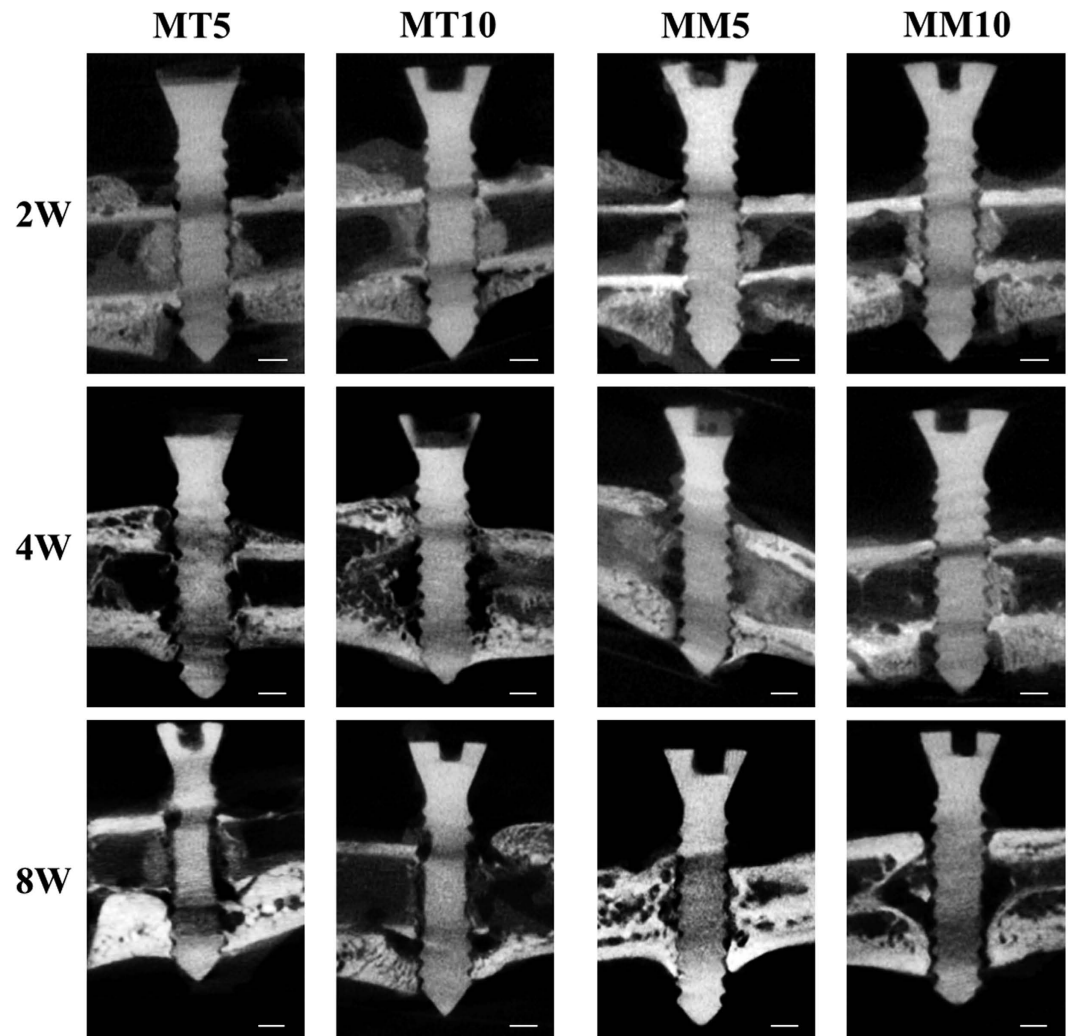
Figure 3. CT image of HP Mg screws in different groups. The bar represents 1 mm.

Micro-CT scan. The representative 2D micro CT images of femurs with screws are shown in Fig. 3. It is demonstrated that a region of low density locates around the cortical bone in all groups during the 8 weeks of implantation. In group MT 5 and MT 10, a massive cavity was found around the screws after 4 weeks of implantation and the screws showed a blurring screw thread contour and a thin screw body after 8 weeks of implantation. Newly formed bone was found around the HP Mg screws, but the connection was not tight. In contrast, the HP Mg screws in both Group MM 5 and MM 10 remained relatively integrated, with only mild changes in the depth of the screw thread after 8 weeks implantation. A large amount of new bone formation that had a tight connection with HP Mg screws was observed. No obvious difference of screws degradation or osteogenesis was found between Group MT 5 and MT 10 at each time point. However, the 3D reconstruction of the HP Mg screws shown in Fig. 4a illustrates that the HP Mg screws in Group MT 5 have a higher corrosion rate than that in Group MT 10. A corrosion crack was found on the HP Mg screws as early as 4 weeks in Group MT 5, and a wider crack was found after 8 weeks of implantation, while the HP Mg screws in Group MT 10 remained integrated after 8 weeks. Although no obvious crack was found in Group MT 10, the screw had a thinner body than that of Group MM 5 and MM 10. The calculated volume loss (Fig. 4b) confirmed that during the 8 weeks of implantation, the volume of the Mg screws in Group MT 5 reduced more than those in Group MM 5 and MM 10. No significant difference was observed between Group MM 5 and MM 10.

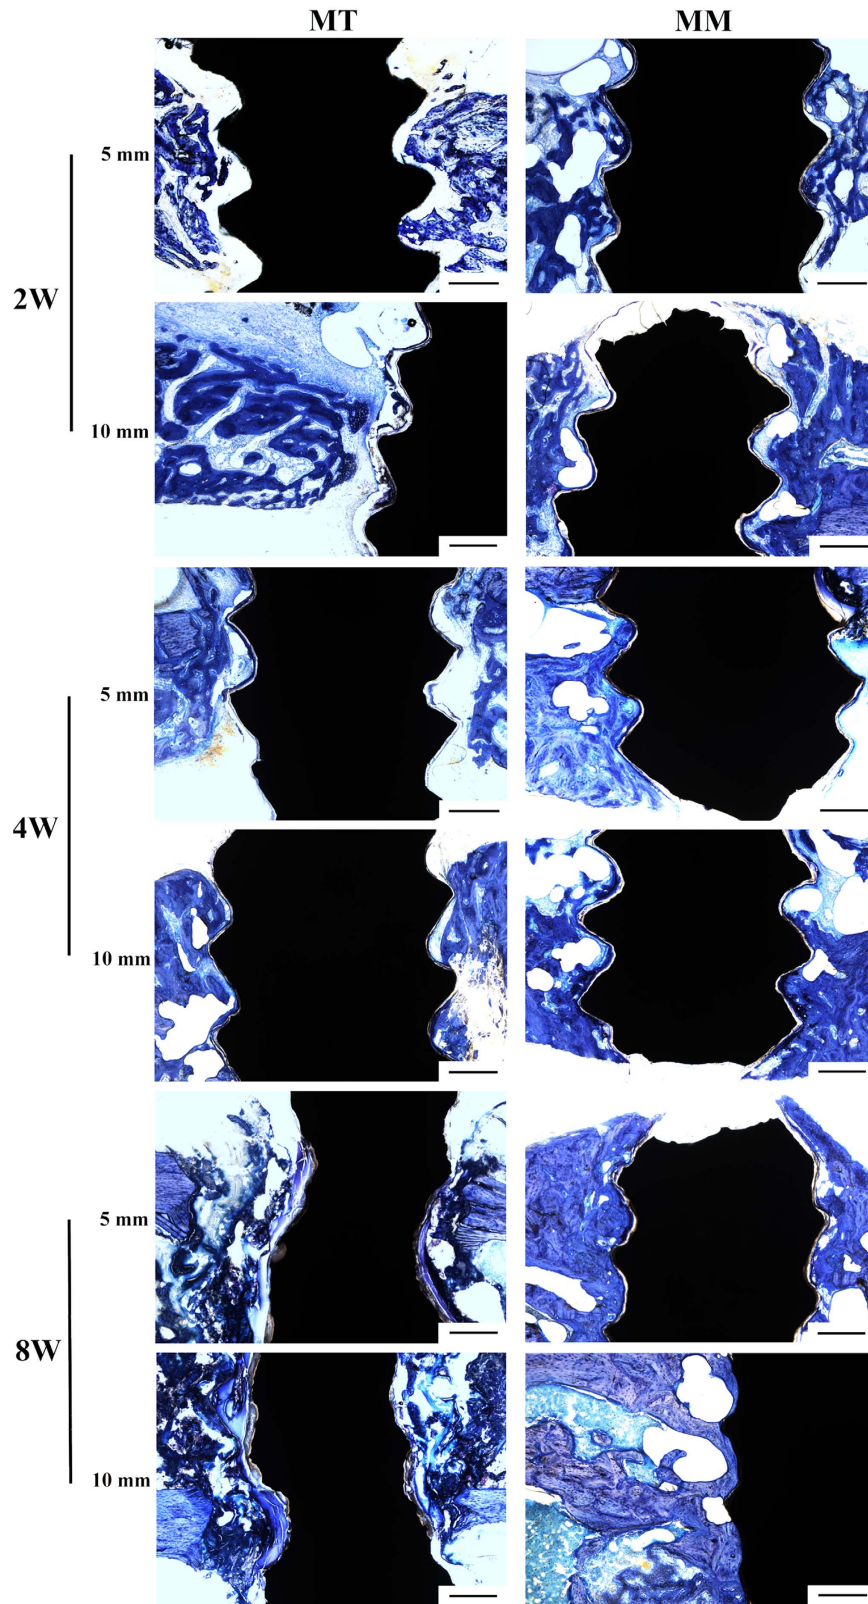
Figure 5. Histological analysis of the bone tissue around the magnesium implant. The bar represents 400 μm .

Histological analysis. Figure 5 illustrates the results of a histological analysis of the bone tissue surrounding the Mg screws. In Group MT 5 and MT 10, inadequate osteogenesis was found after 2 weeks of implantation. Massive cavities were observed in the cortical bone and around the screws, and only part of the newly formed bone (stained in dark blue) contacted the screw. After 4 weeks of implantation, cavities still existed around the screws and the bone tissue did not directly contact the screws; instead, a gap that contained an osteoid structure (stained in light blue without cell structure) existed between the screw and cortical bone. Although fewer cavities were observed after 8 weeks of implantation, the gap between the screw and cortical bone was wider and the content in this gap became disordered. Additionally, it was obvious that the screws in Group MT 5 and MT 10 degraded more severely than those in Group MM5 and MM 10. In contrast, although inadequate osteogenesis and cavities also existed after 2 weeks of implantation in Group MM5 and MM 10, the newly formed bone tissue contacted HP Mg screws well after 4 and 8 weeks of implantation. The BIC presented in Fig. 6 indicates poor osseointegration in Group MT 5. When the distance between Mg and Ti screw increase to 10 mm, the BIC increase slightly. No statistical difference was found between Group MM 5 and MM 10.

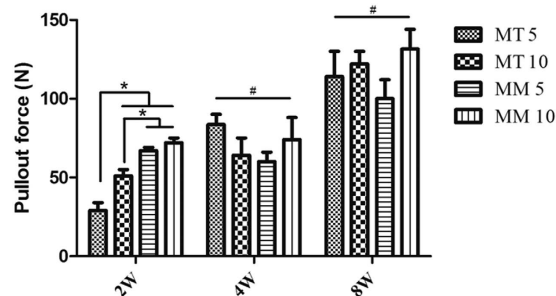
Figure 7. Pullout force of different groups. * $p < 0.05$; # $p > 0.05$.

Pullout test. A dramatic decrease of the pullout force of the HP Mg screws was observed in the first 2 weeks of implantation in Group MT 5 and MT 10. However, no significant difference was found after 4 weeks of implantation among all groups. In general, the pullout force increased steadily over the duration of implantation (Fig. 7). No statistical difference was found between Group MM 5 and MM 10.

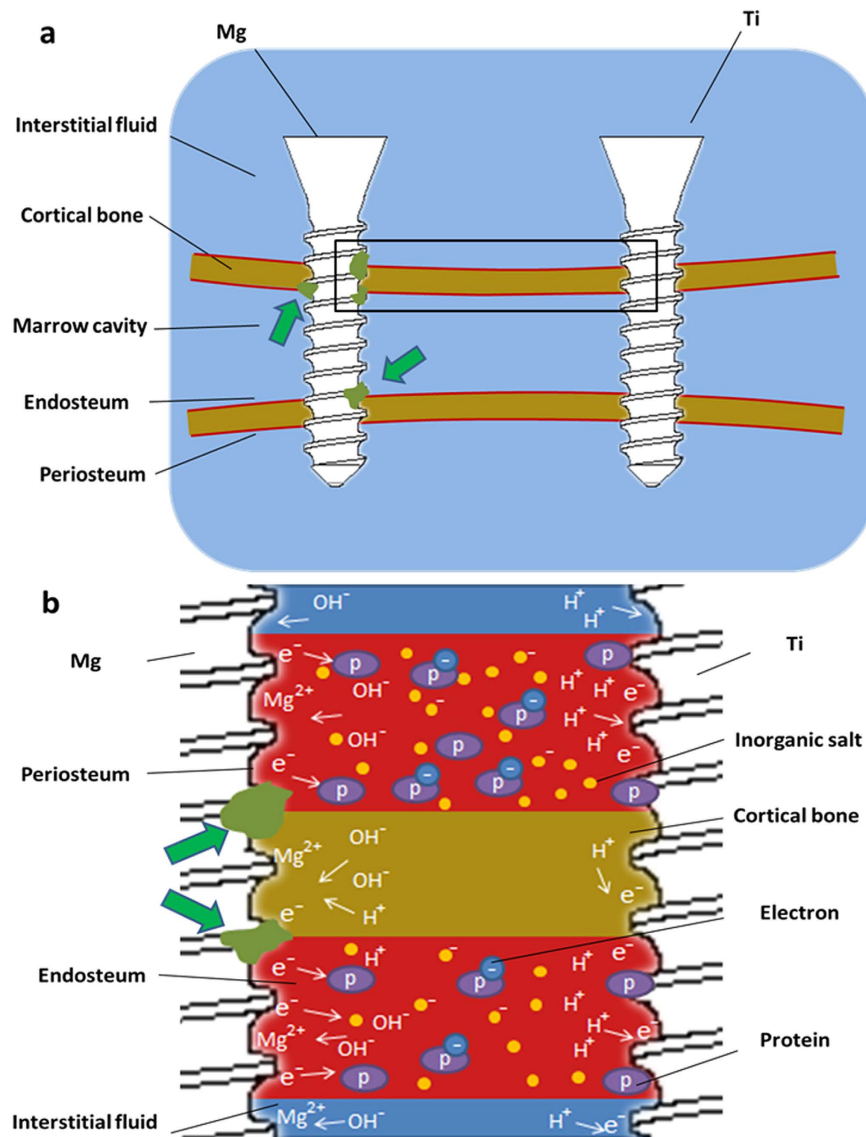
Figure 8. (a) Schematic diagram of the femoral diaphysis with screws implanted. The green arrows point the site that is most susceptible to corrosion. (b) Possible corrosion mechanism of HP Mg screws when co-implanted with Ti screw. (b) is the magnification of rectangular region in (a).

Figure 8 is the schematic diagram of the femoral diaphysis with screws implanted. According to the result of micro CT, the most severe corrosion site was stained in green in Fig. 8a. It should be noticed that these sites were in contact with periosteum or endosteum, which contain abundant blood vessels. It is well known that the plasma contains various proteins, some of which could play a role in the electron transport³⁴. Chen *et al.*³⁵ found side chains of four aromatic amino acids (Phe, His, Tyr, and Trp residues) may promote methionine and cystine residues to participate in the protein electron hole transport. The electrical conductivity of blood vessels was also reported in many researches^{36–38}. Thus, as depicted in Fig. 8b, it is hypothesized that electrons at anode

might migrate to the cathode (Ti screw) through binding with proteins. The electrically conductive blood vessels connected Mg and Ti screws, together with body fluid, formed a galvanic-like cell. The degradation of Mg also occurred in the other part of Mg screw, however, due to limited electron transfer, the corrosion rate was relatively slow. Moreover, as the distance between Mg and Ti screws increases, the electric resistance will increase proportionally and the effect of the potential difference will diminish. It should be pointed out that tissues such as bone and muscle etc. have been proved to have electric resistivity³⁹, indicating that tissues other than blood vessels might also be involved in the process of electron transport. However, exact mechanism needs to be further investigated.
