Intramedullary Stabilization of Pubic Ramus Fractures in Elderly Patients With a Photodynamic Bone Stabilization System (IlluminOss)

Geriatric Orthopaedic Surgery
& Rehabilitation
Volume 10: 1-8
© The Author(s) 2019
Article reuse guidelines:
sagepub.com/journals-permissions
DOI: 10.1177/2151459318824904
journals.sagepub.com/home/gos

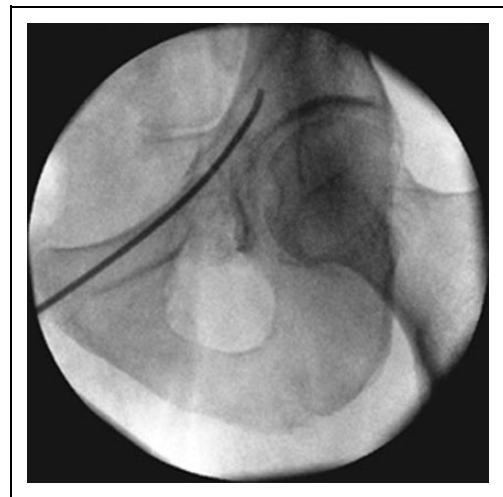
Figure 1. Intraoperative fluoroscopy image: control of the position of the elastic wire titanium elastic nail.

All surgeries were performed in the supine position under general anesthesia. Closed reduction was performed under fluoroscopy guidance in anterior–posterior, inlet, and outlet X-rays. A percutaneous anterior approach superior of the symphysis to pubic ramus was chosen. After identifying the pubic ramus and opening the cortical bone with an awl, an ~3-mm elastic wire (titanium elastic nail) was inserted retrograde to the pubic ramus under fluoroscopy guidance (Figure 1). The position of the wire was controlled with an intraoperative fluoroscopy scan

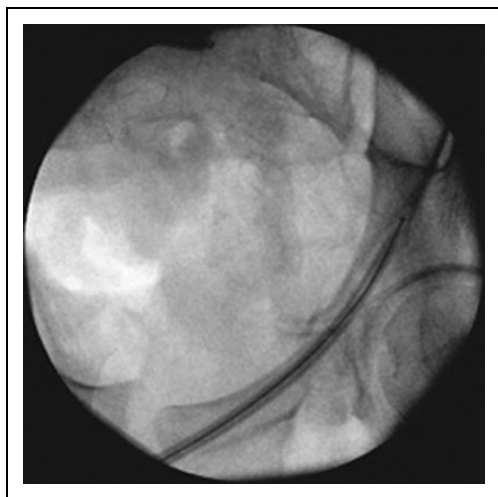
Figure 2. Intraoperative fluoroscopy image: control of the position of the balloon catheter of the IlluminOss system.

(Arcadis Orbic 3D; Siemens, Erlangen, Germany). After controlling the sufficient position of the wire, the intramedullary space was drilled so that the balloon catheter of the IlluminOss system ($\sim 9 \text{ mm} \times 160 \text{ mm}$) could be inserted in the pubic ramus (Figure 2). The next step was to fill the balloon catheter with the photodynamic monomer causing the catheter to expand. After connecting the balloon catheter to the photodynamic curing system, the photodynamic monomer converts to a polymer (Figure 3). This procedure leads to the hardening of the implant and stabilization of the fracture (Figure 4). The hardening procedure lasts for 4 minutes. Final X-rays in anterior–posterior, inlet, and outlet view were performed to control

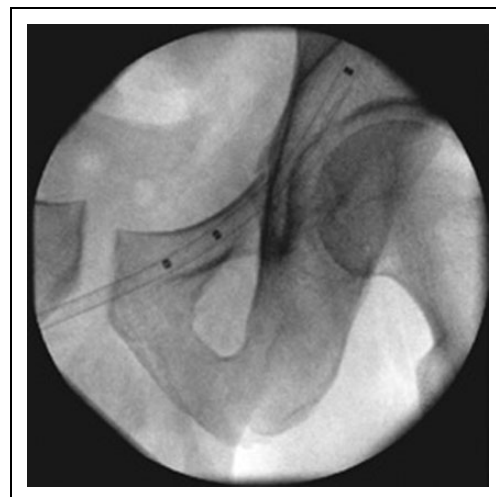
Figure 4. Connection of the photodynamic curing system with the balloon catheter.

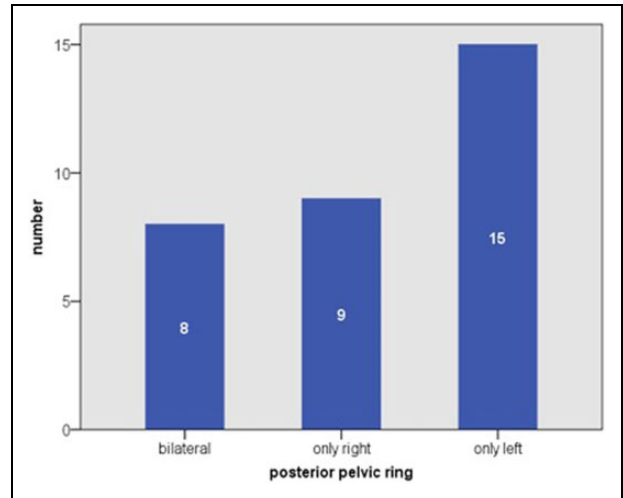
**Figure 6.** Bar diagram showing the distribution of the posterior pelvic ring fractures.

The distribution of the FFP and ASA classification is described in Tables 3 and 4, respectively. In Figures 6 and 7, the distribution of the posterior and anterior pelvic ring fractures is described. The average hospital stay was 16.5 ± 7.9 days (range: 5-37 days), and the mean operation time was 116.8 ± 47.1 minutes (range: 33-255 minutes). During the hospitalization, wound infections with revision surgery were reported in 2 cases. In one case, a misplacement of the PBSS implant following revision surgery was documented. Major complications, such as nerve or vessel injury, did not occur.

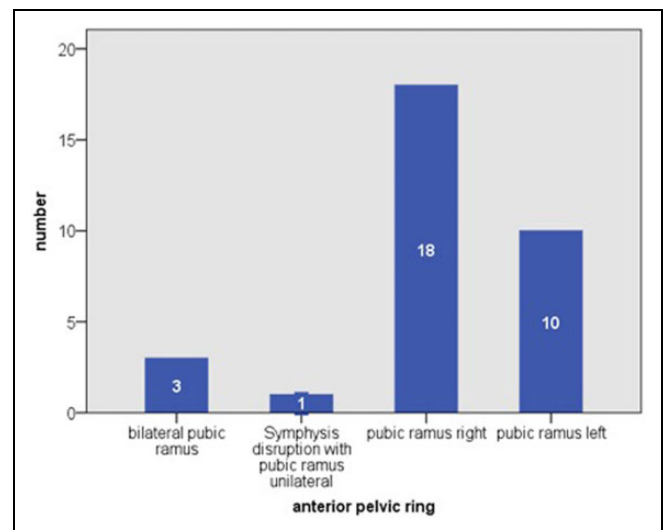
**Figure 7.** Bar diagram showing the distribution of the anterior pelvic ring fractures.

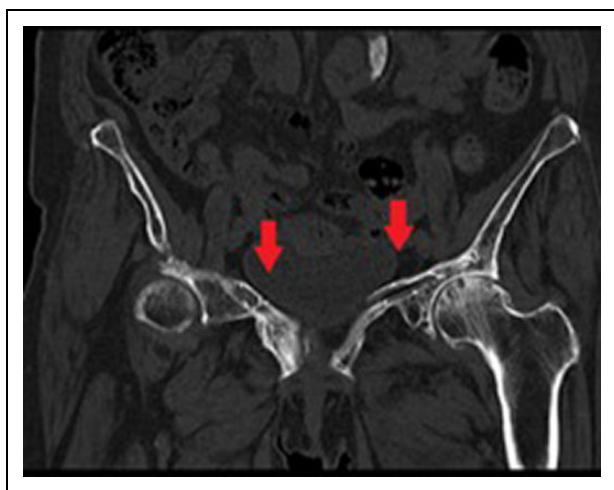
Figure 9. Computed tomography (CT) scan 6 months after the procedure (A, coronal; B, sagittal): The red marker points to the consolidated fractures of both pubic rami.

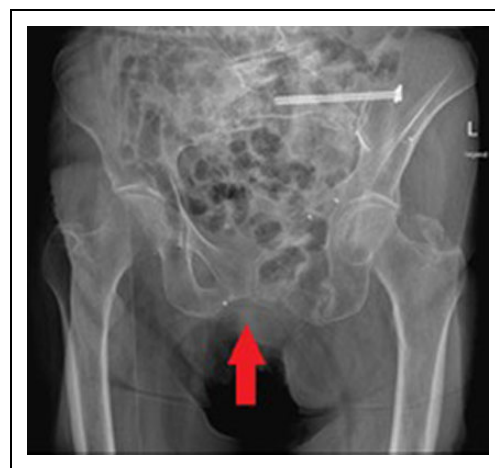
Figure 10. Radiological examination of the pelvis: The red marker points to the dislocated PBSS implant. PBSS indicates photodynamic bone stabilization system.

Twenty-five (78.1%) patients could attend the follow-up examination. A loss to follow-up of 7 patients (21.9%) was reported (Figure 8). The mean time of the follow-up examination was 7.5 ± 1.7 months (range: 6-14 months) after the procedure. The mean VAS score for pelvic/hip pain in the follow-up examination was 3.0 ± 2.2 (range: 0-8), showing a statistically significant reduction ($P < .05$). A total of 11 patients could walk without an orthopedic walking device, 7 patients needed underarm crutches, 6 patients used a walker-rollerator, and 1 patient was immobilized. In the CT scan, consolidated pubis ramus fractures were reported in 96% of the cases ($n = 24$; Figure 9). In one case, implant breakage and dislocation with development of a nonunion were recorded (Figures 10 and 11). In this case, the dislocated part of the

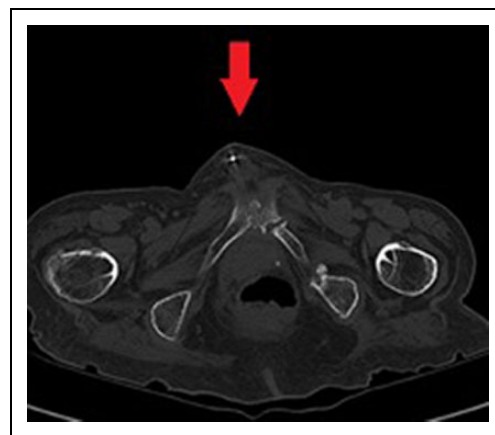
Figure 11. Computed tomography (CT) scan of the pelvis: The red marker points to the dislocated photodynamic bone stabilization system (PBSS) implant and the nonunion.
