The effect of glazing and aging on the surface properties of CAD/CAM resin blocks

PURPOSE. To investigate the effect of accelerated aging on surface properties of glazed CAD/CAM resin blocks using a 2D surface profilometer and a 3D non-contact optical profilometer. **MATERIALS AND METHODS.** Three types of CAD/CAM resin restorative materials, LAVA Ultimate (3M ESPE, St Paul, MN, USA), VITA Enamic (Vita Zahnfabrik H. Rauter, Bad Säckingen, Germany), and Cerasmart (GC Corporation, Tokyo, Japan) were used for this study. CAD/CAM blocks were cut in 3-mm thickness slabs and divided into three groups; Group 1: control group (specimens polished with 600 grit SCI paper); Group 2: specimens sandblasted, silanized, and glazed with Optiglaze Color (GC); Group 3: glazed specimens subjected to 5000 thermocycles (n=15). The surface roughness (R_a and R_z) was evaluated using a profilometer and a 3D scanning instrument. Data were analyzed using two-way ANOVA and Tukey's post-hoc test ($P<.05$). **RESULTS.** LAVA, VITA, and Cerasmart exhibited statistically similar R_a and R_z values for each group ($P>.05$). For VITA and Cerasmart, the specimens in Group 1 exhibited significantly higher R_a valu

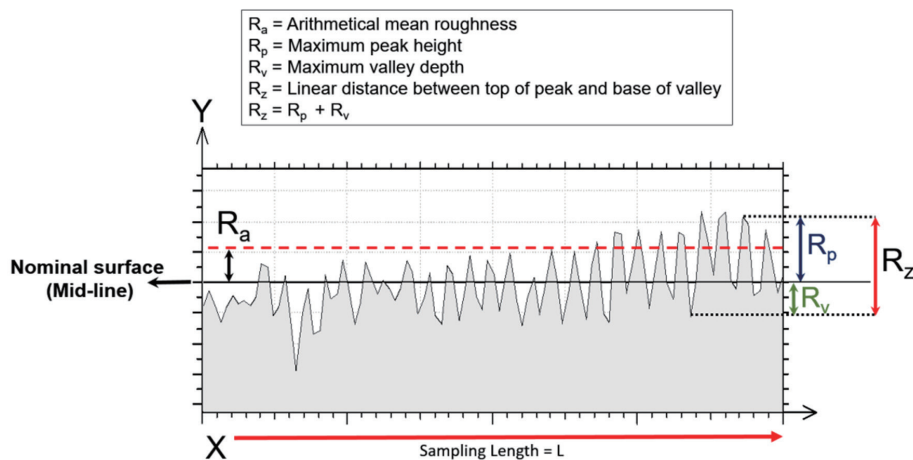
Fig. 1. Illustration of surface roughness parameters.

The surface roughness of specimens was measured using a 2-dimensional profilometer (Surtronic S128, Taylor Habson Ltd., Leicester, England) with a 5- μm diamond stylus angled at 90°. Starting from the midpoint of each specimen, 5 measurements were taken in different directions, with a cut-off length of 0.8 mm and measuring length of 4 mm, and the average roughness value for each specimen was then calculated and recorded (R_a and R_z values, in μm , Fig. 1).¹⁹

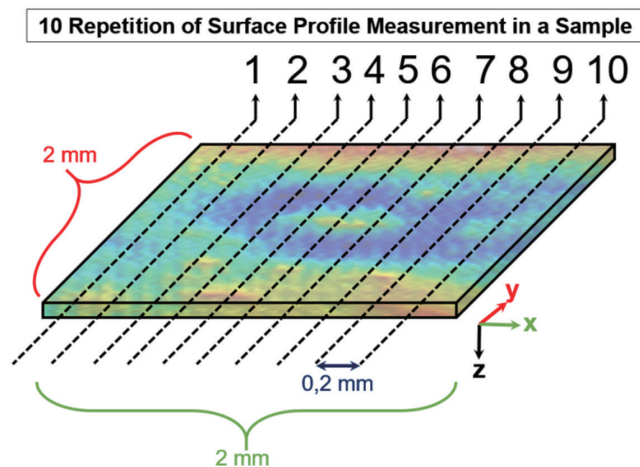
Fig. 2. Illustration of obtaining profile roughness lines from 3D scanned surfaces. Ten repetitions were performed for each measurement and the median value was accepted as the profile image.

parameters of samples, a Nanovea 3D Non-Contact Profilometer PS50 (Nanovea, 6 Morgan Ste 156, Irvine, CA, USA) was used. The non-contact laser profilometer has a leading edge optical pen that uses superior white light axial chromatism. A 2×2 mm square area was used for roughness analyses. The scanning process was accomplished in steps of $20 \mu\text{m}$ in both X and Y directions with 0.1 mm/s velocity. 3D surface topographies and profile roughness evaluations were realized using Mountain Software Version 6.2.7487 (Digital Surf). Profile roughness lines were taken from 3D scanned surfaces. In order to calculate the profile lines, 10 repetitions for each measurement were performed

and the median values were used (Fig. 2). Surface profile lines 0.2 mm apart were taken and percentage error calculations were made for every sample.

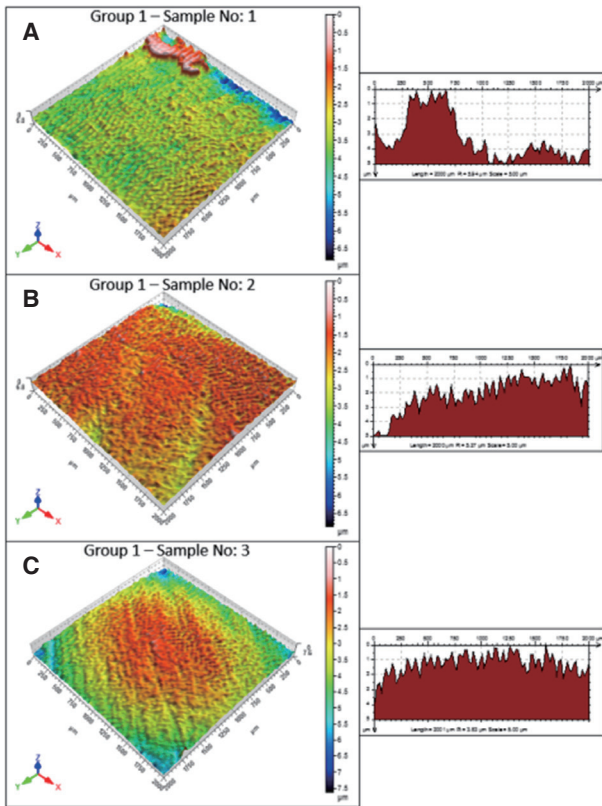
Fig. 3. 3D images of the specimens in group 1 (SiC paper grinding specimens). (A) LAVA, (B) VITA, (C) Cerasmart.

After SiC paper grinding, CAD/CAM restorative surfaces had the largest surface irregularities with concentrated sharp peaks and valleys. Surface roughness or irregularities of LAVA (Fig. 3A) were found higher than VITA (Fig. 3B) and Cerasmart (Fig. 3C). LAVA displayed a rough surface in a small area (Fig. 3A). The surface topography of VITA exhibited smooth in general and surface roughness increased in very small fields (Fig. 3B). For Cerasmart, surface irregularities showed variability with deep scratches, concentrated sharp peaks and valleys (Fig. 3C).

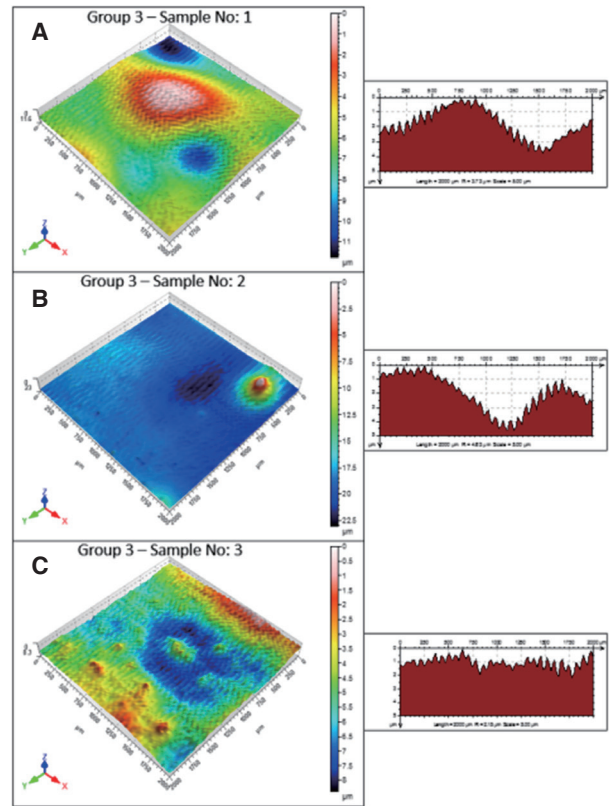
Fig. 5. 3D images of the specimens in group 3 (thermocycled specimens). (A) LAVA, (B) VITA, (C) Cerasmart.

In thermocycled specimens (group 3), surface irregularities of CAD/CAM blocks showed concentrated peaks and valleys (Fig. 5). LAVA and VITA also exhibited slightly less irregularity than Cerasmart (Fig. 5). Surface irregularities of LAVA specimens showed variability. Surface roughness increased from slight to moderate and included excessive roughness in small areas in the form of islets (Fig. 5A). Only in a small area, VITA showed roughness from slight to moderate in a small islet shape (Fig. 5B). Cerasmart showed very variable surface irregularities (Fig. 5C). Surface roughness changed from slight to excessive. In some areas, moderate and slight roughness in the form of islets or peaks were also seen.

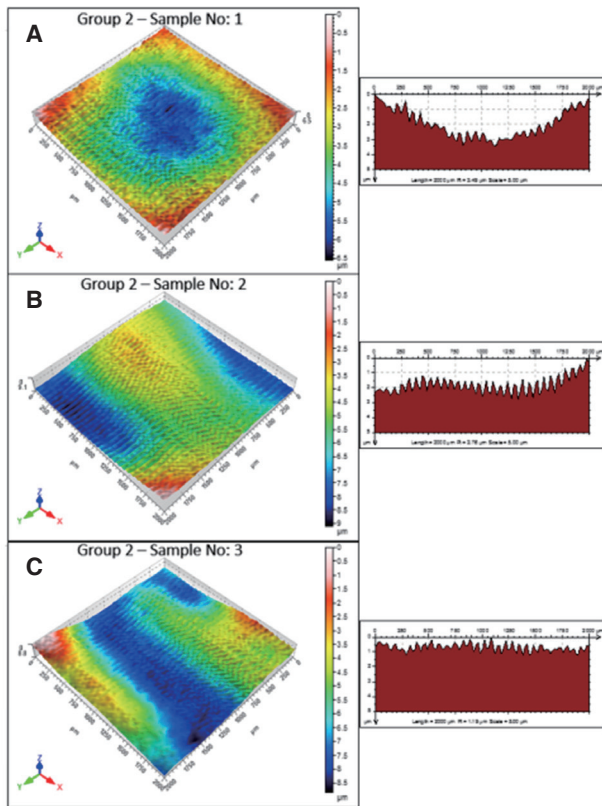
Fig. 4. 3D images of the specimens in group 2 (glazed specimens with Optiglaze Color). (A) LAVA, (B) VITA, (C) Cerasmart.

After Optiglaze color application (group 2), some irregularities and waving were observed on the surface with some concentrated peaks and valleys on the specimens of LAVA, VITA, and Cerasmart (Fig. 4). Surface roughness was moderate in some regions but decreased in others (Fig. 4). LAVA exhibited slightly less irregularity (Fig. 4A), followed by VITA and Cerasmart, respectively (Fig. 4B, 4C).
