Point-of-Care Ultrasound-Directed Evaluation of Elbow Effusion

Peter Patitsas, MD, MBA
Richard Davis, DO
Robert Strony, DO, MBA

Geisinger Medical Center, Department of Emergency Medicine, Danville, Pennsylvania

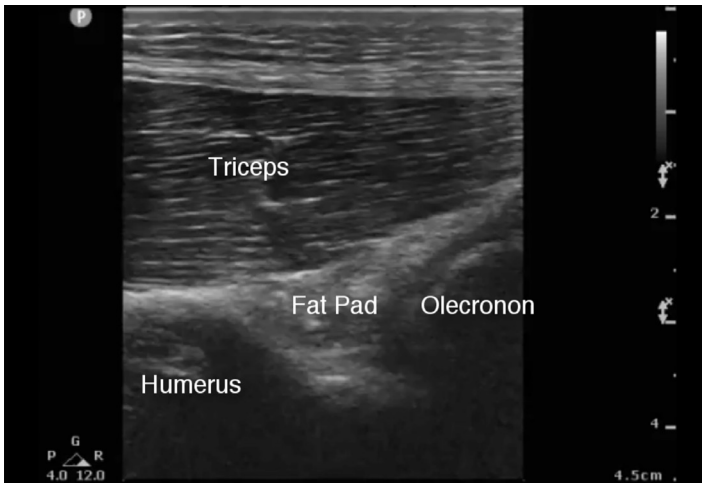
Image 1. Posterior long-axis view of the elbow using a high-frequency linear transducer. The transducer indicator (p) is positioned superiorly and proximally. Note the normal elbow sonoanatomy and the position of the posterior fat pad to the elbow joint.

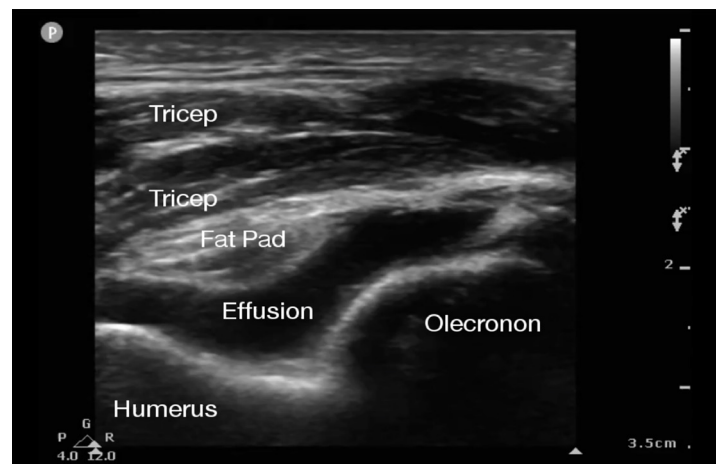
Image 2. Posterior long-axis view of the elbow using a high-frequency linear transducer. The transducer indicator (p) is positioned superiorly and proximally. A large elbow joint effusion is labeled along with relevant anatomy. Note the posterior displacement of the fat pad.

The patient's vital signs on presentation to the ED were within normal limits. He was well appearing and in no distress. On exam, we noted mild associated swelling of the right elbow, but no significant erythema or increased warmth. There was severe pain with any palpation of the right elbow. The right extremity was neurovascularly intact. Additionally, the patient was able to extend the affected wrist, abduct all fingers, and oppose the thumb. The differential diagnosis included hemarthrosis, elbow strain, septic arthritis, or crystalline disease. Complete blood count and basic metabolic panel were unremarkable. C-reactive protein was less than one milligram per liter and erythrocyte sedimentation rate was five millimeters per hour. Three radiographs of the right elbow were unremarkable without sail sign or posterior fat pad observed. We used a posterior oblique ultrasound approach of the right elbow to look specifically at the olecranon fossa. For the purposes of comparison, a normal sonographic appearance of the elbow (posterior approach) is depicted in Image 1. A joint effusion (Image 2) was identified between the olecranon fossa and its associated fat pad. We again used a posterior oblique approach to identify the joint effusion. Using an 18-gauge spinal needle with sterile technique, we aspirated the joint effusion under dynamic ultrasound guidance (Image 3). Six milliliters (ml) of cloudy, purulent fluid was aspirated.

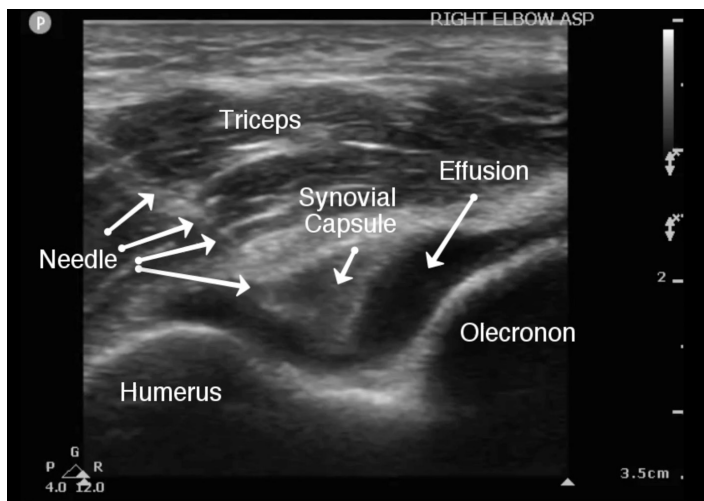
Image 3. Posterior long-axis dynamic guided elbow aspiration using the high-frequency linear transducer and 18-gauge spinal needle. The transducer indicator (p) is again positioned superiorly and proximally. Note the posterior displacement of the synovial joint capsule into the effusion during aspiration.

The elbow arthrocentesis (Image 3) should be performed with the patient sitting upright and at the appropriate height as to allow the sonographer comfort and to identify

landmarks. A high-frequency linear transducer should be used and placed on the posterior aspect of the elbow with the indicator superior and proximally (toward the triceps body). Place the elbow in 90 degrees, arm abducted, with the patient's forearm pronated using a side table to rest the hand. There are specific landmarks of the elbow that should be identified and palpated. Given that we used the posterior oblique approach and olecranon fossa for arthrocentesis, imagine a triangle formed by the lateral olecranon, the head of the radius, and the lateral epicondyle.

The skin should be prepared and cleaned with chlorhexidine. Next, using 1% lidocaine and a small needle (25 or 27 gauge), inject a wheal of local anesthesia into the dermis. With consistent pressure, identify the needle tip and advance the needle under sonographic dynamic guidance until the joint capsule is penetrated and joint fluid is aspirated. Collect synovial fluid, 5 ml to 10 ml, and remove the needle. Apply pressure with gauze for any bleeding observed and dress the puncture site. Send the specimen for testing.⁶
