CLINICAL REPORT

Prosthetic Rehabilitation of Nose After Partial Rhinectomy in a Patient Affected with Mucormycosis: A Case Report

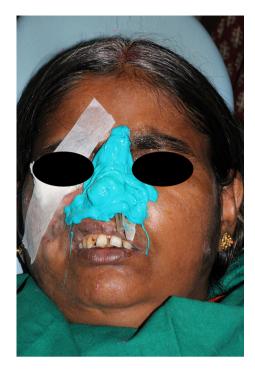
Fig. 1 Polyvinyl silicone (light body) impression keeping airway patent

Fig. 2 Type II gypsum mould poured and fabrication of acrylic shim

Fig. 3 Wax pattern fabrication

The patient was made to sit on a dental chair which was reclined at a 45^o angle. Petroleum jelly was then applied on the eyebrows, eyelashes and surrounding areas. A suction tip, cut to 2 inch length was placed in the left nostril to prevent the displacement of the ala and flow of the material into the nostril of the patient during impression making procedure. The deep undercuts were blocked using moist gauze. The patient was encouraged to breathe through her mouth and impression was made using a light body polyvinyl silicone material (Aquasil LV Ultra light body cartridge, Dentsply sirona) which was used to accurately record the defect site and also cover normal tissues (Fig. 1). Then the material was reinforced using Putty consistency Polyvinyl silicone material (Aquasil soft putty/ regular set, Dentsply). The impression was carefully removed and then poured with type-IV gypsum (Elite Rock thixotropic, Zhermack). Deep undercuts were then blocked on the retrieved cast using modelling wax and self cure clear acrylic (DPIRR cold cure, Mumbai) was mixed and adapted to the defect site. It was allowed to set, then retrieved and trimmed to a uniform thickness of 2 mm. The acrylic baseplate was polished using a sandpaper of 120 grit size. The acrylic baseplate was placed on the cast and checked for the accuracy of fit and retention (Fig. 2). Once satisfactory, wax was moulded on the acrylic baseplate according to patient's descriptions of her preoperative appearance and the knowledge of normal anatomic contours [7]. The wax pattern was verified on the patient (Fig. 3) and flasked using Type-II plaster/ dental plaster. Dewaxing was done by immersing the flasks in boiling

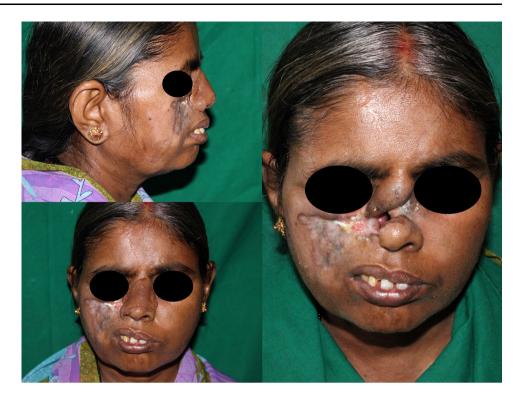
Fig. 4 Flasking of the pattern with two pour technique

Fig. 5 Tryin of the fabricated silicone prosthesis

Fig. 6 Insertion after extrinsic staining

water for 4 min (Fig. 4). The flasks were opened and wax was eliminated using hot water. A primer was then evenly applied on the acrylic baseplate so that silicone could bind to the acrylic material (Universal tray adhesive, Zhermack). Room Temperature Vulcanising Silicone (Silicone for prosthesis, MP Sai enterprises, Thane) was mixed with intrinsic stains and colour matching was done. Different shades of silicone was packed according to the shade of the natural skin adjacent to the prosthesis. The flask was clamped and kept for 24 h so that the material sets sufficiently. It was retrieved the next day, the excess was trimmed and prosthesis was verified on the patient for retention (Fig. 5). Extrinsic staining was done to closely mimic the adjacent pigmentation on the skin. The prosthesis was delivered to the patient and home care instructions were given (Fig. 6).
