CASE REPORT

A cascade of preventable complications following a missed femoral neck fracture after antegrade femoral nailing

Lucas S McDonald¹, Frances Tepolt², Dominic Leonardelli¹, E Mark Hammerberg² and Philip F Stahel^{2*}

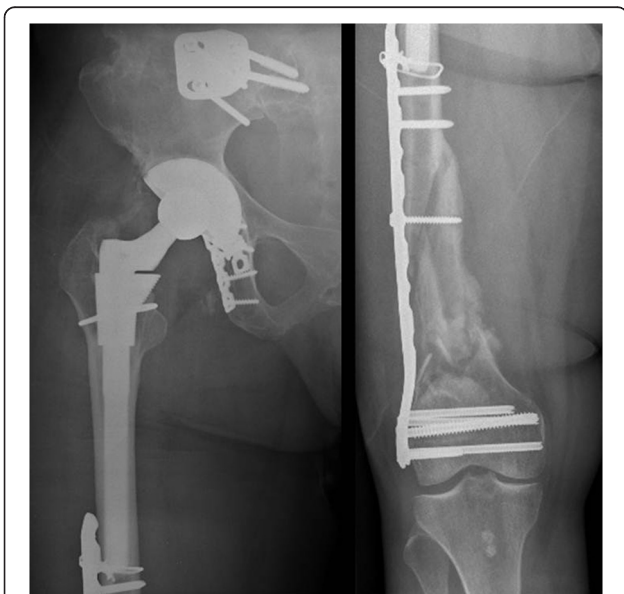
Figure 1 Imaging of the right hip and femur of a 46-year old female patient at first presentation to our institution. Plain radiographs demonstrate a right sacro-iliac joint fusion, right hip arthroplasty after acetabular fracture fixation, and bridge plating of a right distal femur fracture.

She had a leg-length discrepancy with shortening of the right leg secondary to multiple previous surgical procedures, which included a right total hip arthroplasty (THA) after acetabular fracture fixation, ipsilateral sacro-iliac joint fusion, and right-side distal femur plate fixation (Figure 1). The patient also demonstrated a right-sided foot drop. Radiographic evaluation revealed a displaced basicervical femoral neck fracture adjacent to the piriformis entry point of an antegrade femoral interlocking nail. This implant was effectively stabilizing a transverse midshaft femur fracture, with early signs of callus formation (Figure 2). After discussing all treatment options, the patient underwent closed reduction of the femoral neck fracture on a traction table, and revision fixation of both fractures was performed with a reamed cephalomedullary nail (Stryker Gamma 3™, Mahwah, NJ) through a greater trochanter starting point. Postoperative radiographs revealed an adequate cumulative tip-apex distance of <25 mm, however, the reduction appeared to be in slight varus of the hip (Figure 3).

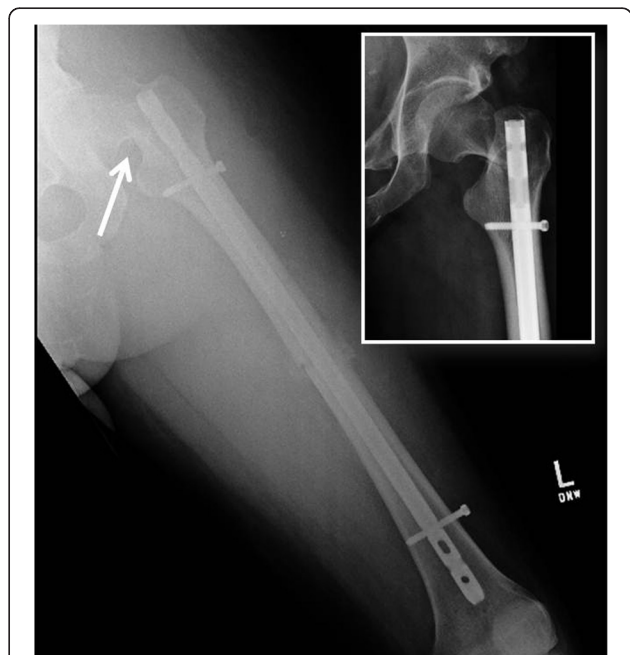
Figure 2 Radiographs of the left femur in the same patient, demonstrating early signs of fracture healing of a transverse femoral shaft fracture treated by intramedullary interlocking nail fixation. The arrow and inset picture depict the displaced femoral neck fracture adjacent to the piriformis starting point of the antegrade nail.

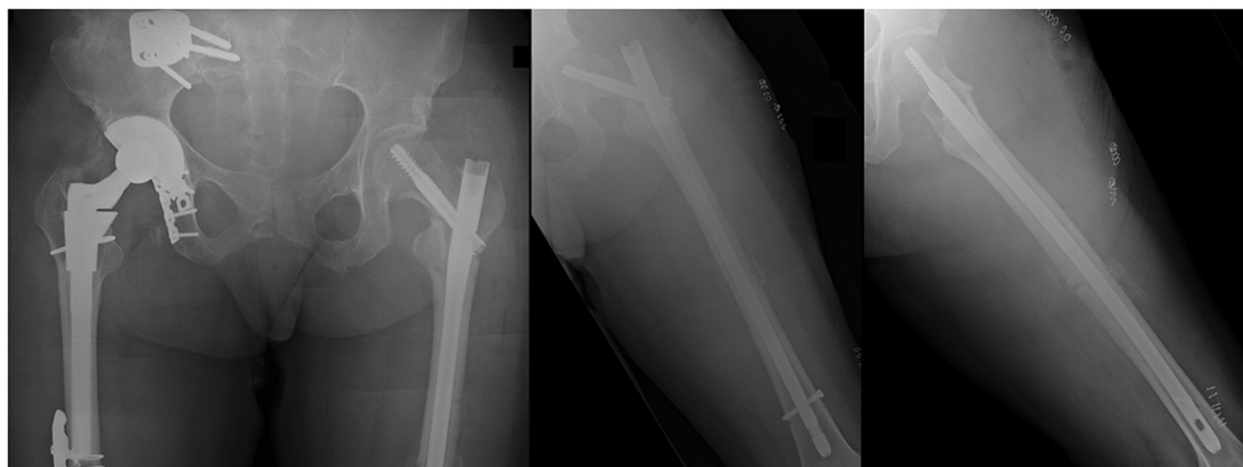
Figure 3 Plain radiographs after the initial surgical revision with reduction and placement of a cephalomedullary nail for fixation of the femoral neck fracture and ipsilateral femur shaft fracture. The fracture appears to be slightly malreduced in varus of the hip.

In the present case, we opted to revise the piriformis nail to a trochanteric entry cephalomedullary nail with a femoral neck lag screw. Despite adequate cumulative tip-apex distance of less than 25 mm, the reduction is slight varus of the hip (Figure 3) may have contributed as a root cause for failure of fixation (Figure 4). Additionally, the patient's early weight bearing before radiographic and clinical healing likely contributed to failure of fixation.

In the present case report, the question of whether the root cause of this patient's displaced femoral neck fracture was iatrogenic or related to the primary trauma remains purely speculation. Management options for revision surgery include: (1) leaving the current femoral shaft implant in place and attempting a closed or open reduction with lag screw fixation around the femoral implant; (2) removing the antegrade femoral nail and applying a sliding hip screw/plate device for the basicervical fracture, in conjunction with and revision femoral fixation by a retrograde nail; or (3) revision fixation of both fractures with a single device, such as a cephalomedullary nail, as performed in the present case (Figure 3).

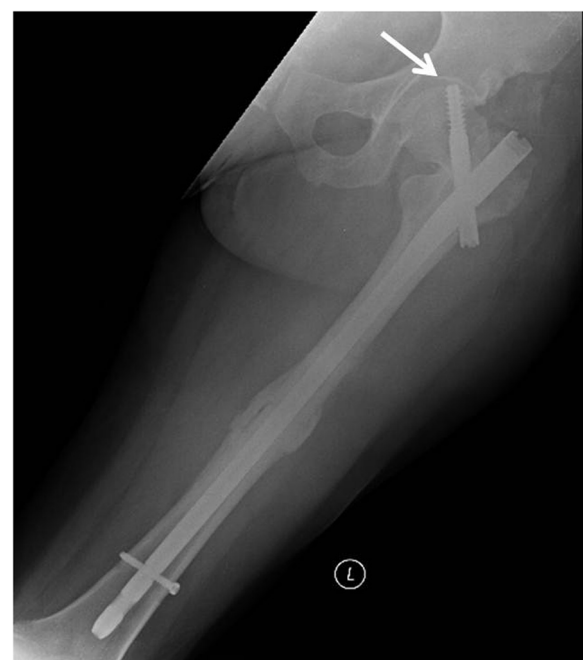
failure of fixation of the basicervical femoral neck fracture, with “cut-out” of the lag screw through the femoral head. The midshaft femur fracture was continuing to heal uneventfully (Figure 4).

Figure 4 Failure of fixation of the cephalomedullary nail by "cut out" of the lag screw through the femoral head (arrow).

Given the unsalvageable damage to the femoral head and acetabulum she was converted to a total hip arthroplasty (THA). The procedure was performed without complications, using non-cemented acetabular cup and press-fit stem components (Zimmer, Warsaw, IN). The stem of the arthroplasty appears to have been placed in slight varus position (Figure 5). On postoperative day one, the patient mobilized with physical therapy and noted a significant leg-length discrepancy, with the left leg approximately 3.5 cm longer than the right, as confirmed by full-length standing X-rays (Figure 6). The patient was offered a revision THA to partially correct the leg length discrepancy. She agreed and a revision THA was performed, including proximal femoral shortening and revision of acetabular and femoral components resulting in a near equal leg length (Figure 7). The patient subsequently sustained an acute anterior dislocation of her left THA revision at one week after discharge from the hospital, possibly related to the shortening procedure (Figure 8). The dislocation was successfully managed by closed reduction under general anesthesia. The intraoperative exam revealed that the hip was stable in full flexion and abduction, but unstable in extremes of extension or adduction. The THA dislocation

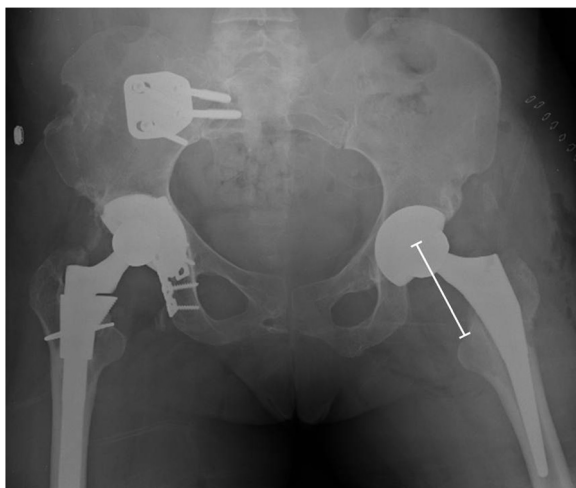
Figure 5 Anteroposterior pelvic radiograph after the 2nd surgical revision of the left hip with a total hip arthroplasty. Note the distance between femoral head center of rotation to the lesser trochanter.

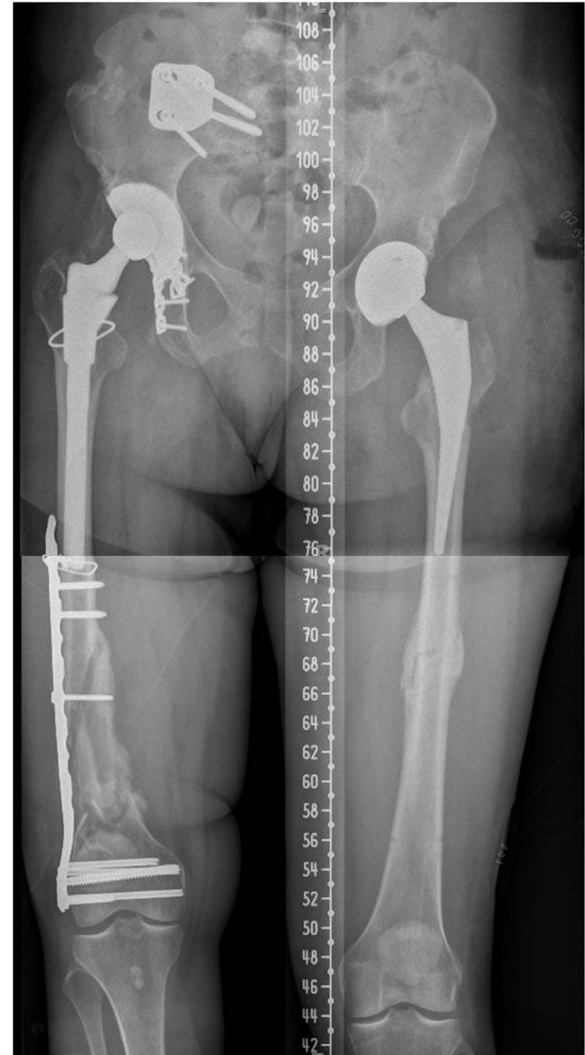
Figure 6 Full-length standing radiographs of bilateral femurs demonstrating a postoperative limb length discrepancy of 3.5 cm lengthening on the left side.

In the present case report, our patient demonstrated a radiographically confirmed LLD of 3.5 cm after the initial joint replacement procedure. Root causes in the present case include the complex nature of the patient’s previous hip and pelvic trauma with shortening of the contralateral femur during the previous THA (Figure 6).

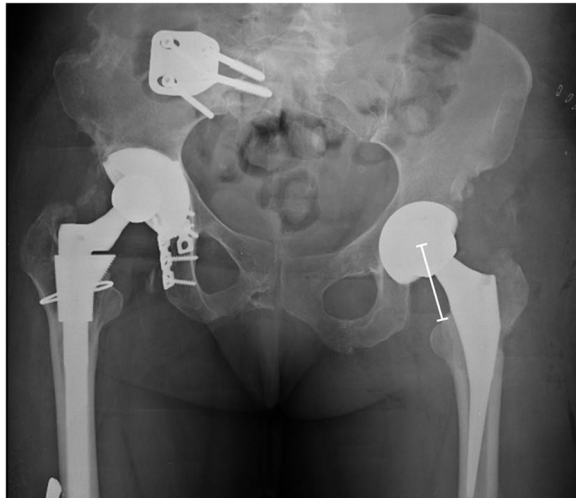
Figure 7 Anteroposterior pelvic radiograph after the revision left total hip arthroplasty. Note the decreased distance between femoral head center of rotation to the lesser trochanter, compared to Figure 5.

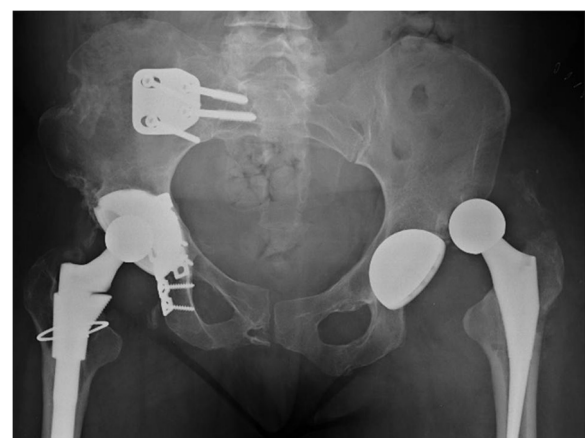
Figure 8 Anterior hip dislocation following revision left total hip arthroplasty. The dislocation was successfully managed by closed reduction and immobilization in a hip abduction brace (not shown).

was successfully managed in a hip abduction orthosis for 6 weeks. The patient had no further complications or adverse events, and presented with an acceptable outcome at one-year follow-up in our orthopaedic clinic.
