Case Report

Ureteral Guidewire Looping and Entrapment above an Impacted Ureter Stone

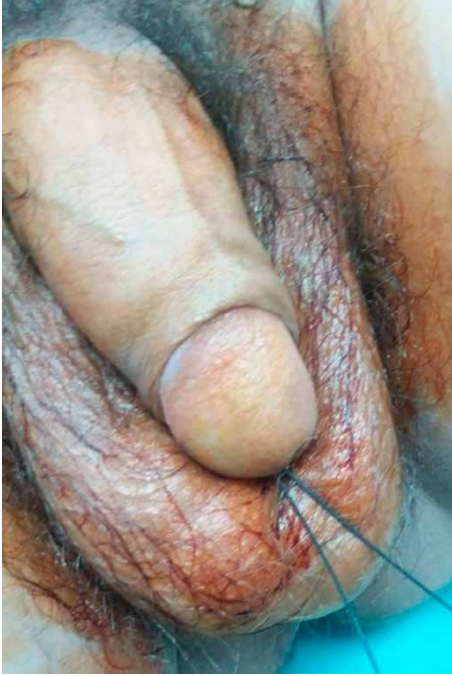
FIGURE 1: Both parts of the guidewire protruding out of the urethral meatus.

A 57-year-old man was referred to our department by a district hospital, after a previous unsuccessful effort of a double-J ureteral stent placement without real-time fluoroscopy. The patient arrived at the emergency department with both parts of a guidewire (Terumo RadiofocusR Guidewire, 180 cm)

Our first step was to pull gently one end of the guidewire under fluoroscopic guidance and local anesthesia, but our effort was unsuccessful. Next, we inserted another hybrid guidewire (Sensor™ Straight Tip, Boston Scientific), which could not bypass the stone and was looping under it. The retrograde urography showed full stop of the contrast at the level of the stone and no extravasation was revealed. Since the patient had no signs of infection, we decided to continue our handling under general anesthesia, so we could inspect the ureter with the semirigid ureteroscope (Karl Storz, 27002L, 43 cm length, 9.5 Fr). The ureteroscope was advanced easily up to the stone. The guidewire had initially perforated the mucosa of the ureter under the impacted stone, was looping intraluminally above the stone, returned submucosally and finally passed intraluminally to get out of the ureter orifice

and out of the meatus. Subsequently, we performed an active stone removal via laser lithotripsy (Dornier. Medilas H Solvo, laser fiber 600 μm). The entrapped guidewire was released after fragmentation of the stone and was easily removed from the ureter. Finally, a 7F-28 cm open-end double-J stent was placed over the second guidewire fluoroscopically. The patient was discharged the next day, with no complications after the

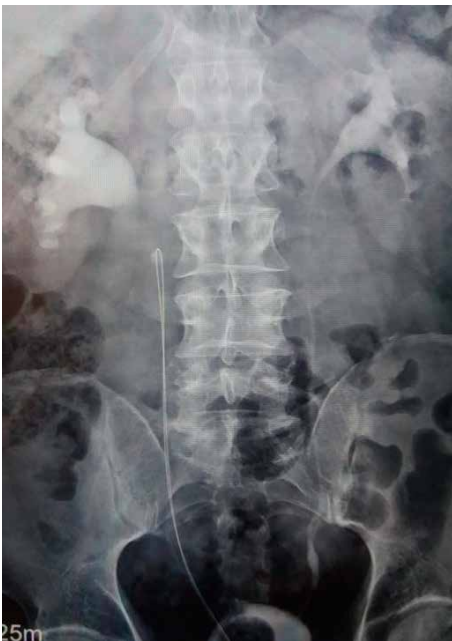
FIGURE 2: IVU reveals a right proximal ureteral obstructing stone and the guidewire looping above it.

protruding out of his urethral meatus (Figure 1). The intravenous urography (IVU), which had been performed at the district hospital after the failed stent insertion, revealed a right proximal ureteral obstructing stone with approximate maximal diameter 9 mm ($9 \times 4 \times 6$ mm) and the guidewire looping above it (Figure 2). IVU was performed instead of CT urography due to unavailability of CT urography at the referring center. The admission laboratory tests revealed no leukocytosis (WBC $10900 \times 10^3/\mu\text{L}$) and normal serum creatinine values (Cre 0.85 mg/dL). Rest of laboratory exams were normal. Also patient was in a good general clinical status.

In our case, the first attempt of double-J placement at the district hospital had been performed without fluoroscopic guidance. If the motion of the guidewire was monitored by fluoroscopy, looping direction might have been avoided. In addition, the length of the guidewire (180 cm, use in vascular surgery procedures) made it easier to form a loop inside the ureter, to come out of the ureteral orifice and out of the urethral meatus. Furthermore, if excessive force is applied when inserting the guidewire, the tip may perforate the wall and progress submucosally or advance outside the ureter. Especially, if the guidewire is forced blindly without fluoroscopy, it is difficult for the operator to realize in time the false route. Gentle maneuvers under fluoroscopy guidance and repositioning of the guidewire when operator feels resistance are important for a safe stent placement [1].
