# Folded large-bore central catheter in the right internal jugular vein as shown by ultrasound: a case report

Journal of International Medical Research

2019, Vol. 47(2) 1005–1009

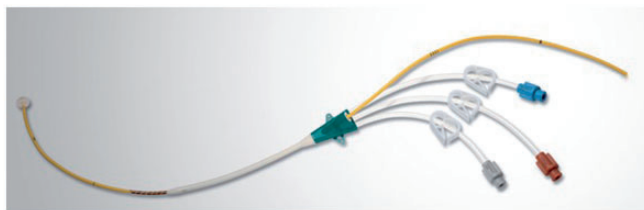
**Figure 1.** Advanced venous access catheter combined with a Swan–Ganz catheter.

After intubation, the patient was positioned to facilitate insertion of the AVA catheter (Figure 1) into the right IJV. In an effort to expand the right IJV, the head was lowered approximately 5 degrees and the face was pointed toward the left. The skin was aseptically prepared, the IJV was punctured with a needle tip under static ultrasound guidance with marking of anatomical landmarks, blood was aspirated, and a guidewire was inserted. The guidewire was inserted until it reached approximately 25 cm from the end of the syringe and was advanced no further to avoid arrhythmia. The presence of the guidewire within the IJV was confirmed by ultrasonography (Figure 2). After a slight incision was made using a scalpel, the AVA catheter combined with a vessel dilator was advanced along the guidewire. No resistance was felt during entry of the dilator along the guidewire into the IJV. When the dilator was considered to have passed the IJV, the sheath was pushed forward; however, the dilator and guidewire were unable to be pulled backward. We assumed that the guidewire tip had become stuck to the vessel wall; therefore, we gently moved

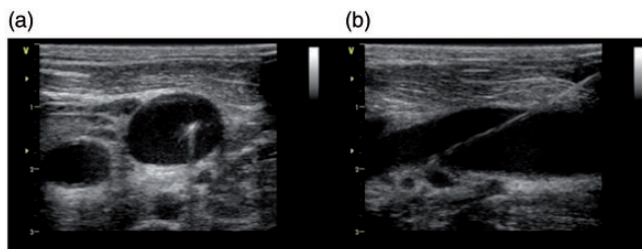
**Figure 2.** Guidewire in the right internal jugular vein. (a) Out-of-plane view and (b) In-plane view.

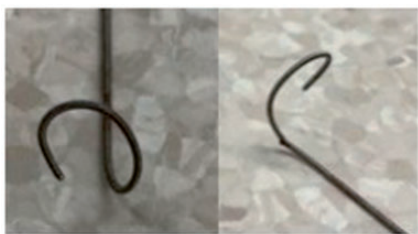
**Figure 3.** Removal of the twisted guidewire tip.

the dilator and guidewire back and forth in an attempt to loosen them. Despite these efforts, the dilator and guidewire were not removed simultaneously; instead, the guidewire was removed first, followed by the dilator. Upon pulling the guidewire out, we found that its end was bent and curved (Figure 3).

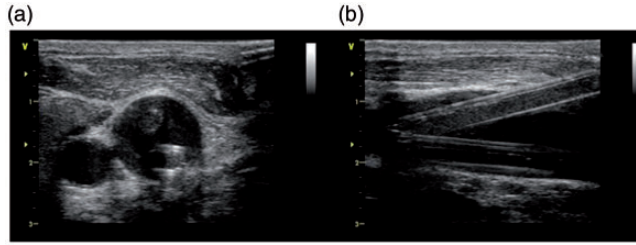
We considered that the catheter was in the appropriate position despite the fact that the guidewire tip was twisted upon removal. We attempted to irrigate the vessel lumen with saline to remove air and prevent blood clot formation, but the blood was not regurgitated. We assumed that the sheath was malpositioned and thus repeated the ultrasound examination, which revealed that the AVA catheter sheath was folded inside the right IJV (Figure 4).

**Figure 4.** Folded advanced venous access catheter sheath in the right internal jugular vein. (a) Out-of-plane view and (b) In-plane view.

We assume that the events that occurred in our patient were due to the interaction between the distal part of the guidewire located on the posterior wall of the vessel and the soft catheter sheath. We hypothesize that in such cases, the tip of the guidewire seen in the ultrasound image is fixed to the blood vessel; the soft sheath within the blood vessel cannot be advanced because the guidewire is fixed, and the sheath therefore starts to bend. As the pushing force increases, kinking of the sheath also increases. Previous reports have shown that the tip of the catheter can travel back to the head during IJV catheterization<sup>13,14</sup>; however, this does not occur with large-bore catheters.<sup>12</sup> We postulate that a 7-Fr catheter would bend into a U shape because it is stiff and that a 9-Fr catheter would kink into a V shape because it is soft. Conventional catheters and large-bore catheters differ in the degree of resistance to bending force because of differences in their inner diameter and thickness of the sheath wall. This is consistent with the previous finding that catheters have different bending resistances upon insertion depending on the material of which they are made.<sup>15</sup>

We gently withdrew the AVA catheter to avoid additional injury. The AVA catheter was pulled out with no resistance, and the IJV was manually compressed for 5 minutes. We observed traces of small pleats in the end of the AVA catheter

large-bore catheter, the various complications caused by a thick guidewire and large catheter cannot be prevented by the use of static ultrasound. In the present case, we performed ultrasonography to confirm that the guidewire had been placed in the vessel, but a complication still occurred. In conclusion, large-bore catheter sheath insertion is more safely performed with real-time than static ultrasound guidance.
