# Corrosion behaviour of welded low-carbon steel in the Arctic marine environment†

Arctic offshore sites have high potential for the exploration of energy resources; thus, data concerning the behaviour of structural materials in the Arctic environment are required. Here, we report the corrosive characteristics of welded low-carbon steels under simulated Arctic low-temperature conditions. The corrosion tendencies in the submerged and splash zones of offshore structures were investigated by immersion tests, salt spray tests (SST), and cyclic corrosion tests (CCT). The effects of decreasing seawater temperature on the corrosion were identified, and the differences in corrosion between the base metal (BM) and weld metal (WM) were analysed. In particular, the BM showed higher corrosion than the WM, indicating that the parent metal (PM) is corroded more than the fusion zone (FZ) in weld joints under severe corrosion conditions. Thus, we have identified the importance and influence of the thermal expansion of materials on corrosion under Arctic conditions.

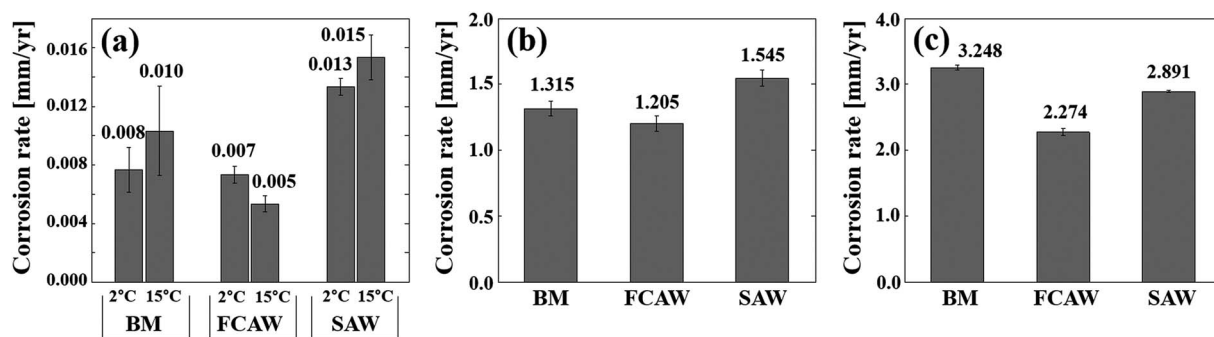
Fig. 1 Corrosion rates of experimental specimens obtained from various corrosion tests. (a) Immersion test, (b) salt-spray test, and (c) cyclic corrosion test.

15 °C were set as the representative temperatures, and the corrosion differences according to the climate were compared. In this figure, only the final corrosion rates are shown, and detailed test data is given in the ESI.†

Concerning the immersion test results (Fig. 1a), the corrosion rate of all specimens showed a satisfactory value of 0.005–0.015 mm y<sup>−1</sup>. The degree of corrosion was in the order of FCAW < BM < SAW, and the difference between BM and FCAW was very small. The BM specimen showed a slight higher corrosion rate than FCAW but lower than SAW, thus the degree of corrosion was in the order of FCAW < BM < SAW. As the seawater temperature decreased, no noticeable decrease in corrosion was observed. No pitting corrosion was found, and partial red-brown general corrosion was observed.

In the salt spray tests (Fig. 1b), the corrosion rate was 1.205–1.545 mm y<sup>−1</sup>, which is 70 times higher than that measured in the seawater immersion tests. This indicates that the base material is very weak in salt spray exposure conditions. The corrosion tendency was similar to the results of immersion test in the order of FCAW < BM < SAW. In general, SST is less relevant to reproduce practical corrosive conditions, but tests were conducted to compare corrosion differences between specimens under constant temperature conditions in saline conditions and for comparison with the CCT test results.

The CCT test was conducted by lowering the exposure temperature to −40 °C after the salt spray step. As shown in

Fig. 1c, serious corrosion rate in the range of 2.274 to 3.248 mm y<sup>−1</sup> was confirmed. The degree of corrosion was in the order of FCAW < SAW < BM, and the formation of a significant rust layer was visually observed (ESI†). The corrosion level determined from the CCT was more than 130 times higher than the seawater immersion test, and it was confirmed that the corrosion change of the steel was caused by the repeated wetting and drying, as well as temperature changes. In particular, by comparing the results shown in Fig. 1a and b we confirmed the specific corrosion of the BM is slightly higher than FCAW but much lower than SAW. This is important information for base metals and weld joints in the design of the offshore materials; thus, we identified the causes.

As shown in Fig. 1, the corrosion trends for the BM and the WM under Arctic conditions were confirmed. In the submerged simulated condition test, rust was produced in the form of general corrosion, but it was difficult to visually distinguish the corrosive difference between the BM and the WM specimens because of the small amount of corrosion. However, when comparing the corrosion rates *via* measuring the weight loss, the values for the WM specimens were generally higher than those of the BM specimens. This indicates that the corrosion influence on FZ or HAZ is relatively higher than those of the PM.
