Endodontic management of a fused left maxillary second molar and two paramolars using cone beam computed tomography: A case report

Specialty type: Dentistry, oral surgery and medicine

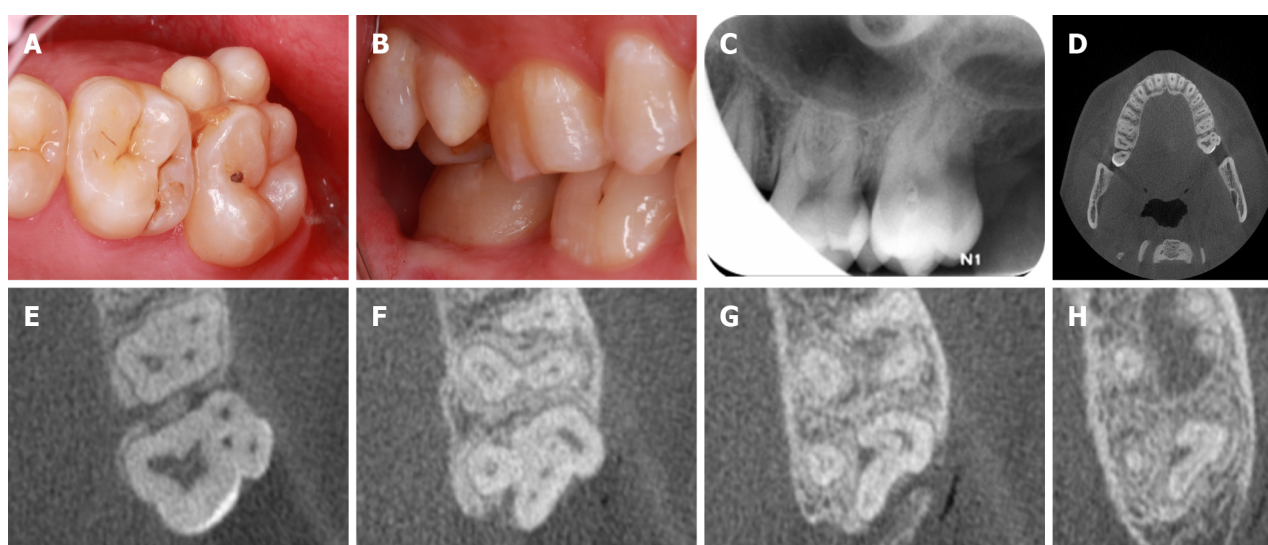
Figure 1 Representative preoperative intraoral photographs and radiographs of the fusion tooth. A: Occlusal intraoral view revealing the presence of two supernumerary paramolars on the buccal aspect of the maxillary left second molar, with evidence of distinct developmental grooves separating these teeth and additional evidence of food impaction; B: Buccal view; C: A preoperative radiograph of the left maxillary second molar; D: Cone-beam computed tomography (CBCT) axial cross-sections of the maxillary fused second molar and paramolars; E-H: CBCT images revealed three slightly curved, patent root canals, which were associated with the maxillary second molar, and there was single similar canal for each of the fused paramolars. The apex of the irregular bending isthmus area that was formed by the intersection of three teeth was connected in a periapical transmission image.

Clinical analyses revealed the presence of two extra teeth on the buccal aspect of the maxillary left second molar (#15); however, these teeth were separated by distinct developmental grooves ([Figure 1A](#) and [B](#)). Long-term impaction of food caused gingival recession in this region, but no caries or other obvious defects were detected. Decay in the intersecting groove was evident. Pain was evident in response to percussion, but responses were normal for the adjacent and contralateral teeth. The visual analogue scale (VAS) score of the #15 tooth was 3.5. The readings of the pulp viability test of the #15 and #2 teeth were 21 and 20, respectively. A pulp electric viability test yielded normal responses, which were identical to those of the control teeth. The periodontal probing depth of the #15 tooth was < 3.0 mm. No mobility or swelling was evident. The Oral Hygiene Index-Simplified (OHI-S) and Decayed Missing Filled-Index (DMF-Index) scores are shown in [Tables 1](#) and [2](#).

Digital periapical radiography was performed preoperatively, and the results did not provide sufficient information ([Figure 1C](#)). Tooth fusion was suspected; therefore, CBCT was considered to be appropriate. After obtaining informed consent from the patient, CBCT imaging was performed to assess the root canal systems of the fused left maxillary second molar and supernumerary teeth *via* 3D technology (New Tom VG10048S; Quantitative Radiologys.r.l, Verona, Italy). The axial, sagittal, and coronal sections confirmed that the maxillary left second molar and two paramolars were fused, and no such abnormalities were evident on the other side ([Figure 1D](#)). Three slightly curved and patent root canals were present in the maxillary second molar, and each of the fused paramolars contained a single similar canal. The apex area of the irregular bending isthmus was observed in the periapical transmission image ([Figure 1E-H](#)).

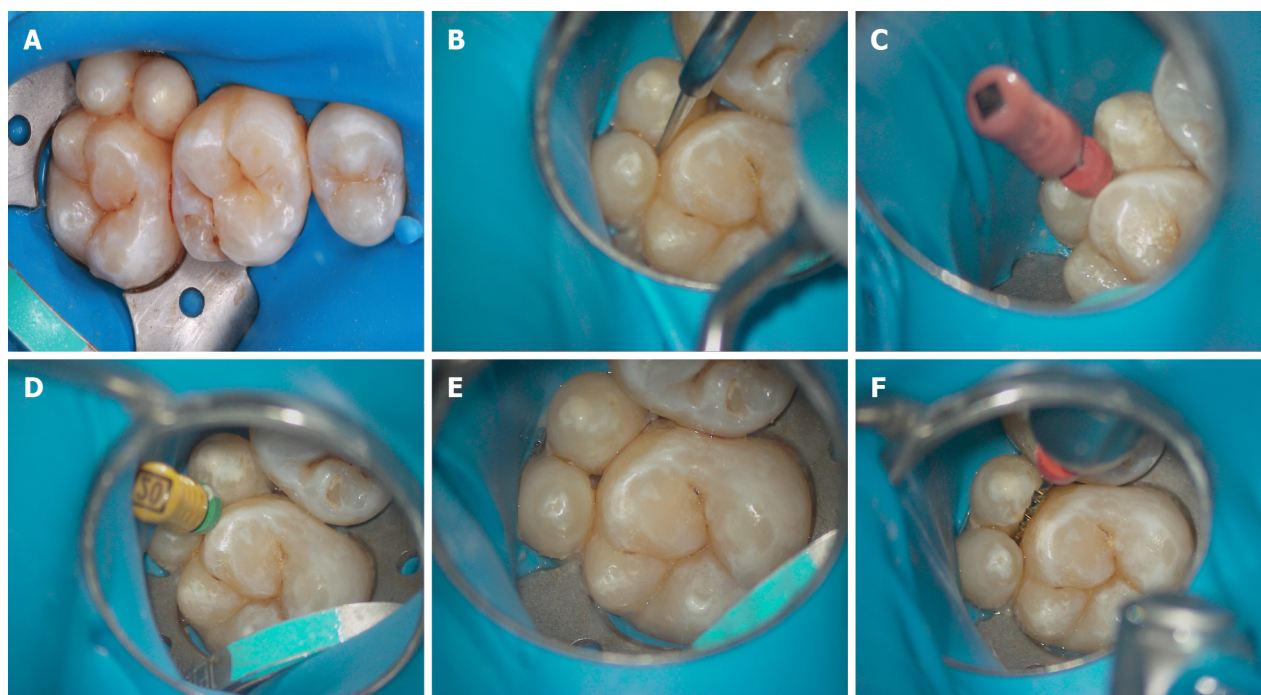
Figure 2 Representative intraoral photos of the fused tooth during root canal therapy. A: A rubber dam was positioned; B: A ball drill (ET BD) and ET 20 of the ultrasonic equipment (P5 Newtron) were used to remove the damaged tissue under a microscope; C: An electronic apex locator was utilized to determine the working lengths with 6#K-file; D-E: Filing was performed until size 20# was reached; F: Waveone Gold Ni-Ti rotary instruments were used to clean and shape the canals.

The patient provided informed consent to undergo a planned endodontic treatment of the isthmus that was formed at the fusion joint. A rubber dam was properly positioned ([Figure 2A](#)), and a ball drill (ET BD) and ET 20 ultrasonic equipment (P5 Newtron; ACTEON Satelec, Merignac, France) were used to remove the decay under a microscope ([Figure 2B](#)). The working lengths were determined with an electronic apex locator (EAL) and a #6K file ([Figure 2C](#)), and filing was performed until reaching a #20

size (Figure 2D and E). Next, the isthmus was cleaned and shaped *via* a crown-down approach using Waveone Gold Ni-Ti rotary instruments (Dentsply Sirona, Switzerland) with considerable 3% NaOCl and 17% EDTA irrigation (Figure 2F). Strong electrolytic water and ultrasonication (P5 Newtron) were used for a final irrigation, and the canals were dried with paper points. Then a calcium hydroxide [Ca(OH)₂] paste was applied to the canals, and the access cavity was sealed using Cavit™av.

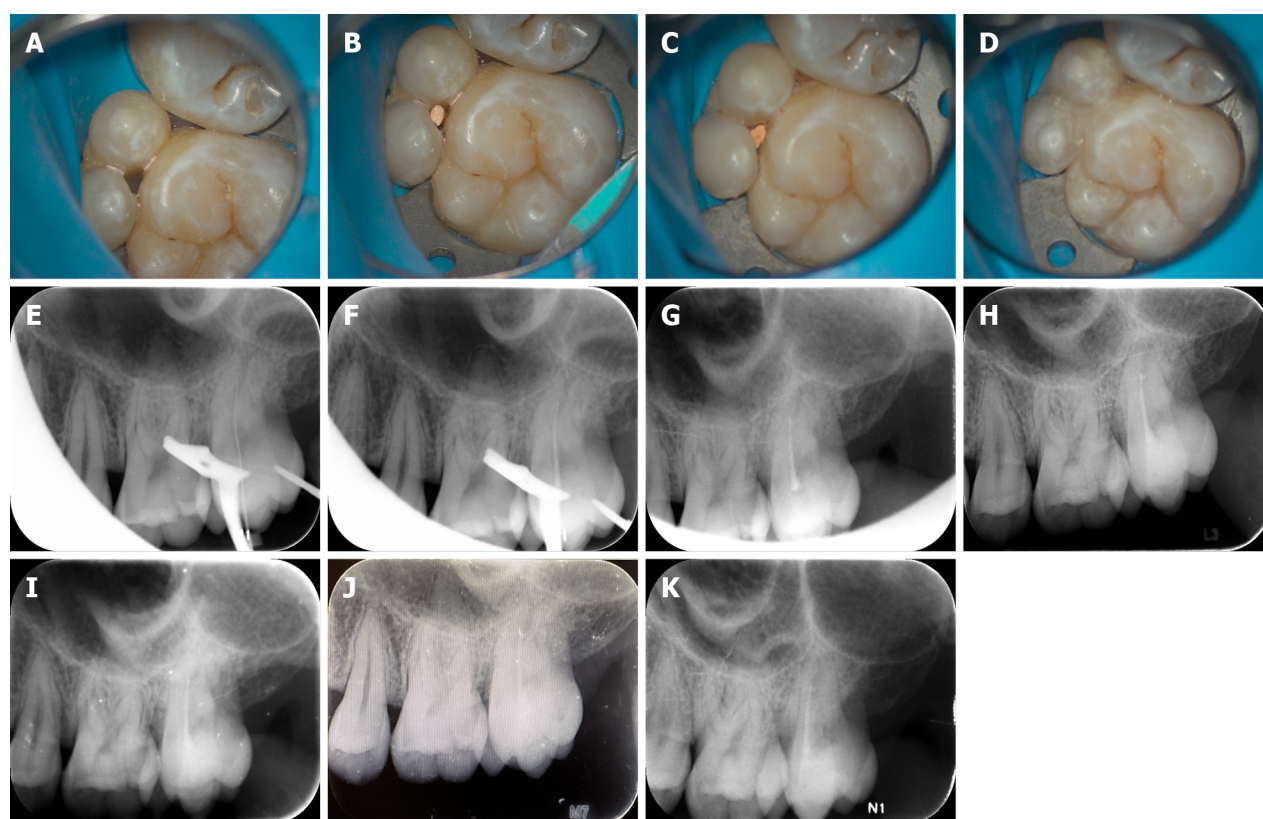
Figure 3 Representative intraoral photos of the fused tooth during root canal therapy and radiographs at different follow-up periods. A: The canals were dried following a final irrigation; B: Occlusal view of the canal tip; C: Complete canal obturation was achieved via vertical gutta-percha condensation; D: Image of the nanoresin-mediated seal of the access cavity; E: Working length radiograph; F: Cone fit radiograph; G: A final digital PAX revealed that the canals were well-obtured; H-K: A radiograph taken during the 6-, 12-, 18-, 24-mo follow-ups revealed good treatment outcomes.

At 10 d post-operation, the patient experienced no pain upon percussion or cold stimulation. The VAS score of the #15 tooth was 0. Complete canal obturation was achieved through the single cone technique (Figure 3A-C) with IROOT SP (Innovative BioCreamix Inc, Vancouver, BC, Canada), and the access cavity was then sealed with flow and nanoresin (3M Dental Products, MN, United States) (Figure 3D). A final digital PAX was taken at this time, in which well-obtured canals were observed (Figure 3G).

X-ray examinations (Figure 3H-K).
