Research article

Corrosion resistance of galvanized roofing sheets in acidic and rainwater environments

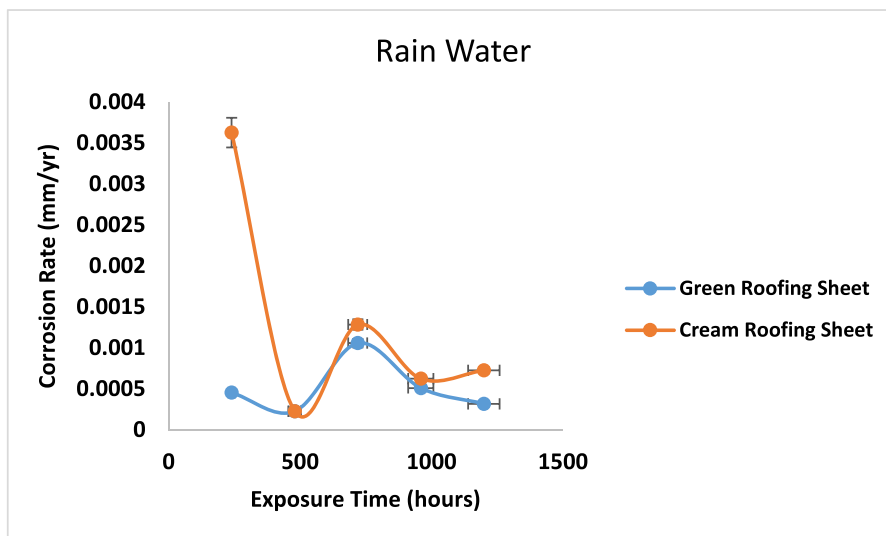
Results of corrosion rate results obtained from the recorded weight loss experiment calculations for the specimen immersed in rainwater solution at different time intervals are presented in Figure 1. The corrosion rate was varied with the exposure time (1200 hours in total). The graph shows that the cream roofing sheet had the highest corrosion rate in the first ten days (240 hours), which decreased to 480 hours. The possible cause of the decrease is passivation [17, 18]. Between 720 and 1200 hours, there was alternating rise and fall in corrosion rate, possibly due to depassivation and passivation. Depassivation occurs when the protective oxide film is broken, rendering the anodic metal surface at that point.

On the other hand, the green roofing sheet showed a preliminary low corrosion rate at 480 hours, indicating passivation. However, at 720 hours, there was a rise in corrosion rate followed by a gradual decrease until the end of the experiment. This observation is in agreement with the literature [17]. In rainwater, the green roofing sheet was the least affected, with lower corrosion rate values. Hence, it can be inferred that the cream roofing sheet samples with the higher corrosion rate values were the most affected in the rainwater solution.

Figure 1. Corrosion rate of roofing sheets against exposure time in rain water.

The green roofing sheet was the least affected in the rainwater weight-loss experiment, with lower corrosion rate values. In addition, the lowest corrosion rate values were observed in the rainwater experiments compared with the acidic environment tests.

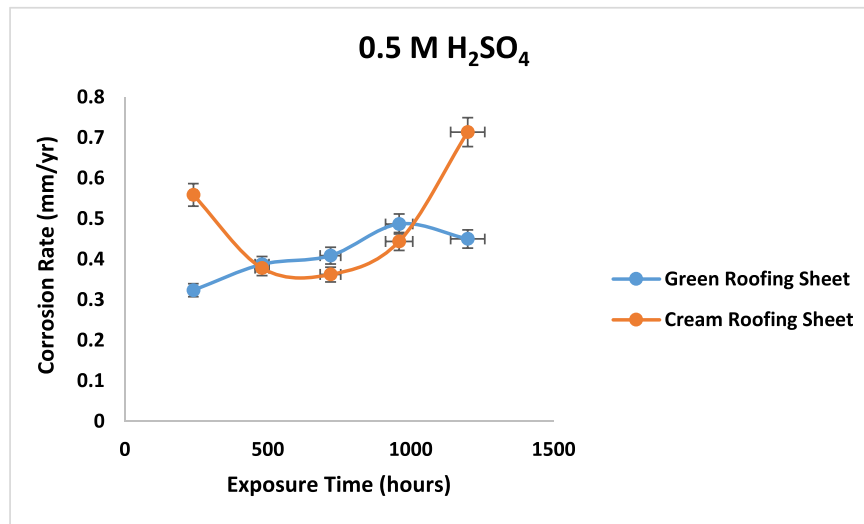
Results of corrosion rate obtained from the calculations of the recorded weight loss experiments values for the specimen immersed in 0.5 M H_2SO_4 solution at separate time intervals are presented in Figure 2.

Figure 2. Corrosion rate of different roofing sheets against exposure time in 0.5 M sulfuric acid.

The graph shows that the effects of sulfuric acid solution on the cream roofing sheet are at the highest and peak corrosion rate at 0.71 mm/yr at 1200 hours. In a sulfuric acid environment, green roofing sheet was the least affected, with a low corrosion rate value of 0.45 mm/yr at 1200 hours. Therefore, the samples with the highest corrosion rate over the exposure time, the cream roofing sheet, were the most affected in sulfuric acid solution.

In sulfuric acid (H₂SO₄) solution weight-loss experiments, the cream roofing sheet has the top corrosion rate value while the green roofing sheet has the minimal value.

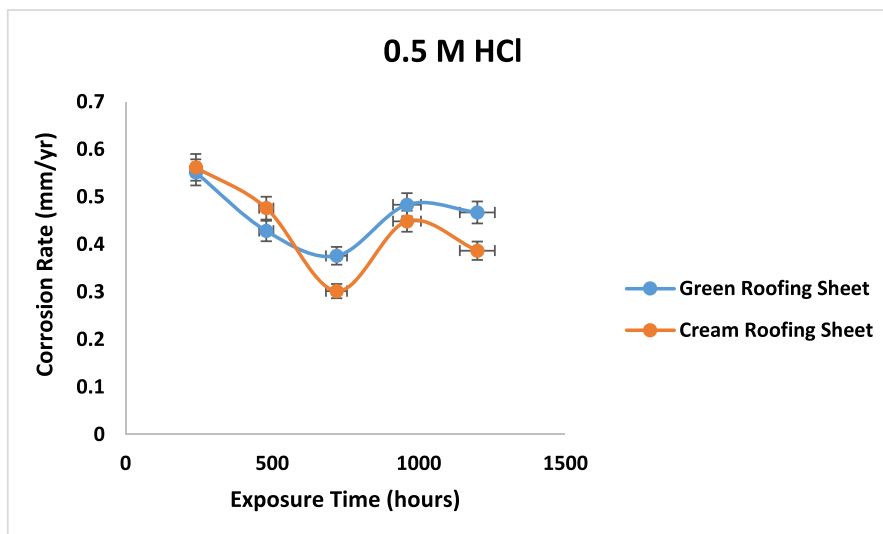
Results of corrosion rate obtained from the calculations of the recorded weight loss values for the specimen immersed in HCl solution at different exposure times are shown in Figure 3. The graph shows that in hydrochloric acid solution, the green roofing sheet has the highest corrosion rate of 0.47 mm/yr at 1200 hours. Cream roofing sheet was the least affected at the end of 1200 hours exposure period, with the corrosion rate of 0.39 mm/yr. Hence, the highest corrosion rate overexposure sample was the green roofing sheet, which was more corrosive in the hydrochloric acid solution.

Figure 3. Corrosion rate of different roofing sheets against exposure time in 0.5 M Hydrochloric acid.

In hydrochloric acid (HCl) solution weight-loss experiments, the green roofing sheet recorded the maximal corrosion rate compared to the cream roofing sheet. However, the green roofing sheet was least affected by rainwater and H₂SO₄ medium and should be habitually demanded in buildings because of their moderate-length life span and durability.

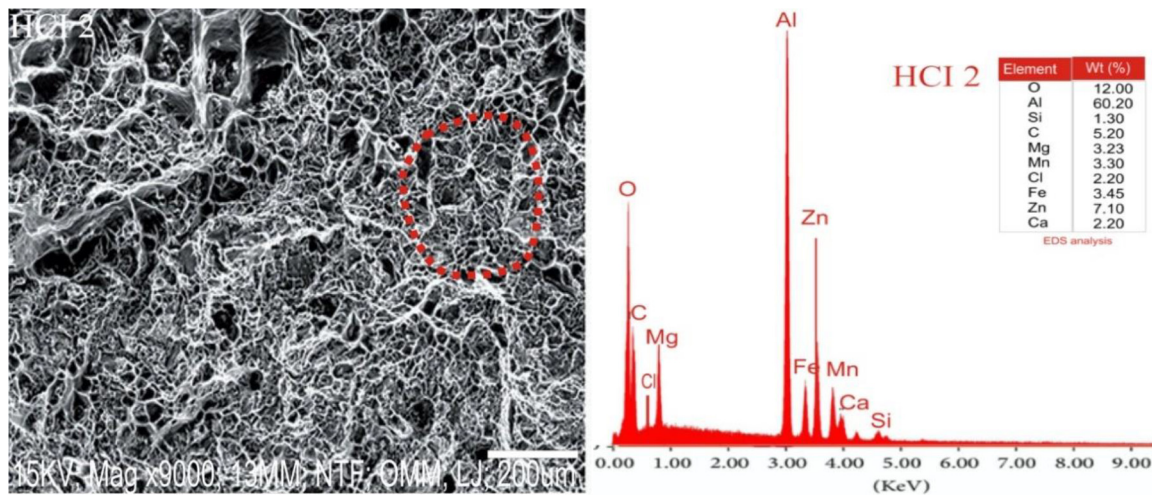
Figure 4 shows the surface morphology and EDS of green roofing sheets exposed to HCl for 480 hours.

In Figures 4 and 5, the surface elemental content of the sample before 20 days exposure and after 50 days exposure as shown reveal a higher percentage composition of the base element of aluminum as 60.20 % and 75.20 %, respectively, with a short percentage composition of the galvanizing elements (zinc, iron, manganese, and magnesium). The EDS shows the presence of oxygen and chloride ions which would have assisted in the corrosion process. The results were due to the formation of an impermeable protective oxide film on the surface of the roofing sheet samples causing a general corrosion attack [19, 20, 21].

Figure 4. Surface morphology of exposed green roofing sheet sample in HCl for 480 hours.

The red circled portion signifies the region where the energy dispersive x-ray spectroscopy is taken from the sample to characterize the analyzed volume's elementary structure and components.

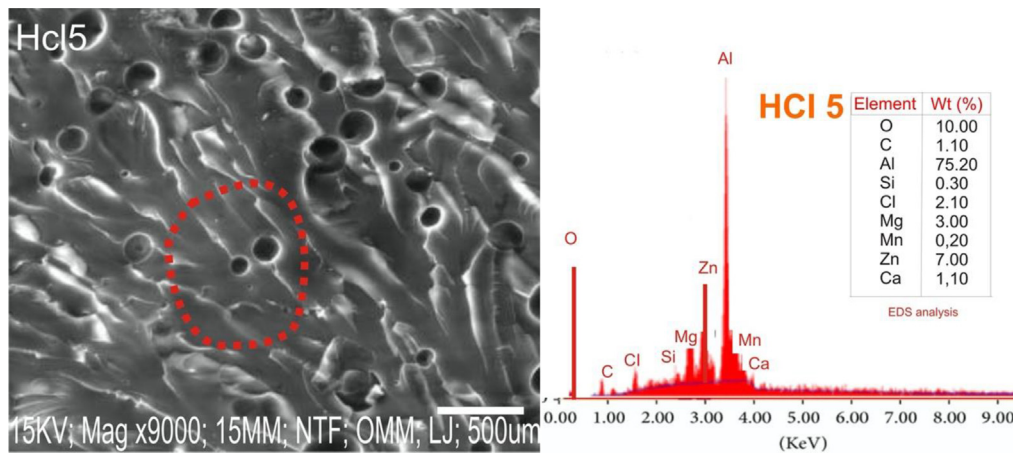
Figure 5. Surface morphology of exposed green roofing sheet sample in HCl for 1200 hours.

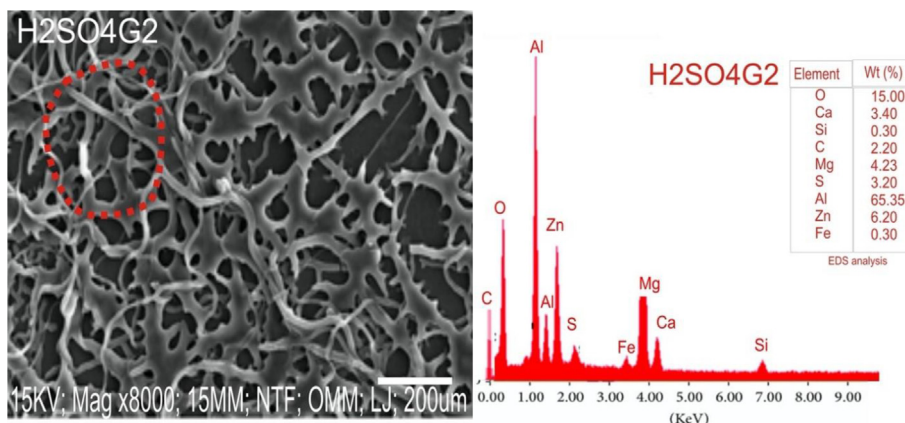
In Figures 6 and 7, the surface elemental content of the sample before 20 days exposure and after 50 days exposure are shown, which revealed a higher percentage composition of the base element of aluminum of 65.35 % and 72.30 %, respectively, with a very low percentage composition of the galvanizing element of zinc, manganese, calcium, and magnesium.

The coatings and galvanizing elements were exposed due to oxygen and sulphur from the sulphuric acid environment.

Figure 6. Surface morphology of exposed green roofing sheet sample in H₂SO₄ for 480 hours.

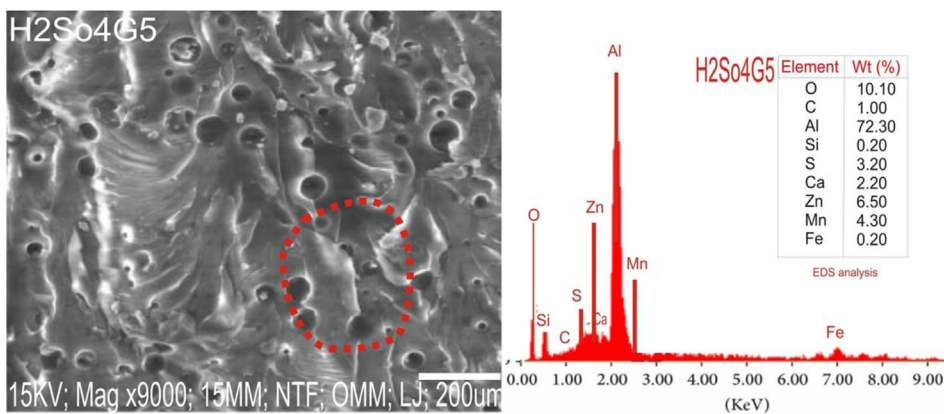
Figure 7. Surface morphology of exposed green roofing sheet sample in H₂SO₄ for 1200 hours.

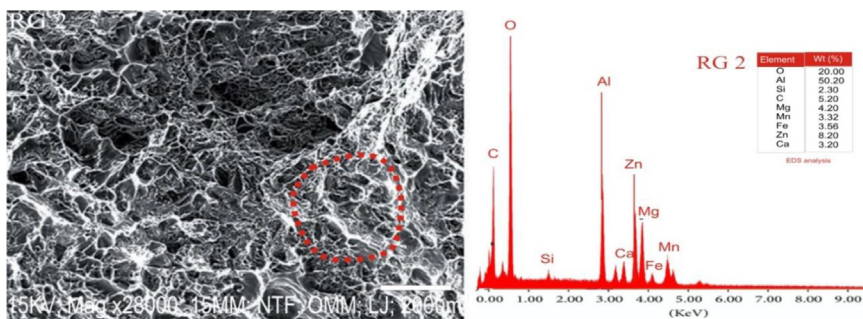
In Figures 8 and 9, the surface elemental content of the sample after 20 days exposure and after 50 days exposure reveal a higher percentage composition of the base element of aluminium of 50.20 % and 70.70 %, respectively.

Figure 8. Surface morphology of exposed green roofing sample in Rain Water for 480 hours.

respectively, with a shallow percentage composition of the galvanizing element of zinc, iron, silicon, and magnesium. It is also seen that the coatings and the galvanizing element were exposed due to the presence of carbon dioxide in the solution.

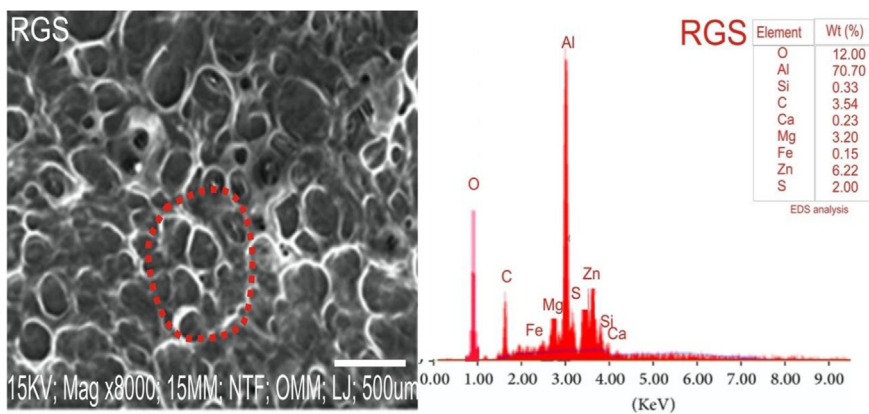
Figure 9. Surface morphology of exposed green roofing sheet sample in Rain Water for 1200 hours.
