What a Ratchet! A Gripping Case Report of an Entrapped Finger with an Unyielding Wrench

Summary: Finger entrapment with rings or ring-like objects is an uncommon possible hand emergency. In cases in which noncutting removal is ineffective, ring cutters or dental drills with carbide or diamond burs have been successfully used. However, objects composed of hard metallic alloys, such as lug nuts or wrenches, are often resistant to such equipment. In these instances, larger diameter metal cutting burs or rasps may be more advantageous. Due to their increased size and cutting power, these tools are better suited to handle the toughness of hard metals. In this case report, we present the effective and efficient removal of a stainless steel wrench from an entrapped digit using a helicoidal rasp. Availability of this instrument within orthopedic departments may prevent the delays often described in the treatment of finger entrapment when traditional cutting equipment fails. (*Plast Reconstr Surg Glob Open* 2024; 12:e5833; doi: [10.1097/GOX.0000000000005833](https://doi.org/10.1097/GOX.0000000000005833); Published online 22 May 2024.)

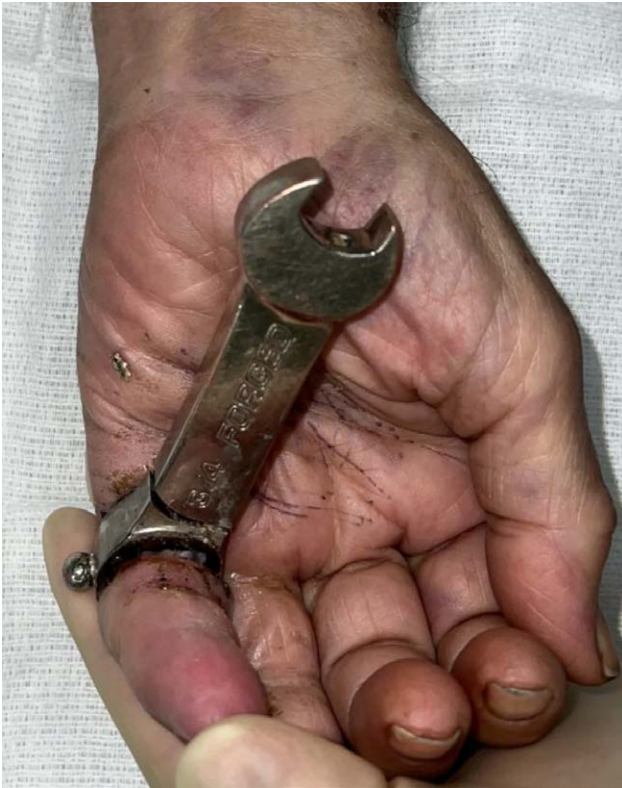
Fig. 1. The boxed end of a combination wrench is entrapped on the small finger proximal to the proximal interphalangeal joint. The boxed end is circular without an opening and overlapped a smaller ring beneath. Neither object could be removed with nondestructive methods and both were eroding through the skin.

A 65-year-old right hand dominant man presented to the emergency room with his left small finger entrapped on the boxed end of a three-fourth inch combination wrench (Fig. 1). The patient had a history of schizoaffective disorder and lived in a group facility. He placed the wrench on his small finger for “protection” from other residents approximately 6 weeks before presentation.

Over the week before presentation, he stated the finger became more swollen and he was no longer able to rotate the wrench without pain. On close inspection of the finger during physical examination, an additional ring was observed underneath the wrench, both of which eroded the dorsal skin. Due to the chronicity of the injury and similar pulse oximeter measurement of 92% between the incarcerated and nonincarcerated fingers, removal in the emergency room was deferred. The patient was admitted, started on antibiotics, and scheduled for removal of the wrench and ring in the operating room the next morning.

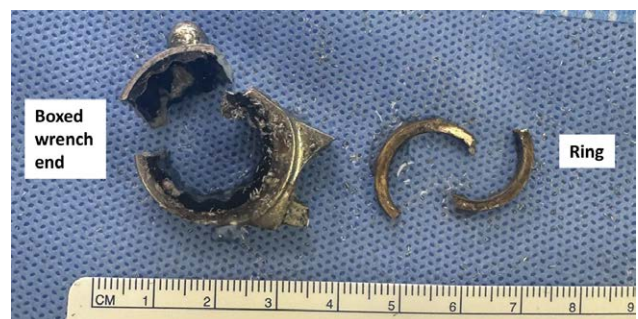
Fig. 2. The boxed wrench end and ring after destructive removal.

In the operating room, the patient received a regional block and sedation, an upper arm tourniquet was placed, and the extremity was exsanguinated. A disposable metal cutting helicoidal rasp with a 3.2-mm diameter × 18.3-mm head length (Stryker, Kalamazoo, Mich.; product no.: 5120-080-030) was used alongside a Stryker handpiece and foot pedal. (See figure, Supplemental Digital Content 1, which shows how metal cutting Helicoidal Rasp 3.2-mm diameter × 18.3-mm head length was used with a Stryker handpiece to cut into the boxed end of a three-fourth inch combination wrench. A freer elevator was wedged between the finger and the metal to protect the underlying structures. Copious irrigation was performed with cystoscopy tubing connected to a hanging saline bag. <http://links.lww.com/PRSGO/D230>.) To protect the skin, a Freer elevator was

placed between the wrench and ring and the wrench was cut dorsally over the extensor mechanism with copious irrigation. The wrench was then rotated, and a second cut was again made dorsally. Each cut lasted for a duration of 2 minutes. With the wrench now freed, the cutting technique was repeated for the ring with cuts performed in 10-second intervals. Figure 2 shows a photograph of the boxed wrench end and ring after destructive removal. The tourniquet was released after 15 minutes, and the small finger perfused. The dorsal skin was eroded with exposed paratenon, and volar skin was intact (Fig. 3). The patient was dressed with xeroform, cast padding, and all cotton elastic and discharged the following day with instructions of once daily dressing changes.

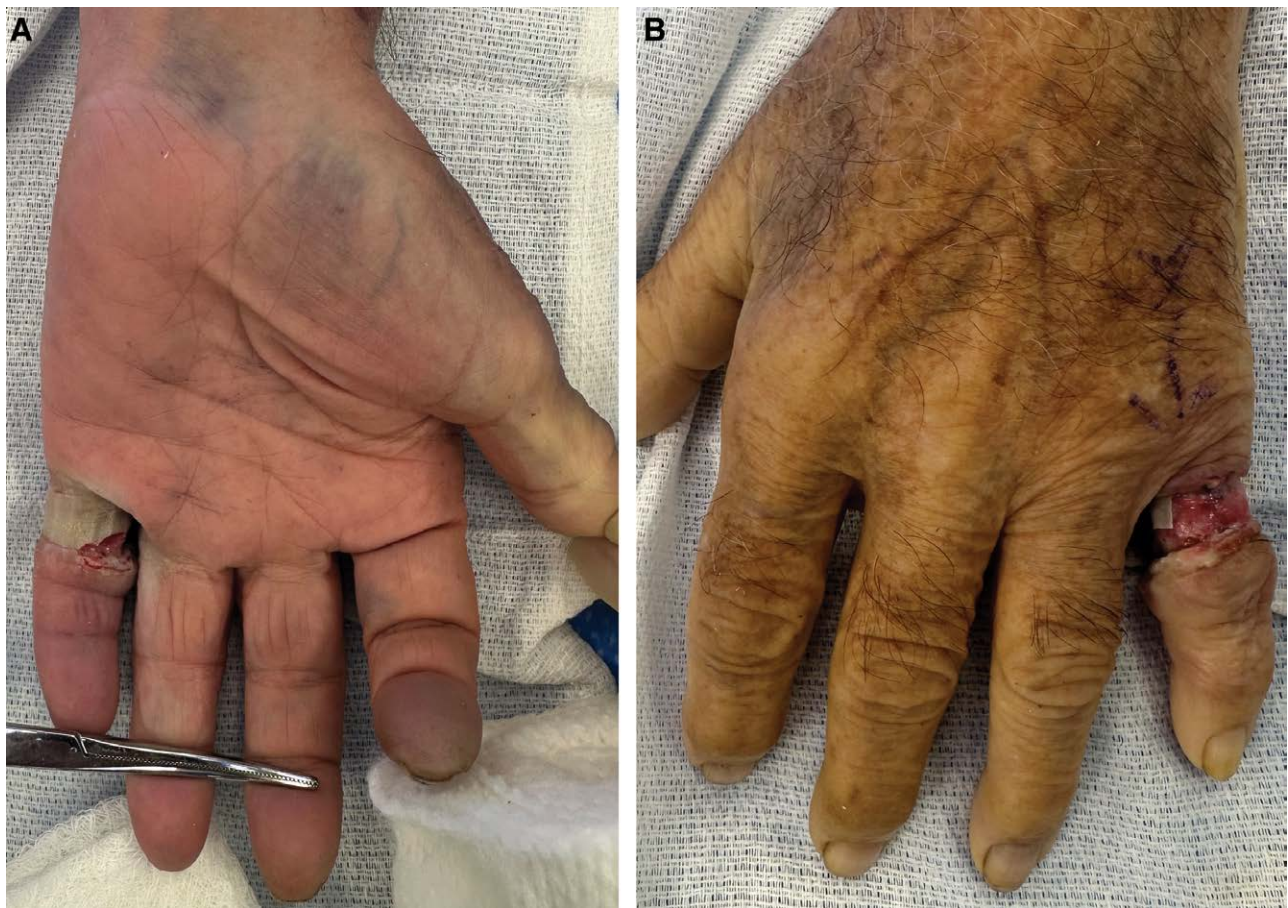
Fig. 3. Pictures of the hand after removal of the boxed wrench and ring. The volar skin (A) was intact, but the dorsal skin (B) was eroded with intact paratenon. The small finger perfused well after the tourniquet was removed.
