# Blunt traumatic diaphragmatic hernia: Pictorial review of CT signs

Ravinder Kaur, Anuj Prabhakar<sup>1</sup>, Suman Kochhar<sup>1</sup>, Usha Dalal<sup>2</sup>

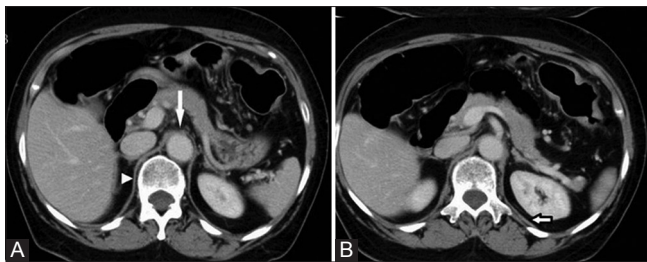
**Figure 1 (A and B):** (A) Normal diaphragmatic crura: (A) The crura (arrowhead) are noted on either side of the vertebra and are well delineated when in contact with fat. The medial arcuate ligament (arrow) is seen as a thin isodense band superior to the celiac axis (B) The lateral arcuate ligament (arrow) may be visible on CT scans as it courses toward the 12<sup>th</sup> rib

lateral arcuate ligaments. The right crus is attached to the first, second, and third lumbar vertebrae, while the left crus is attached to the first and second lumbar vertebrae [Figure 1A and B]. The fibrous margin of the right and left crura forms the median arcuate ligament.<sup>[7]</sup>

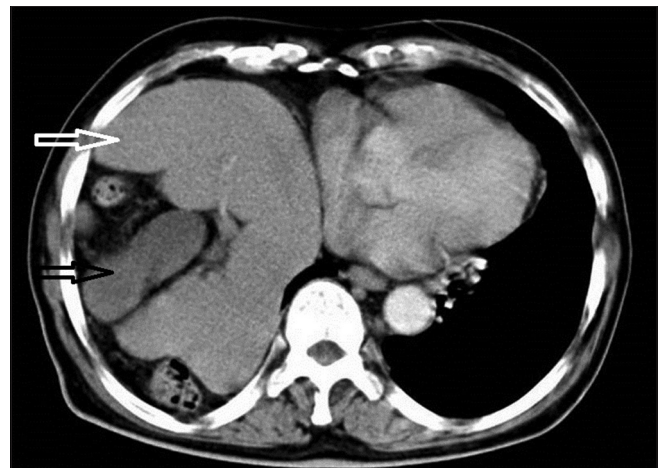
**Figure 2:** Right diaphragmatic hernia. A 77-year-old male patient with history of a road side accident 3 years ago presented with breathlessness. Contrast-enhanced axial CT image shows herniation of the liver (White arrow) and the colon (Black Arrow) through a right-side diaphragmatic rupture

The left hemidiaphragm is injured in 50-80% of blunt diaphragmatic rupture and the right hemidiaphragm in 12-40% of cases [Figure 2]. Injury to the left hemidiaphragm is more common due to an area of congenital weakness in its posterolateral aspect. Also, the liver plays a protective role in the right diaphragm injuries by preventing herniation of the abdominal viscera.<sup>[16]</sup> Anteroposterior elongation and shearing of diaphragm in lateral thoracoabdominal impact and transmission of abdominal pressure to diaphragm in frontal impact are the possible mechanisms resulting in blunt traumatic diaphragmatic hernia.<sup>[17]</sup>

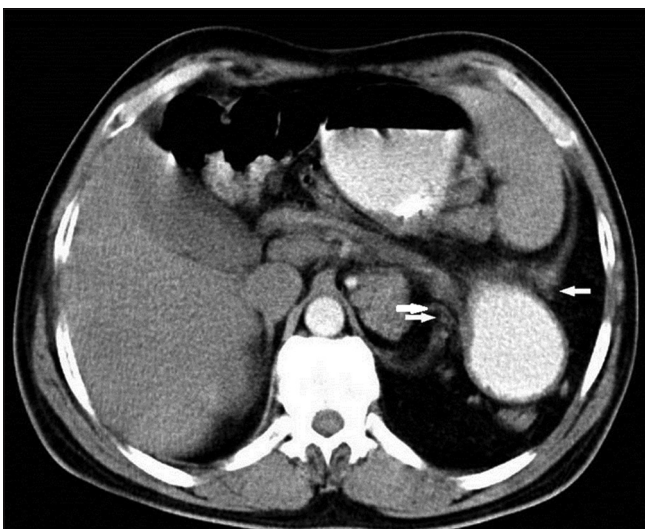
**Figure 3:** Diaphragm discontinuity sign and dangling diaphragm sign: A 45-year-old male patient with history of motor bike accident 4 months ago presented with pain chest and cough. Axial contrast-enhanced CT image of upper abdomen reveals diaphragm discontinuity sign (white arrows) and dangling diaphragm sign (double white arrows)

- **Dangling diaphragm sign:** The “dangling diaphragm” is a conspicuous sign of diaphragmatic injury. Free edge of the torn diaphragm is visible as it curls inward toward the center of the abdomen away from the chest wall at near right angle [Figure 3]. The sign differs from diaphragmatic discontinuity in that it results in comma-shaped fragment of the diaphragm, whether or not a gap in the diaphragm is appreciated. The dangling diaphragm sign has a sensitivity of 54% and a specificity of 98%.<sup>[18,19]</sup> This sign is linked to the segmental diaphragmatic defect
- **Dependent viscera sign:** Normally, the diaphragm prevents the upper abdominal viscera from coming

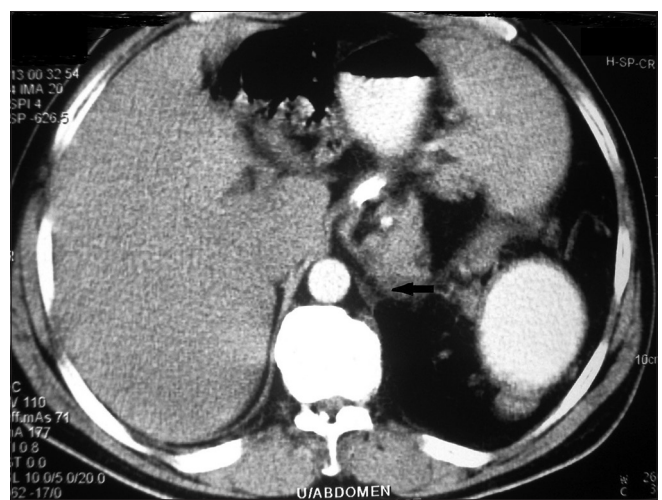
**Figure 4:** Segmental non-visualization of diaphragm. A 35-year-old female patient with history of fall from height 1 year ago presented with pain and vomiting. Axial contrast-enhanced CT image of upper abdomen reveals segmental non-visualization of diaphragm - only a part of the left crus is noted (arrow) and the rest of the diaphragm is not visualized

- **Segmental non-visualization of diaphragm:** Segmental non-visualization of diaphragm is distinct from diaphragmatic discontinuity. This manifests as an isolated absence of a section of the injured diaphragm [Figure 4]. Sensitivity and specificity of this finding are 85.9% and 67.7%, respectively<sup>[16]</sup> for blunt diaphragmatic rupture. This sign may be falsely positive in elderly patients in

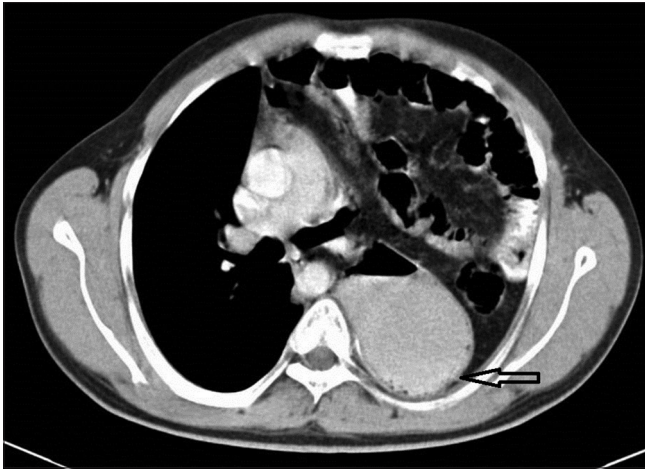
**Figure 5:** Dependent viscera sign. A 62-year-old male patient with history of motor bike accident 6 months ago presented with dyspnea. Axial contrast-enhanced CT image of chest reveals the stomach and bowel loops herniating into the thorax. The contrast-filled stomach is in direct contact with the posterior thoracic wall (Black arrow) (dependent viscera sign)

in contact with the posterior chest wall in the supine position. When the diaphragmatic integrity is lost, the viscera herniate and shift posteriorly to lie in a “dependent” position against the chest wall [Figure 5]. On the left, the stomach or bowel either abuts the posterior ribs or is situated posterior to the spleen and on the right, the upper-third of the liver contacts the posterior chest wall. Some authors have emphasized that this sign has low sensitivity for the detection of small diaphragmatic ruptures, ruptures in an atypical location (e.g., an anterior location), and ruptures associated with a large pleural effusion<sup>[20]</sup>

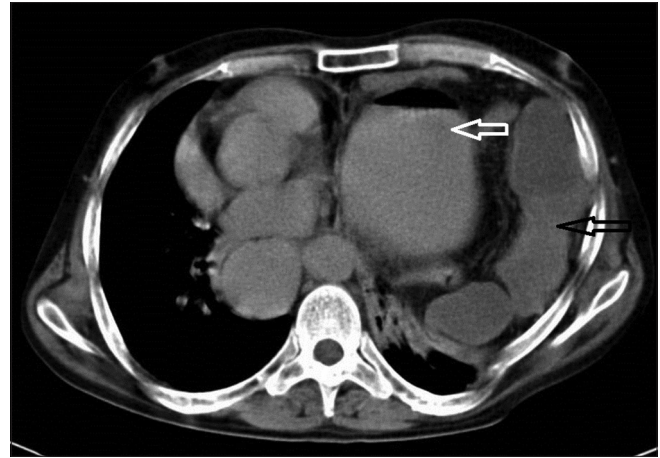
**Figure 6:** Intrathoracic herniation of the abdominal viscera. A 40-year-old male patient with history of motor vehicle accident 6 months ago presented with breathlessness. Axial CT image of chest reveals intrathoracic herniation of bowel loops (Black arrow) and stomach (White arrow) into the left hemithorax secondary to post-traumatic diaphragmatic rupture

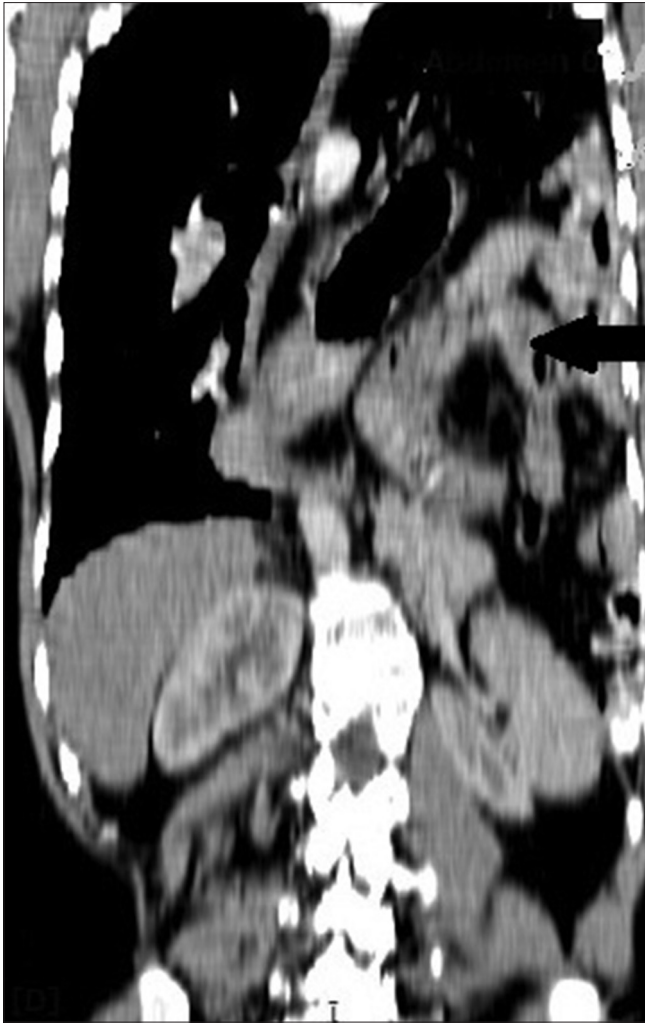
**Figure 7:** A 35-year-old man with history of blunt trauma 12 years ago presented with breathlessness. Coronal CT image reveals herniation of stomach and small bowel loops (black arrow) in the left hemithorax through the large defect in the left diaphragm due to its rupture

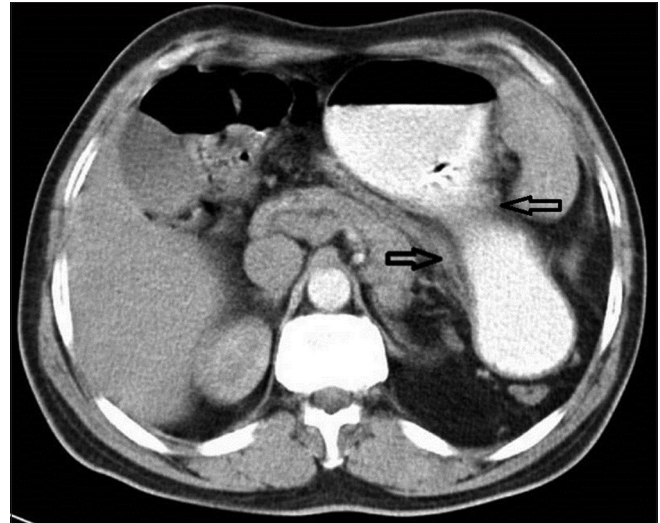
**Figure 8:** Collar sign: Same patient as in Figure 3. Axial CECT image of upper abdomen shows luminal narrowing of the herniated stomach at the site of the diaphragmatic tear (arrows)

- Collar sign: When the abdominal contents herniate into the diaphragm, luminal narrowing is noted at the site of the diaphragm rent. This appearance is known as the “collar sign” on imaging<sup>[4]</sup> [Figure 8]. Multiple organs may combine to manifest this sign. This sign has a sensitivity of 25-85% and a specificity of 80-100%. The collar sign is less valuable for right-sided injuries

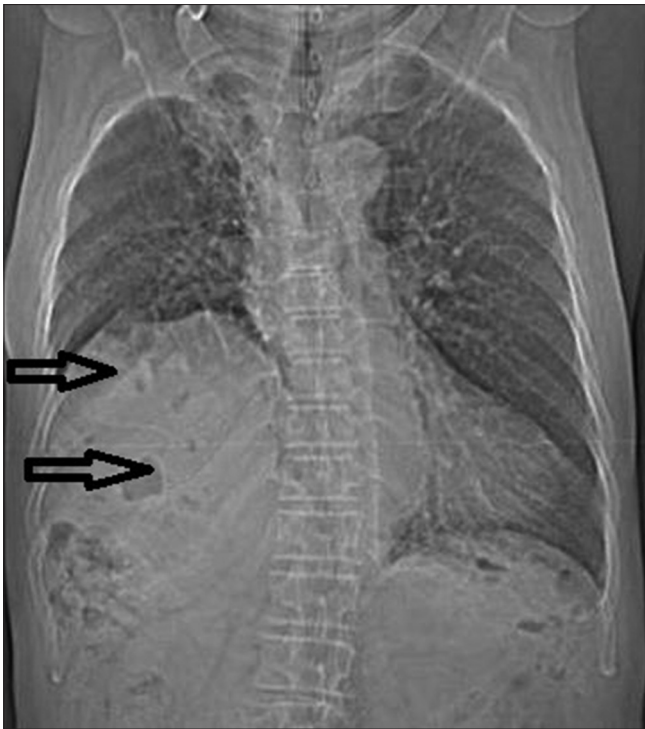
**Figure 9:** Elevated abdominal organs: Same patient as in Figure 2. CT topogram reveals elevation of liver and large bowel loops (Black arrows) on the right side

- Elevated abdominal organs: When the left-sided abdominal organs are visible 4 cm or more above the dome of the right hemidiaphragm or the right-sided abdominal organs are visible 5 cm or more above the dome of the left hemidiaphragm, they are considered to be abnormally elevated [Figure 9]. The sensitivity and specificity for this sign are 78.1% and 92.8%, respectively<sup>[3]</sup>

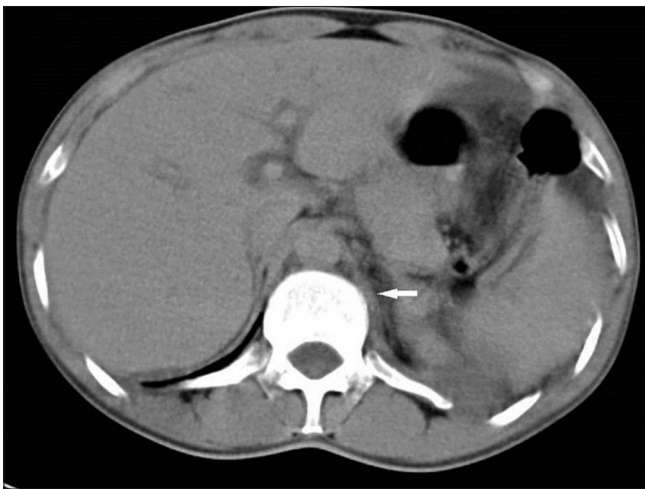
**Figure 11:** Hypoattenuated hemidiaphragm: Same patient as in Figure 6. Axial plain CT image of abdomen reveals hypodense and thickened left crus (white arrow) as compared to the right crus

- Hypoattenuated hemidiaphragm and associated rib fractures: A hypoattenuated hemidiaphragm found in association with other features of blunt diaphragmatic rupture like segmental non-recognition and thickening of the diaphragm may indicate devascularization of the diaphragmatic muscle [Figure 11].<sup>[2]</sup> Rib fractures are also an indicator of diaphragmatic rupture, as a fractured rib may lead to diaphragmatic laceration; however, this sign has poor sensitivity.

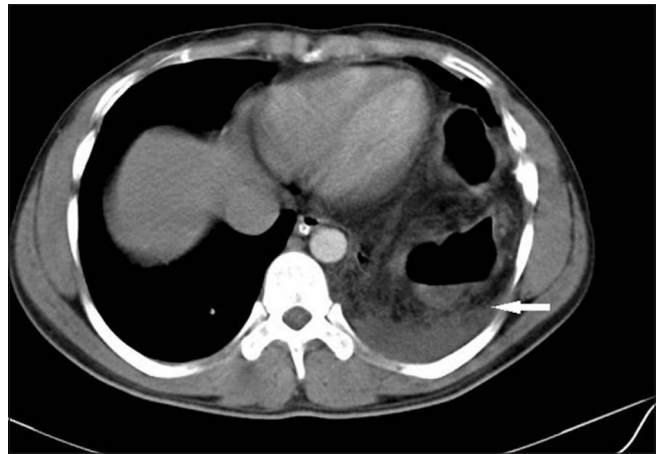
**Figure 10:** Thoracic fluid abutting abdominal viscera. A 37-year-old male patient with history of trauma few days ago presented in the emergency with features of intestinal obstruction. Axial contrast-enhanced CT image of upper abdomen reveals left pleural effusion that is abutting the herniated bowel (arrow)

- Thoracic fluid abutting abdominal viscera: Post-traumatic diaphragmatic rupture may be associated with pleural effusion. The herniating viscera may come in contact with this fluid [Figure 10]. The sensitivity of this sign is 44.4%, while its specificity is 68.5%.<sup>[3]</sup>

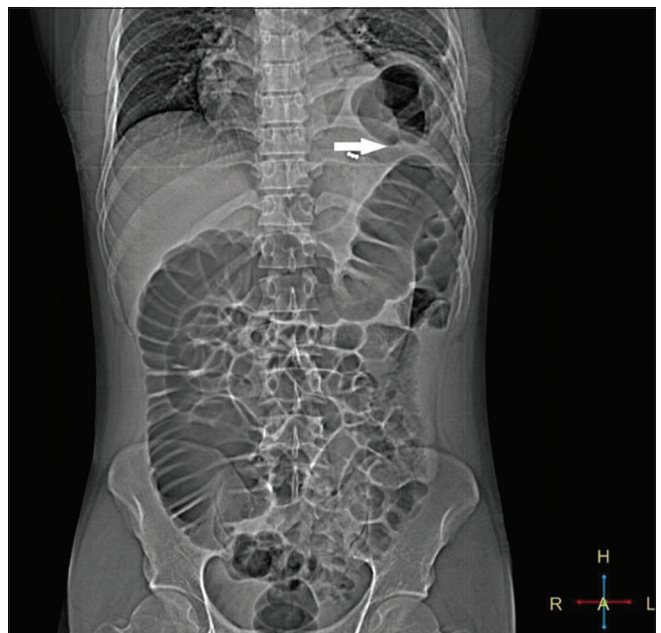
**Figure 12:** A 37-year-old male patient with history of trauma few days ago presented in the emergency with features of intestinal obstruction. CT topogram reveals a dilated air-filled large bowel herniating into the left hemithorax. The site of obstruction (arrow) is seen as an abrupt cut-off of the air column at the level of the diaphragm

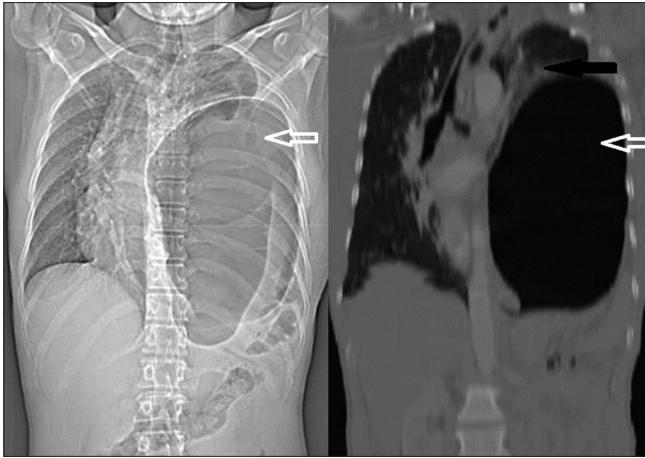
**Figure 13:** Tension gastrothorax. A 30-year-old male patient with history of trauma a month ago presented with vomiting and breathlessness. CT topogram and coronal image show evidence of air within the left hemithorax (air in dilated stomach) (white arrow) with absence of lung markings within, collapse of underlying lung, and mediastinal shift, similar to pneumothorax. However, in this case, the collapsed lung is pushed superiorly (black arrow) suggesting a diaphragmatic hernia, as opposed to a pneumothorax in which the lung is pushed inferomedially

opposite side. The clinical picture and imaging appearance are similar to tension pneumothorax [Figure 13].
